The captain's inappropriate response to a stick shaker activation was the probable cause of an unrecoverable stall and the crash of a Colgan Air Bombardier Q400 on approach to Buffalo Niagara (New York, U.S.) International Airport the night of Feb. 12, 2009, according to the U.S. National Transportation Safety Board (NTSB).

STARTLED AND CONFUSED

A bad reaction to a stick shaker triggered a stall.

This article is based on NTSB Accident Report NTSB/AAR-10/01, "Loss of Control on Approach; Colgan Air, Inc., Operating as Continental Connection Flight 3407; Bombardier DHC-8-400, N200WQ; Clarence Center, New York, February 12, 2009." The full report is available from the NTSB Web site, <www.ntsb.gov/publictn/2010/AAR1001.pdf>.

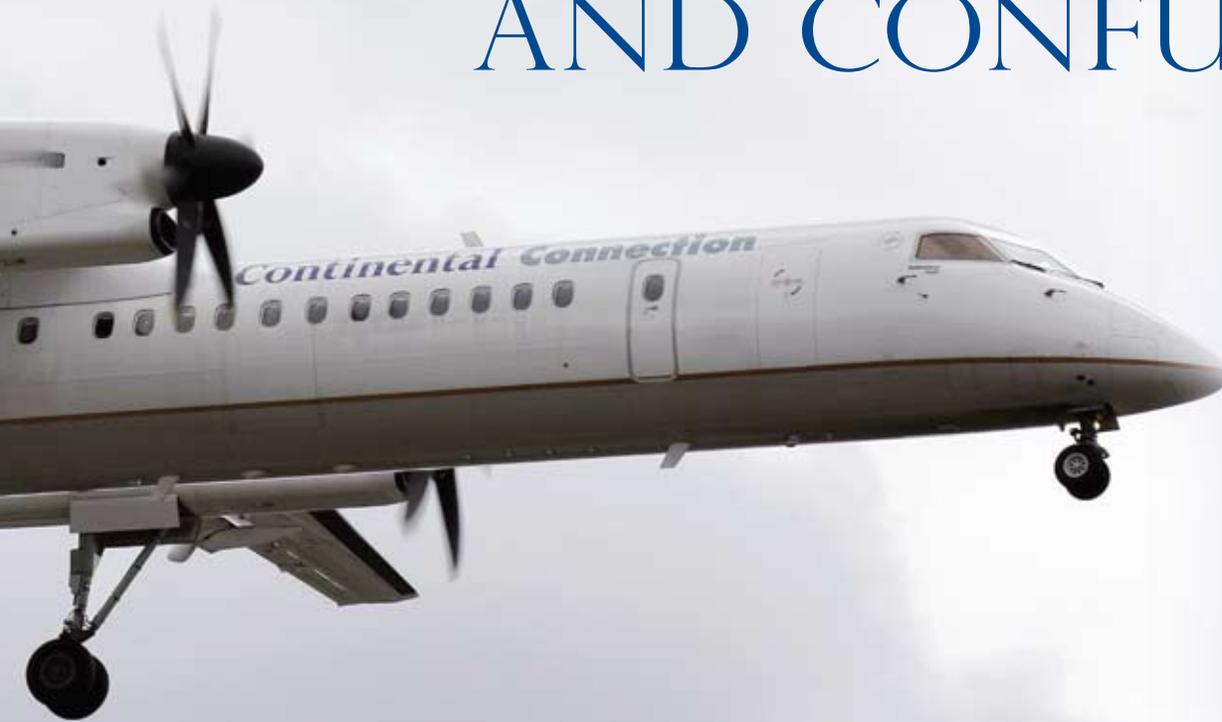
Fatigue was a likely factor in the crash of this Q400.

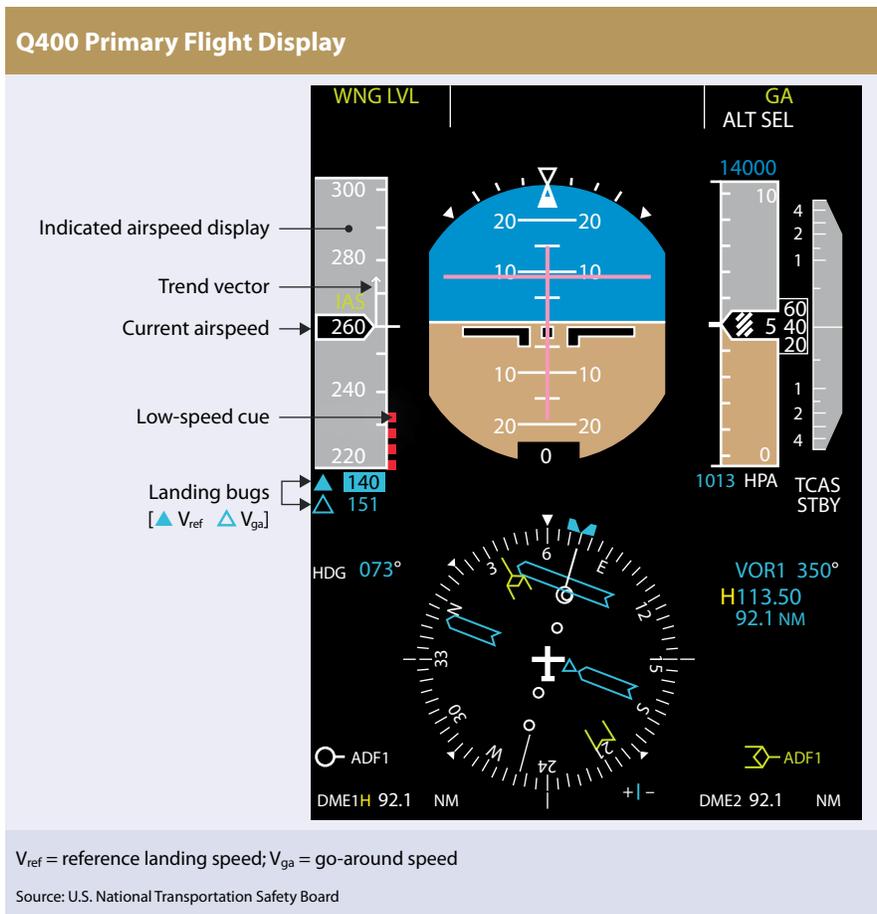
Figure 1

Other cues were provided by the airspeed data on the PFDs. Each display has a vertical airspeed scale with a trend vector, a white arrow, that indicates increasing or decreasing airspeed. The tip of the arrow indicates what the airspeed will be in 10 seconds if the trend continues. The trend vector in Figure 1, for example, shows that

airspeed is increasing from 260 kt and will be about 278 kt in 10 seconds.

A red and black vertical bar appears next to the airspeed scale to warn that airspeed is too low. The stick shaker activates when the indicated airspeed drops below the top of the bar. In addition, the displayed airspeed changes from white to red to provide another warning that airspeed is too low.

These low-speed cues were presented on the PFDs "with adequate time for the pilots to initiate corrective action, but neither pilot responded to the presence of these cues," the report said. "The failure of both pilots to detect this situation was the result of a significant breakdown in their monitoring responsibilities and workload management."
