**A fatal S-92A crash prompts a TSB call for action to keep large transport helicopters running for at least 30 minutes without main gearbox oil.**

# Running on Empty

*This article is based on TSB aviation investigation report A09A0016, Main Gearbox Malfunction/Collision With Water; Cougar Helicopters Inc; Sikorsky S-92A, C-GZCH; St. John’s, Newfoundland and Labrador, 35 NM E; 12 March 2009.*

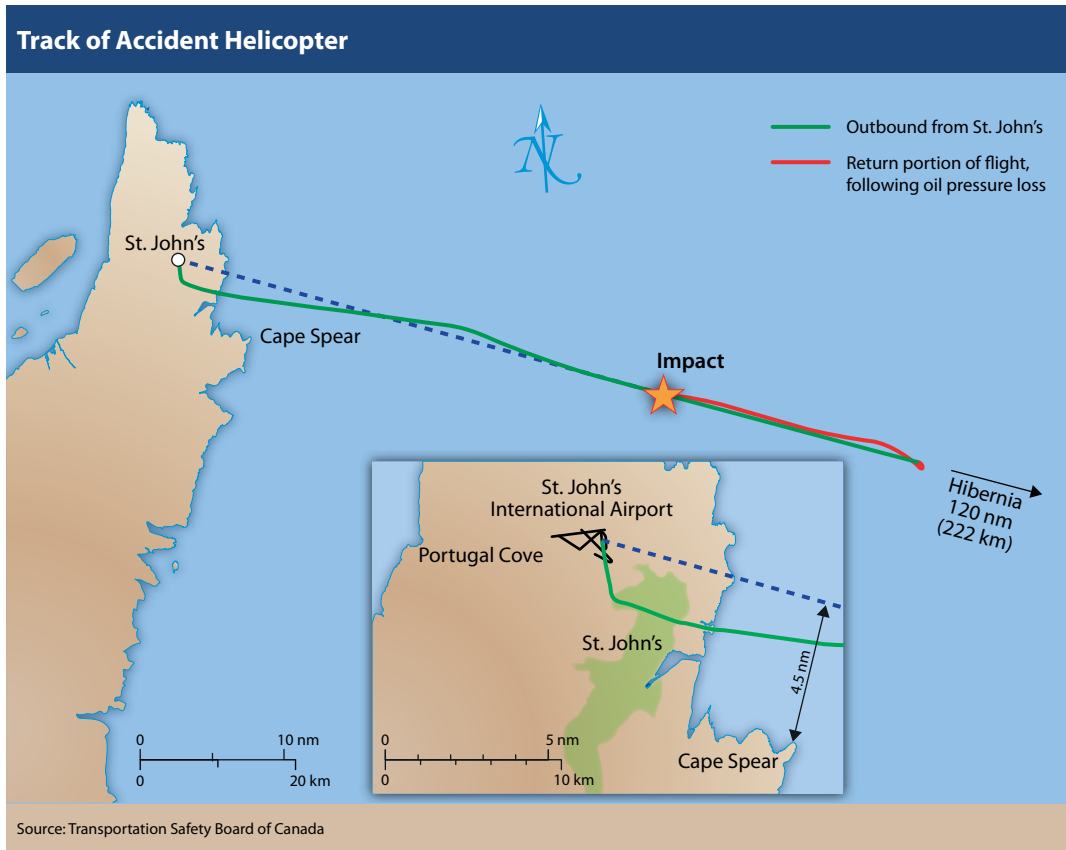
Figure 1

The helicopter departed from St. John’s International Airport at 0917 local time and, at 0932, leveled off at 9,000 ft; the amended instrument flight plan estimated a 1040 arrival time at the oil rig (Figure 1, p. 20). At 0945, according to data from the flight data recorder (FDR), MGB oil pressure began decreasing. An amber “MGB OIL PRES” caution message illuminated and was followed almost immediately by a red “MGB OIL PRES” warning message, accompanied by the aural warning of “GEARBOX

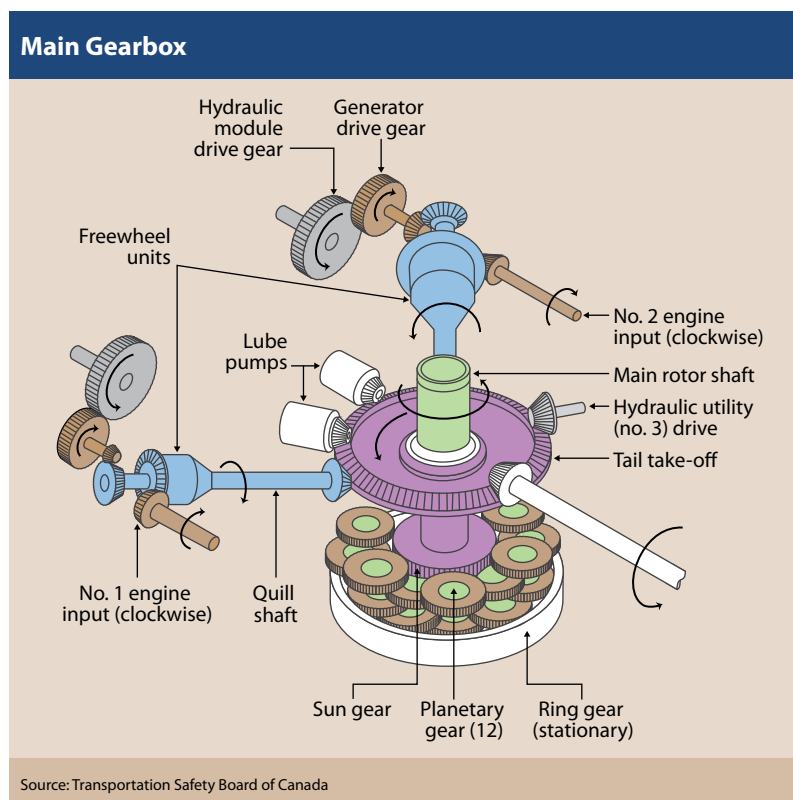
Figure 2

The MGB is part of the helicopter’s main transmission assembly (Figure 2). The oil filter bowl in the accident helicopter was attached to

the MGB housing with “three equally spaced titanium alloy stud and self-locking nut assemblies,” the report said. Manufacturers select the types of fasteners to be used, and Sikorsky chose titanium alloy studs “because these had been used successfully on other Sikorsky products. ... Also, Sikorsky declared that there was no reported history of in-service titanium stud failures.”

The oil filter bowl fasteners included anodized titanium alloy studs, silver-plated steel nuts and cadmium-plated steel washers. Anodizing and plating are used to make parts more resistant to corrosion, wear and galling — defined in the report as a type of wear in which material is “removed or displaced from a surface”; titanium and titanium alloys are prone to galling, the report said.

Sikorsky asked operators to return the titanium studs that were removed, and “all of these studs, as well as the studs recovered from the occurrence helicopter and the other Cougar helicopters, had different severities of galling, which would be consistent with a difference in the number of times the nut was installed and removed,” the report said.

The report said that Cougar Helicopters “did not effectively implement the mandatory maintenance procedures in ... AMM Revision 13, and therefore, damaged studs on the filter bowl assembly were not detected or replaced.”

In October 2008, Sikorsky stopped using titanium studs in new S-92As and said that failed titanium studs in helicopters already in service should be replaced with steel studs; the following month, a revision of the aircraft maintenance manual (AMM) described mandatory inspection procedures for detecting damaged MGB mounting stud threads; and in January 2009, an

alert service bulletin was issued requiring the replacements within 1,250 flight hours or one year.
