A flight crew’s landing on a taxiway prompts calls to enhance ASDE-X, airport lighting and ATC communication.

BY WAYNE ROSENKRANS

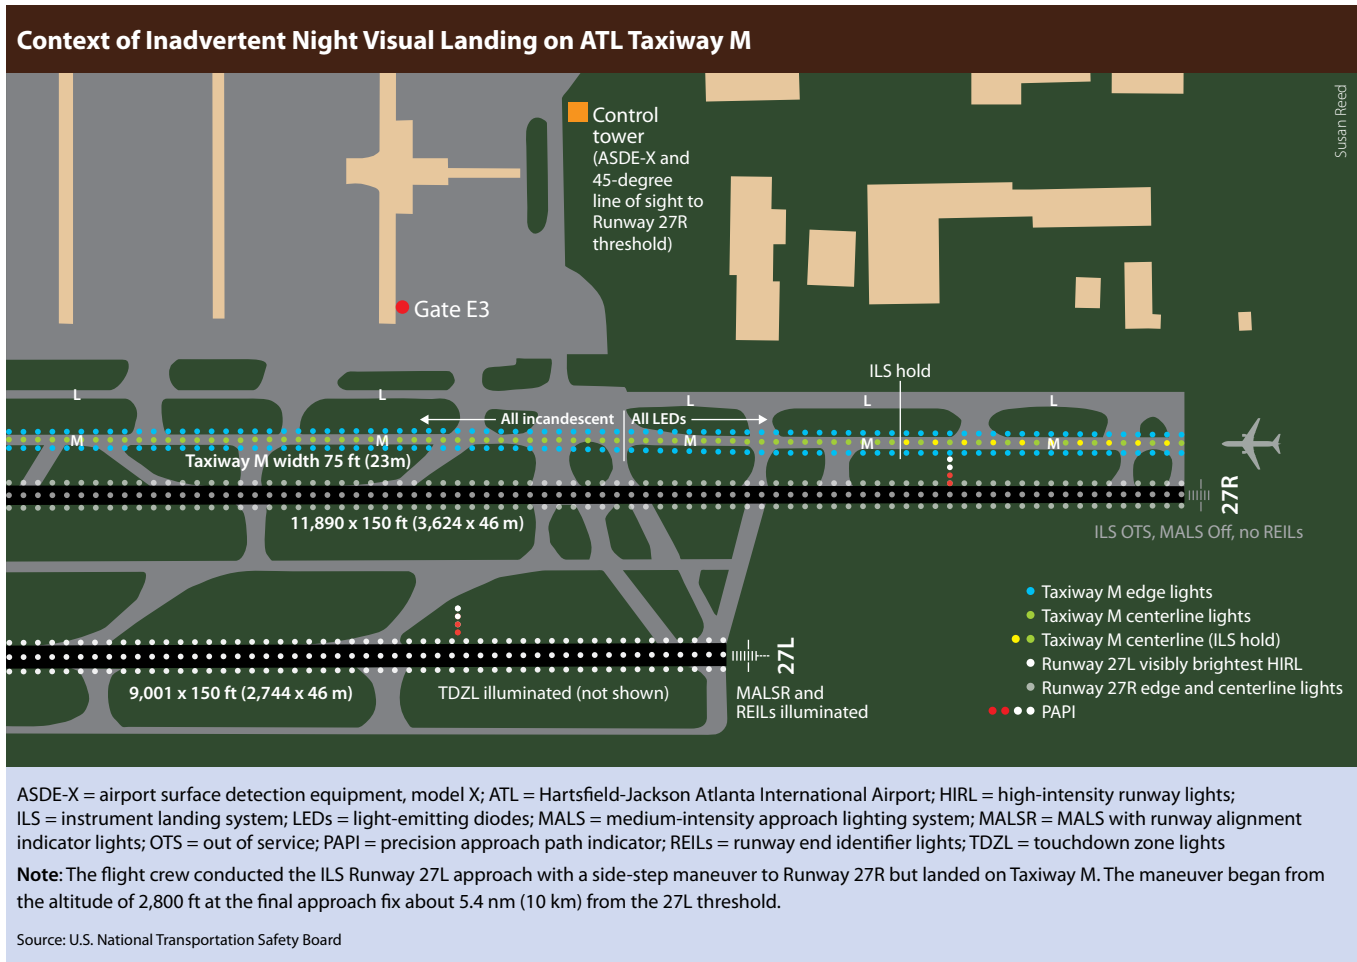
Figure 1

Multiple visual cues could have misguided the captain to align with Taxiway M instead of Runway 27R while on final approach, however, the NTSB said. “These cues included numerous taxiway signs along the sides of Taxiway M which, from the air, appeared to be white and could be perceived as runway edge lights. In addition, the blue light-emitting diode (LED) lights used on the eastern end of Taxiway M [Figure 1, p. 44] were per-

ceived to be brighter than the adjacent incandescent lights on the airfield, and the alternating yellow and green lights in the ILS critical area [of Taxiway M] provided the appearance of a runway centerline.

“The edge and centerline lights for Runway 27R were set to step 1 [the correct minimum intensity, as the FAA specifies during nighttime visibility of more than 5 mi (8 km)] at the time of the incident, the edge lights for Taxiway M were set to the maximum settings [that is, step 3 on the east and west ends and step 5 in the mid-section instead of the FAA-specified step 1 for all edge lights], and Taxiway M centerline lights were set to step 2 [instead of the FAA-specified step 1 for the east and west ends and step 3 for the mid-section].”^{1,2}

An airport maintenance supervisor noted that management had directed that the nighttime appearance of the north and south sides of the airport be uniform, and also had increased the centerline preset for Taxiway M to step 2 “to compensate for the difference in the output level of the LED and the incandescent lighting,” the NTSB said.

The NTSB’s latest safety recommendations call for advisory circular (AC) revisions clarifying that airport

operators should inform air traffic managers of such changes. The NTSB also proposed amending FAA Order 7210.3, “Facility Operation and Administration,” to direct that “at airports with air traffic control towers equipped with airport lighting control panels that do not provide direct indication of airport lighting intensities, the air traffic manager annually reviews and compares, with the airport operator, the preset selection settings configured in the tower lighting control system to verify that they comply with FAA requirements.”
