Spiral Dive

An overwater departure on a dark, stormy night ends in the Mediterranean.

This article is based on the Lebanese Ministry of Public Works and Transport “Investigation Report on the Accident to Ethiopian 409, Boeing 737-800, Registration ET-ANB, at Beirut, Lebanon, on 25th January 2010.” ET 409, January 2012.

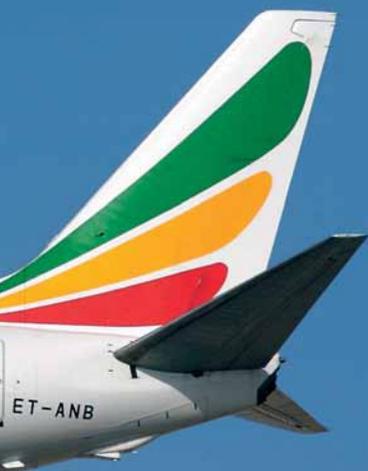
Investigators determined that the captain likely experienced spatial disorientation and lost control of this 737.

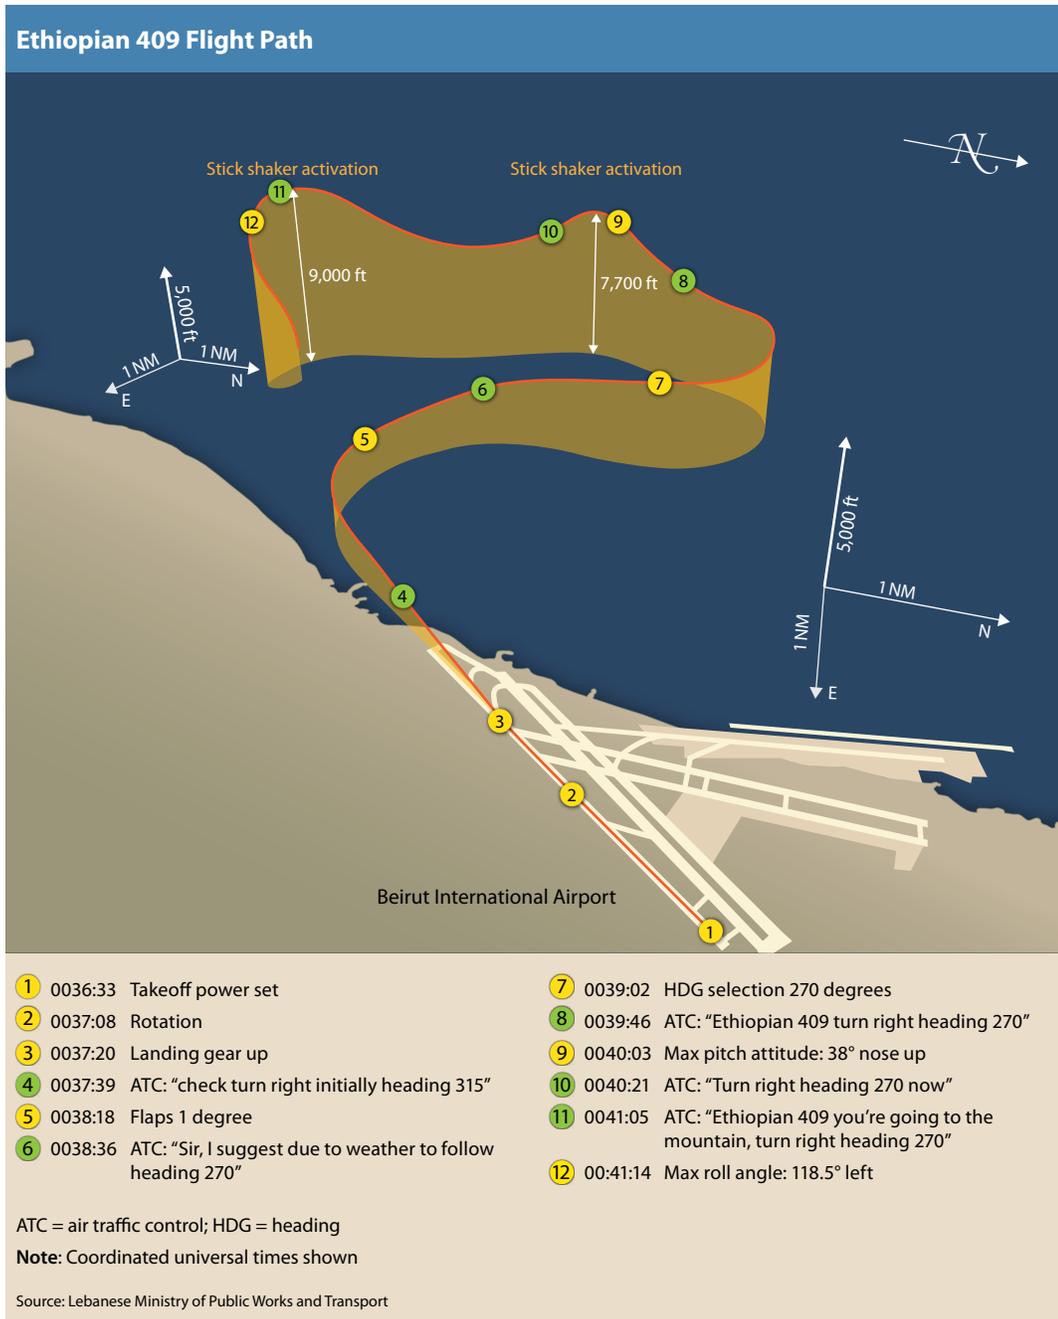
The 737 was lifting off the runway when the controller again revised the clearance, instructing the crew to turn right to an initial heading of 315 degrees (Figure 1, p. 14). The first officer acknowledged the instruction and set the assigned heading on the aircraft's mode control panel (MCP).

During this exchange, the captain had continued the right turn through the selected heading of 315 degrees, and the bank angle had increased beyond 35 degrees, triggering two enhanced ground-proximity warning system "BANK ANGLE" warnings.

“This was associated with a sharp left [control] wheel input ... which resulted in a roll angle of 45 degrees, reaching a maximum of 64 degrees left [bank] and triggering five automatic ‘BANK ANGLE’ calls,” the report said.
