# Watery Illusions

Pilots of the Super Puma misunderstood their location during an overwater approach to a North Sea helideck.

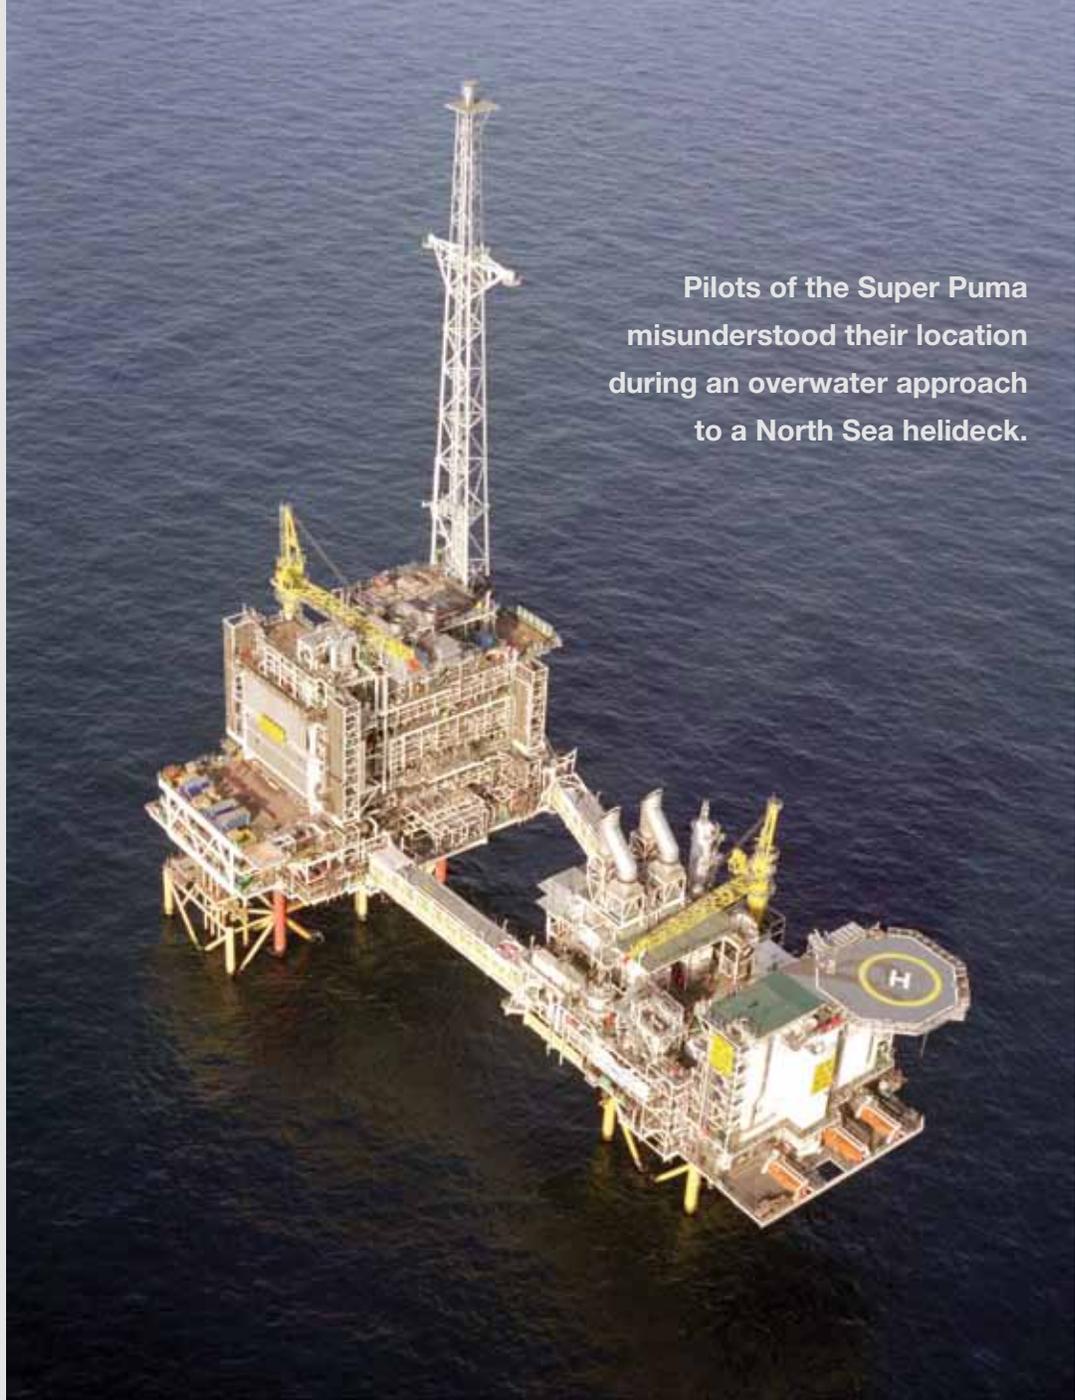
Fog or low clouds during the approach probably degraded the visual cues provided by platform lighting, accident investigators said.

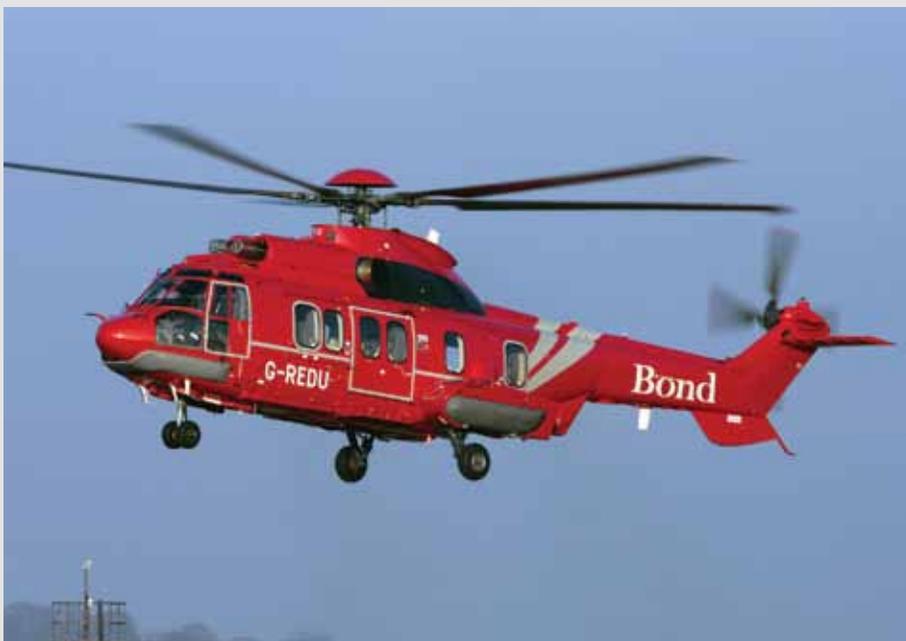
The Eurocopter EC225 LP Super Puma was destroyed by the impact with the sea, exposure to salt water and damage incurred during salvage operations.
