# Verge of Consciousness

Hypoxia prevented the pilot from understanding what the gauges were telling him.

BY MARK LACAGNINA

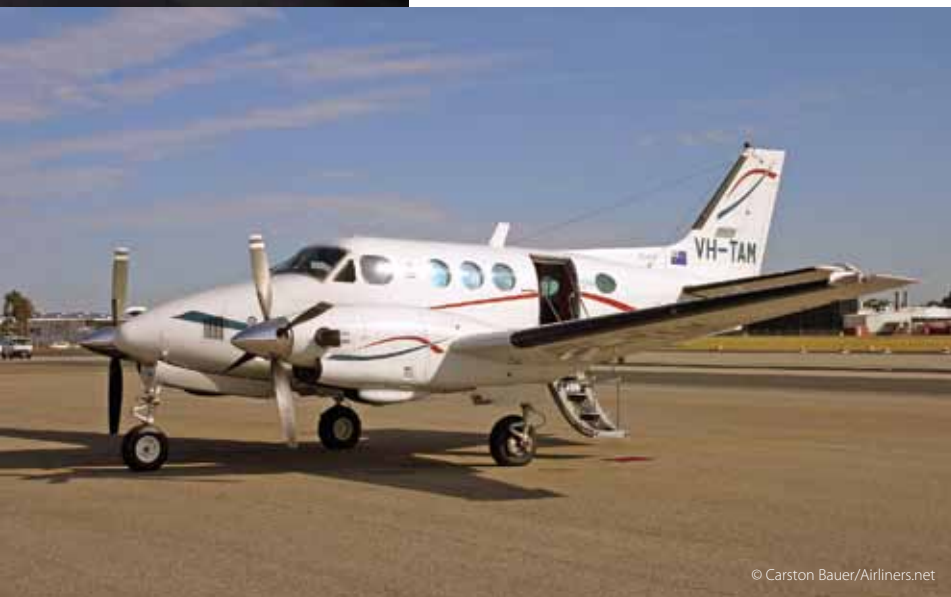
The pilot also told investigators he noticed that the cabin altimeter was indicating 20,000 ft. “He recalled feeling some concern at this but at the time being unable to reason what to do to alleviate that concern,” the report said.

If the pressurization system had been set properly and was functioning properly, the indicated cabin altitude at FL 210 should have been about 8,000 ft. An indication of 20,000 ft meant that the cabin was not pressurized.

The cabin altimeter reading caused concern ... and confusion.

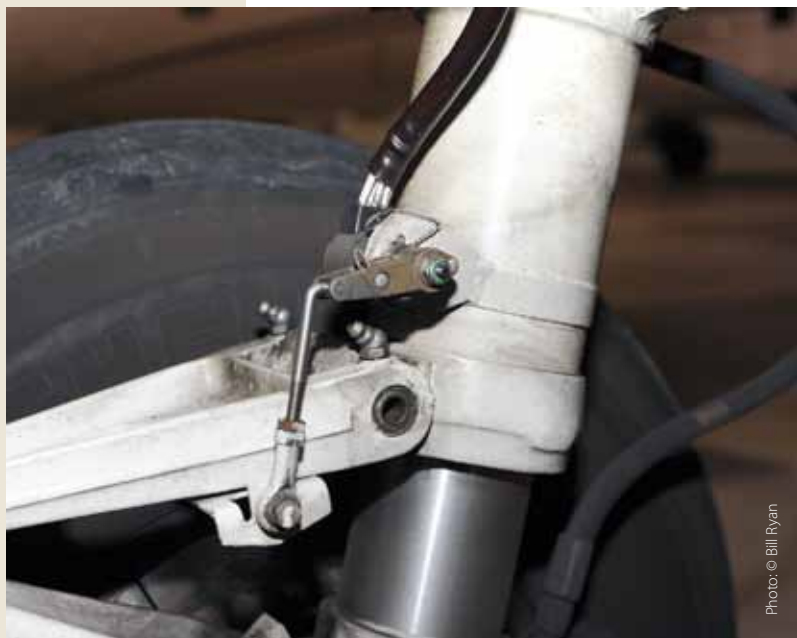
An incorrectly adjusted squat switch prevented the cabin from pressurizing when the landing gear was retracted.

The safety switch on the incident aircraft was not adjusted correctly. “Maintenance personnel [who examined the switch said] that the adjustment was found to be on a ‘hairline’ setting, with the effect that the switch sometimes worked correctly and at other times did not,” the report said.

The switch apparently did not extend sufficiently to close the safety outflow valve on takeoff for the incident flight. Thus, although the cabin pressurization controller had been set correctly, the cabin did not pressurize, and the pilot did not detect the anomaly.
