An area of the fuselage that didn't meet Boeing's thickness specifications is blamed for a 757's rapid decompression.

BY LINDA WERFELMAN

THIN SKINNED

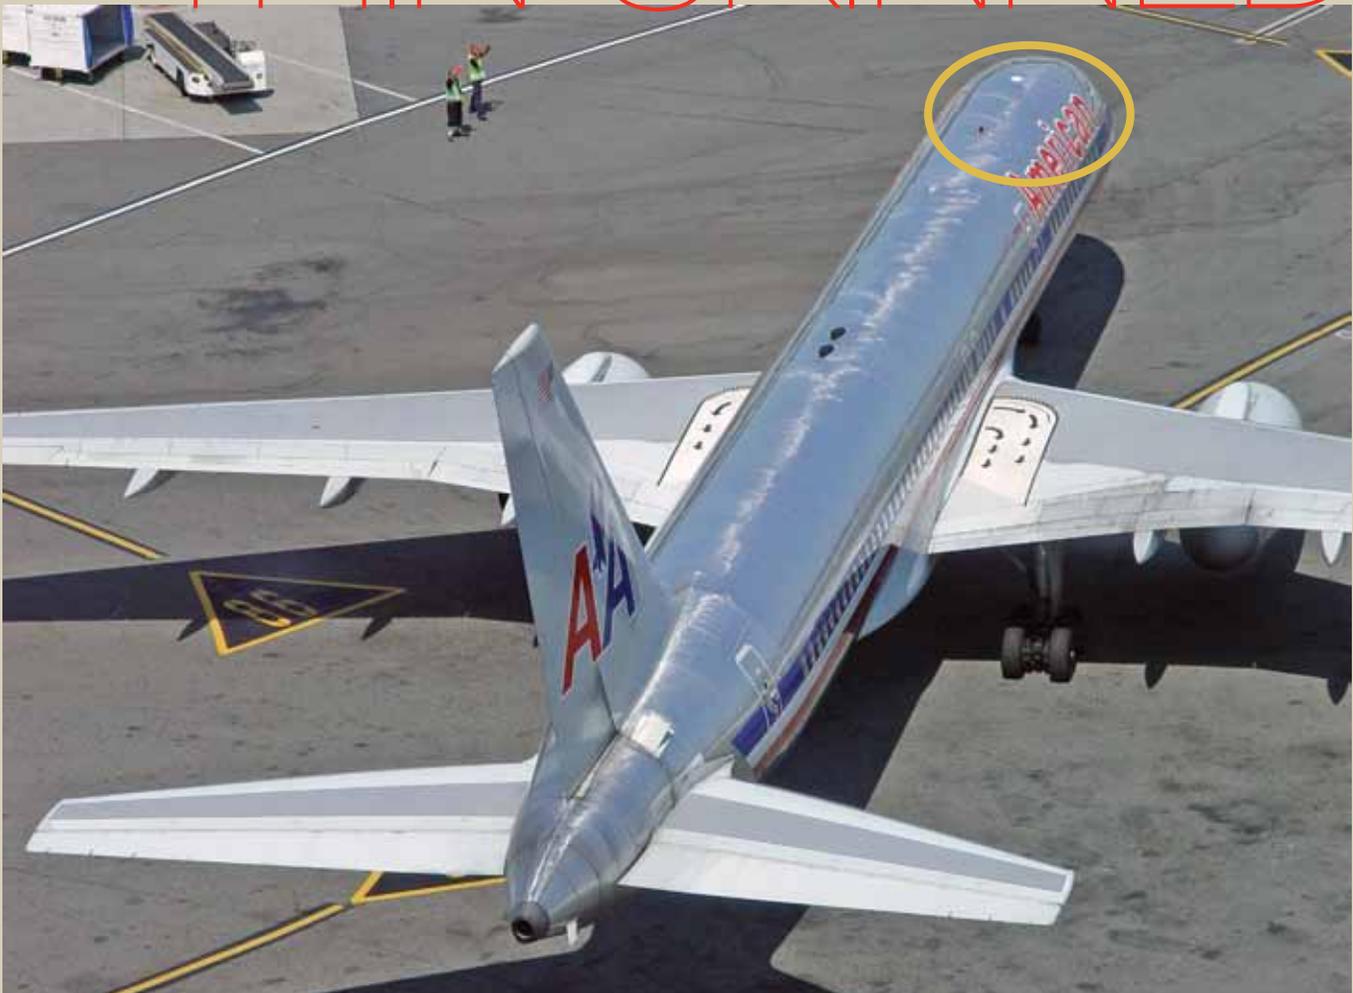
This 757 is one of several airplanes to experience a fuselage rupture above a forward passenger door, accompanied by a rapid decompression.

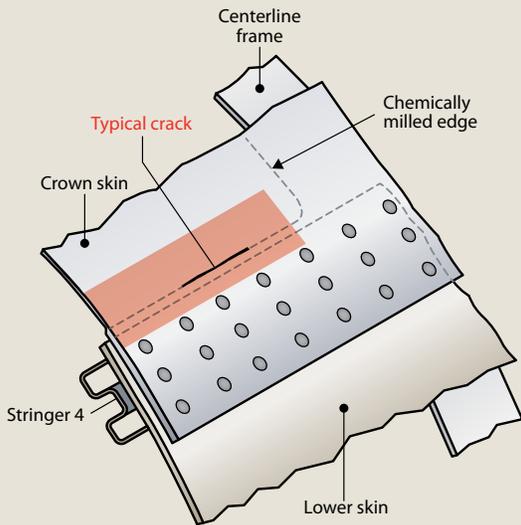
Figure 1

In its final report on the Miami accident, the NTSB noted fatigue cracking in the fuselage crown skin, where the rupture occurred, “along the lower longitudinal step of the chemically milled pocket just above the stringer S-4L (left) lap joint.” The fatigue cracks began at multiple locations on the

Although Boeing specified that the skin in that area of the fuselage must be 0.039 in (0.99 mm) thick, investigators measured the thickness at 0.035 in (0.89 mm) to 0.037 in (0.94 mm), the report said (see “Milling Process”).

Area of Cracking in Boeing 757 Fuselage

Note: Cracks were found above the left forward passenger door.

- On Nov. 22, 2010, Boeing issued Service Bulletin (SB) 757-53-0097, calling for repetitive external inspections, about every 300 flight hours, for cracks in the fuselage skin in the area of the fuselage rupture in the accident airplane.
- On Jan. 10, 2011, with the issuance of Airworthiness Directive (AD) 2011-01-15, the FAA mandated the inspections recommended in the service bulletin.
