# No Decision at DECISION HEIGHT

**Citation pilots were taken off guard by a fast-moving fog bank.**

BY MARK LACAGNINA

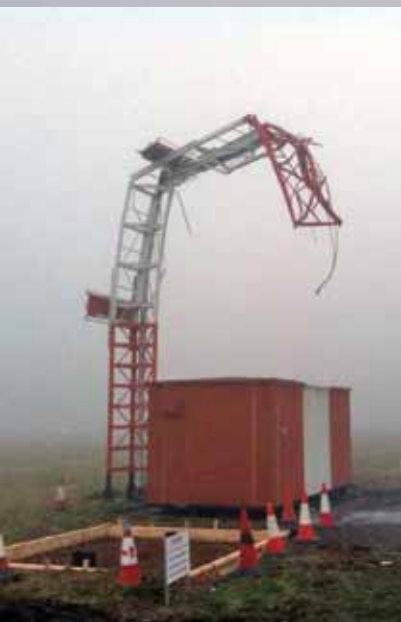
The aircraft struck the glideslope antenna before hitting the ground.

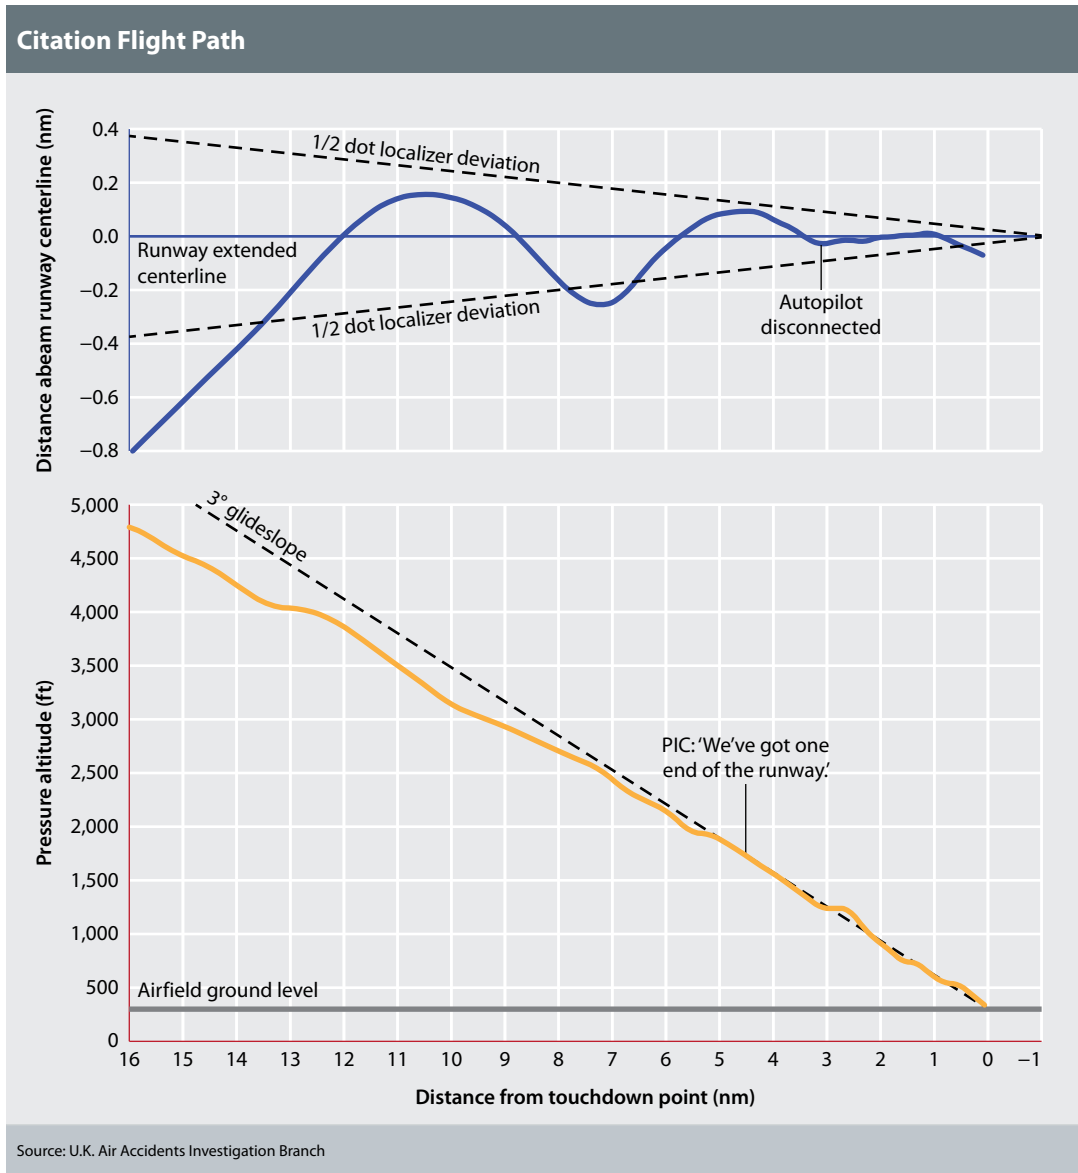
Figure 1

Apparently because of the high speed, the aircraft flew through the localizer centerline about 12 nm (22 km) from the runway touchdown zone (Figure 1, p. 24). The autopilot then turned the aircraft to a track of 158 degrees but again failed to capture the localizer. Groundspeed was 242 kt when the Citation flew through the localizer centerline about 9 nm (17 km) from the runway touchdown zone.

centerline a third time about 6 nm (11 km) from the touchdown zone. The copilot disengaged the autopilot and hand-flew the aircraft, establishing it on the localizer about 3 nm (6 km) from the runway touchdown zone. Groundspeed by then had decreased to 122 kt.
