START-UP PROBLEMS

An in-flight engine fire followed maintenance technicians' use of an inappropriate procedure to manually start a balky engine on an MD-82.

BY LINDA WERFELMAN

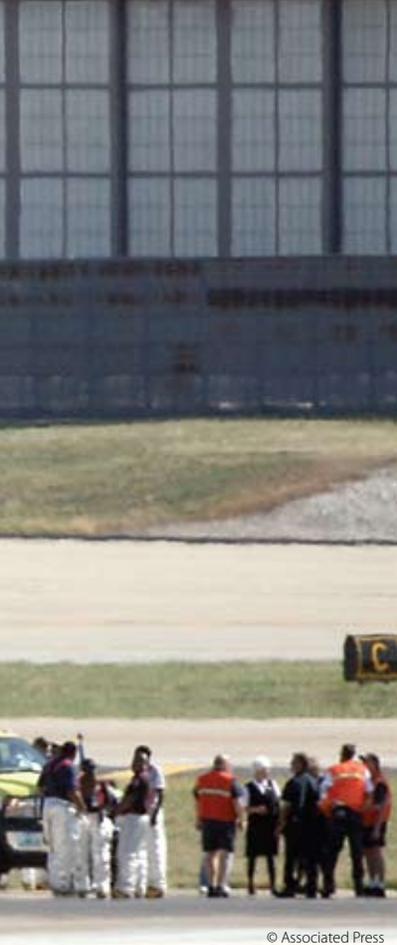
Airport vehicles surround an MD-82 after an emergency landing in St. Louis in 2007. Below, an airport worker examines soot near the left engine.

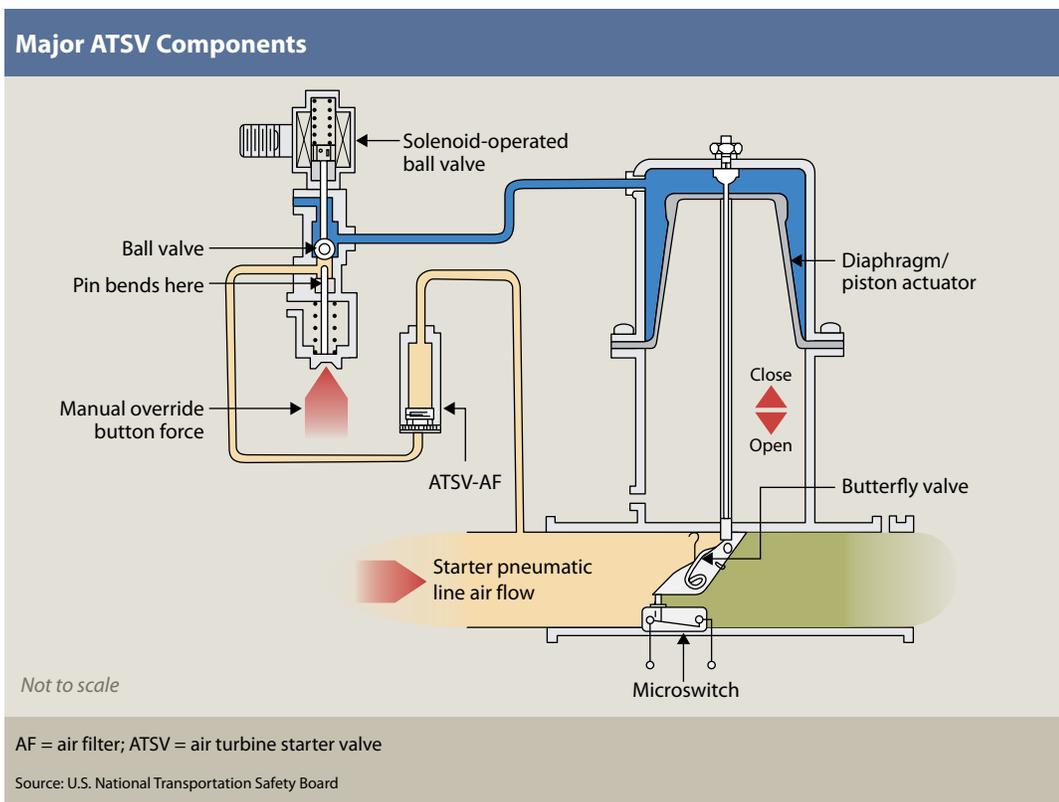
Figure 1

Each engine had an engine-start system consisting of a pneumatic air turbine starter (ATS), an ATSV — which the report described as an “electrically controlled and pneumatically operated butterfly-type valve” that controls airflow into the ATS, an ATSV air-filter assembly, an engine-start switch, an “ATSV-OPEN” light, an engine-start system wiring harness and a pneumatic line that carries air from the pneumatic power source to the ATSV inlet (Figure 1, p. 36).

After a 1996 incident ... Boeing ... cautioned maintenance personnel not to use any tool to depress the manual override button.

After a 1996 incident involving an uncommanded ATSV-open event during climbout, Boeing issued All Operators Letter 9-2549, which cautioned maintenance personnel not to use any tool to depress the manual override button. The investigation of that incident determined that the manual override button had stuck in the override position because its internal pin had been bent.

Use only hand pressure to depress override button. Use of screwdriver or other type of prying device to depress override button can deform slender pin mechanism inside valve. A deformed override button pin can hold solenoid switcher ball off its seat, which allows valve to open uncommanded when air pressure is available to engine start valve.
