How seemingly small deviations conspired in an approach accident.

Anatomy of a System Failure

BY SHAWN PRUCHNICKI

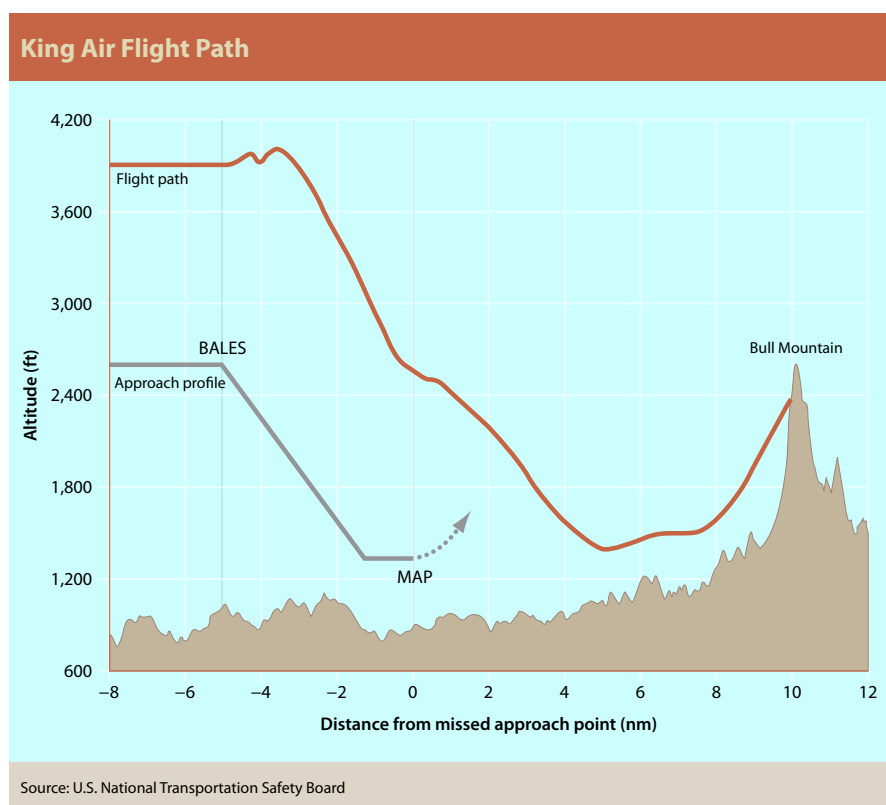
Figure 1

The King Air crossed BALES inbound at 4,000 ft — 1,400 ft higher than the charted crossing altitude of

2,600 ft (Figure 1). The aircraft was 2 nm (4 km) past BALES — and 3 nm (6 km) from the end of the runway, where the missed approach point (MAP) is located — when the crew began a descent from 4,000 ft. They passed through 2,600 ft as they passed the MAP.

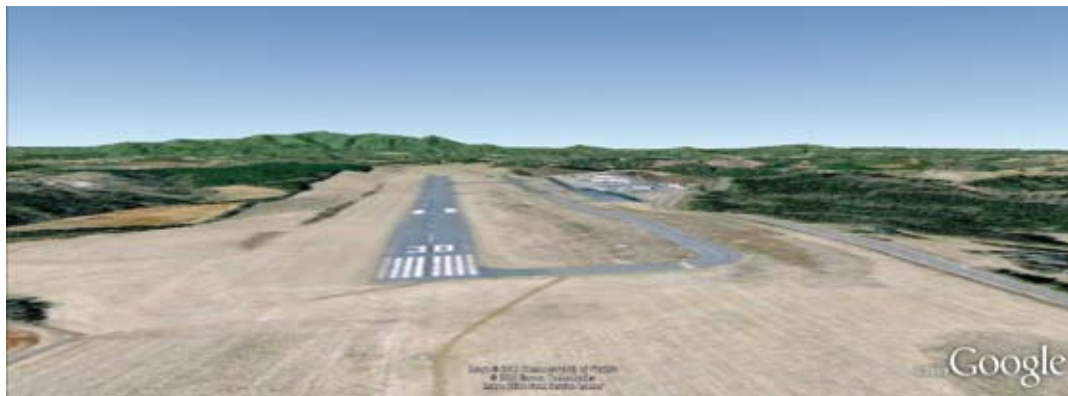
In visual conditions, Bull Mountain is a prominent feature on the extended centerline of Runway 30 at the Martinsville airport.
