The NTSB says a Bell 222 HEMS pilot's inadequate preflight planning was responsible for his helicopter's collision with a radio tower.

Poor Planning

This article is based on NTSB accident report CEN09MA019 and accompanying docket information.

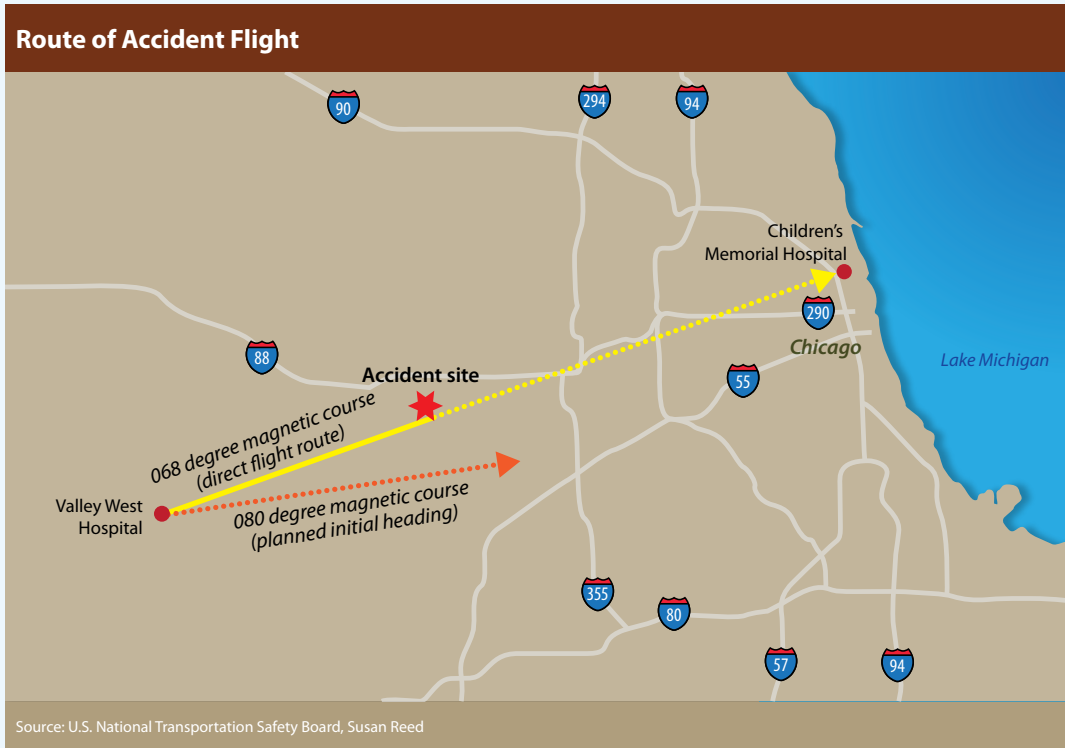
Figure 1

The radar display at the DuPage air traffic control tower showed one aircraft with a position and track that corresponded to the accident helicopter’s direct track from 0LL7 to 40IS, at an altitude between 1,300 and 1,400 ft. The radio station tower was “in line with the flight path depicted by the recorded radar track,” the report said. The final radar return was at 2358:25.
