The 737 stalled after the autothrottles disengaged without notice.

IDLE

This article is based on AAIB Aircraft Accident Report 3/2009, “Report on the Serious Incident to Boeing 737-3Q8, Registration G-THOF, on Approach to Runway 26, Bournemouth Airport, Hampshire, on 23 September 2007.”

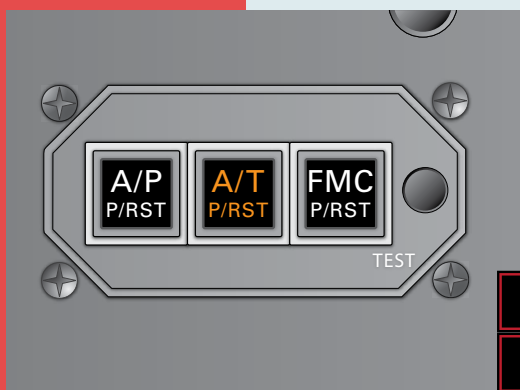
The autothrottle (A/T) annunciator flashes so often during approach that it may be perceived as a nuisance message.

Why the pilots did not see the flashing red light on the instrument panel that warns of autothrottle disengagement also was unanswered. The annunciator is a small rectangular pushbutton lens in the upper center of the instrument panel. Labeled “A/T P/RST” — “autothrottle, push to reset” — the annunciator also generates a flashing amber caution light when airspeed is 10 kt above or 5 kt below the selected speed or decreases to “alpha floor,” or 1.3 times the stalling speed.

“The autothrottle warning ... flashes amber routinely for extended periods during the approach phase of flight,” the report said. “It is likely that flight crews are subconsciously filtering out what is perceived as a nuisance message.”

As a result, AAIB recommended that Boeing and the U.S. Federal Aviation Administration review the effectiveness of the autothrottle system disengagement warnings in 300-, 400- and 500-series 737s and improve them if necessary. AAIB also called on the European Aviation Safety Agency to review Certification Standard 25 for transport category airplanes to “ensure that the disengagement of autoflight controls, including autothrottle, is suitably alerted to flight crews.”

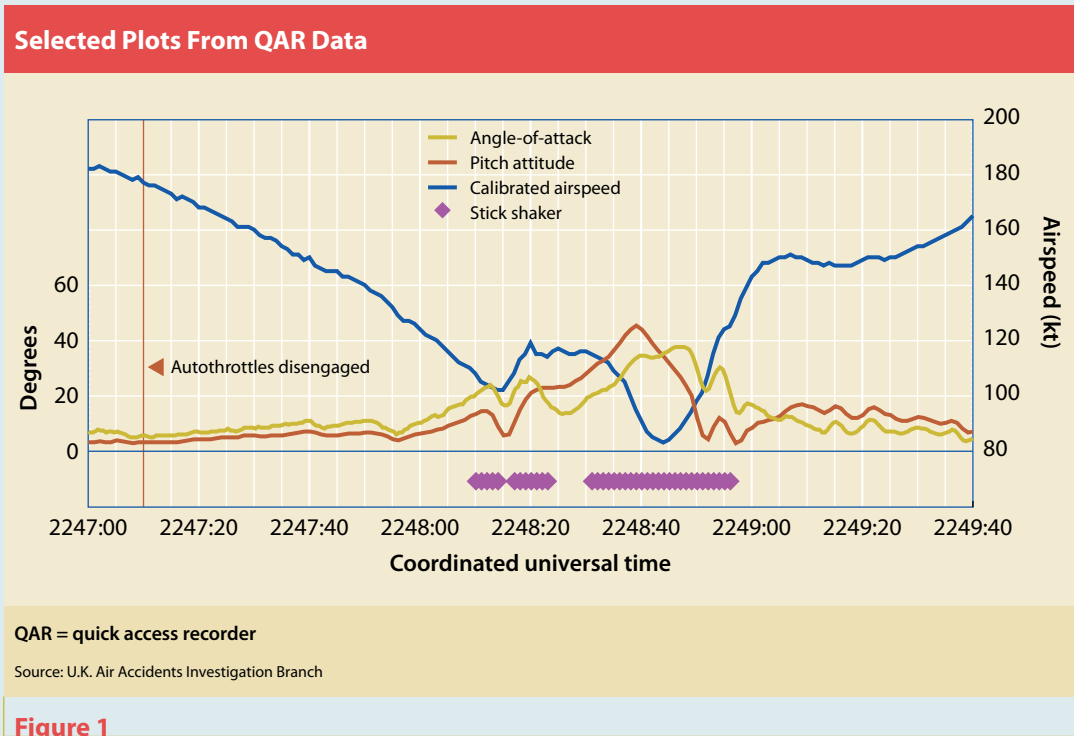
Figure 1

The aircraft was descending through 1,540 ft with a 12-degree nose-up pitch attitude and airspeed slowing below 110 kt when the commander moved the thrust levers full forward. As he did so, the stick shaker activated to warn of an impending stall (Figure 1, page 30). The commander engaged the autopilot’s control wheel steering mode and moved his control column forward, reducing the pitch attitude to 5 degrees nose-up. “The stick shaker operation stopped, and the minimum airspeed was 101 kt,” the report said. “A small, apparently unintended application of right aileron induced a right roll.”

Calibrated airspeed (CAS) decreased below 107 kt as the pitch attitude reached 36 degrees and the left bank increased beyond 13 degrees. The TOGA mode disengaged. A right rudder control input brought the wings level before the 737 stalled with a nose-up pitch attitude of 44 degrees.
