BY MARK LACAGNINA

Beyond Redemption

Spatial disorientation turned a minor upset into a major accident.

This article is based on the technical commission of inquiry’s report, “Technical Investigation Into the Accident of the B737-800 Registration 5Y-KYA Operated by Kenya Airways That Occurred on the 5th of May 2007 in Douala.” The full report is available at <www.ccaa.aero/surete-et-securite-aerienne-141>.

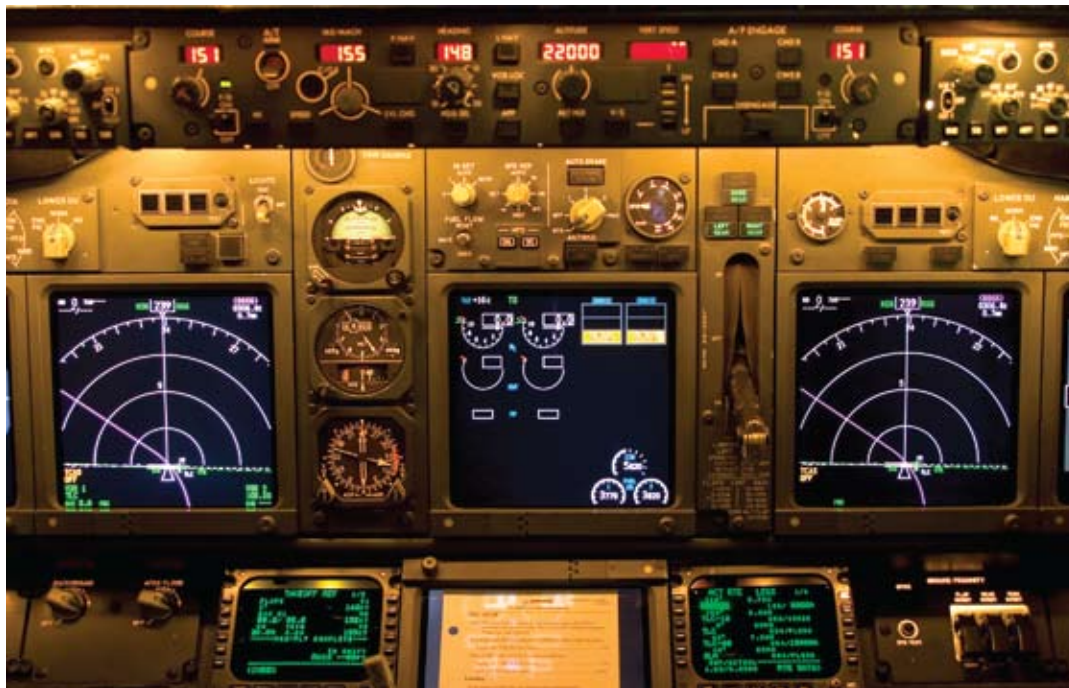
Neither pilot noticed that the autopilot did not engage when the “CMD” (command) push button, on the right side of the mode control panel at the top this photo, was pressed.

Recorded flight data showed that the “CMD” (command) push button on the mode control panel had indeed been pressed to engage the autopilot, but the report said that the autopilot likely failed to engage because forward pressure was being applied manually to a control column at the same time. The report said that the captain’s subsequent behavior indicated that he believed the autopilot was engaged and that trim inputs effected by the autothrottle in response to excessive airspeed changes might have reinforced that impression.
