Something Changed

The short runway was familiar, but the big new bizjet was not.

This article is based on TSB Aviation Investigation Report A07A0134, “Touchdown Short of Runway; Jetport Inc.; Bombardier BD-700-1A11 (Global 5000), C-GXPR; Fox Harbour Aerodrome, Nova Scotia; 11 November 2007.”

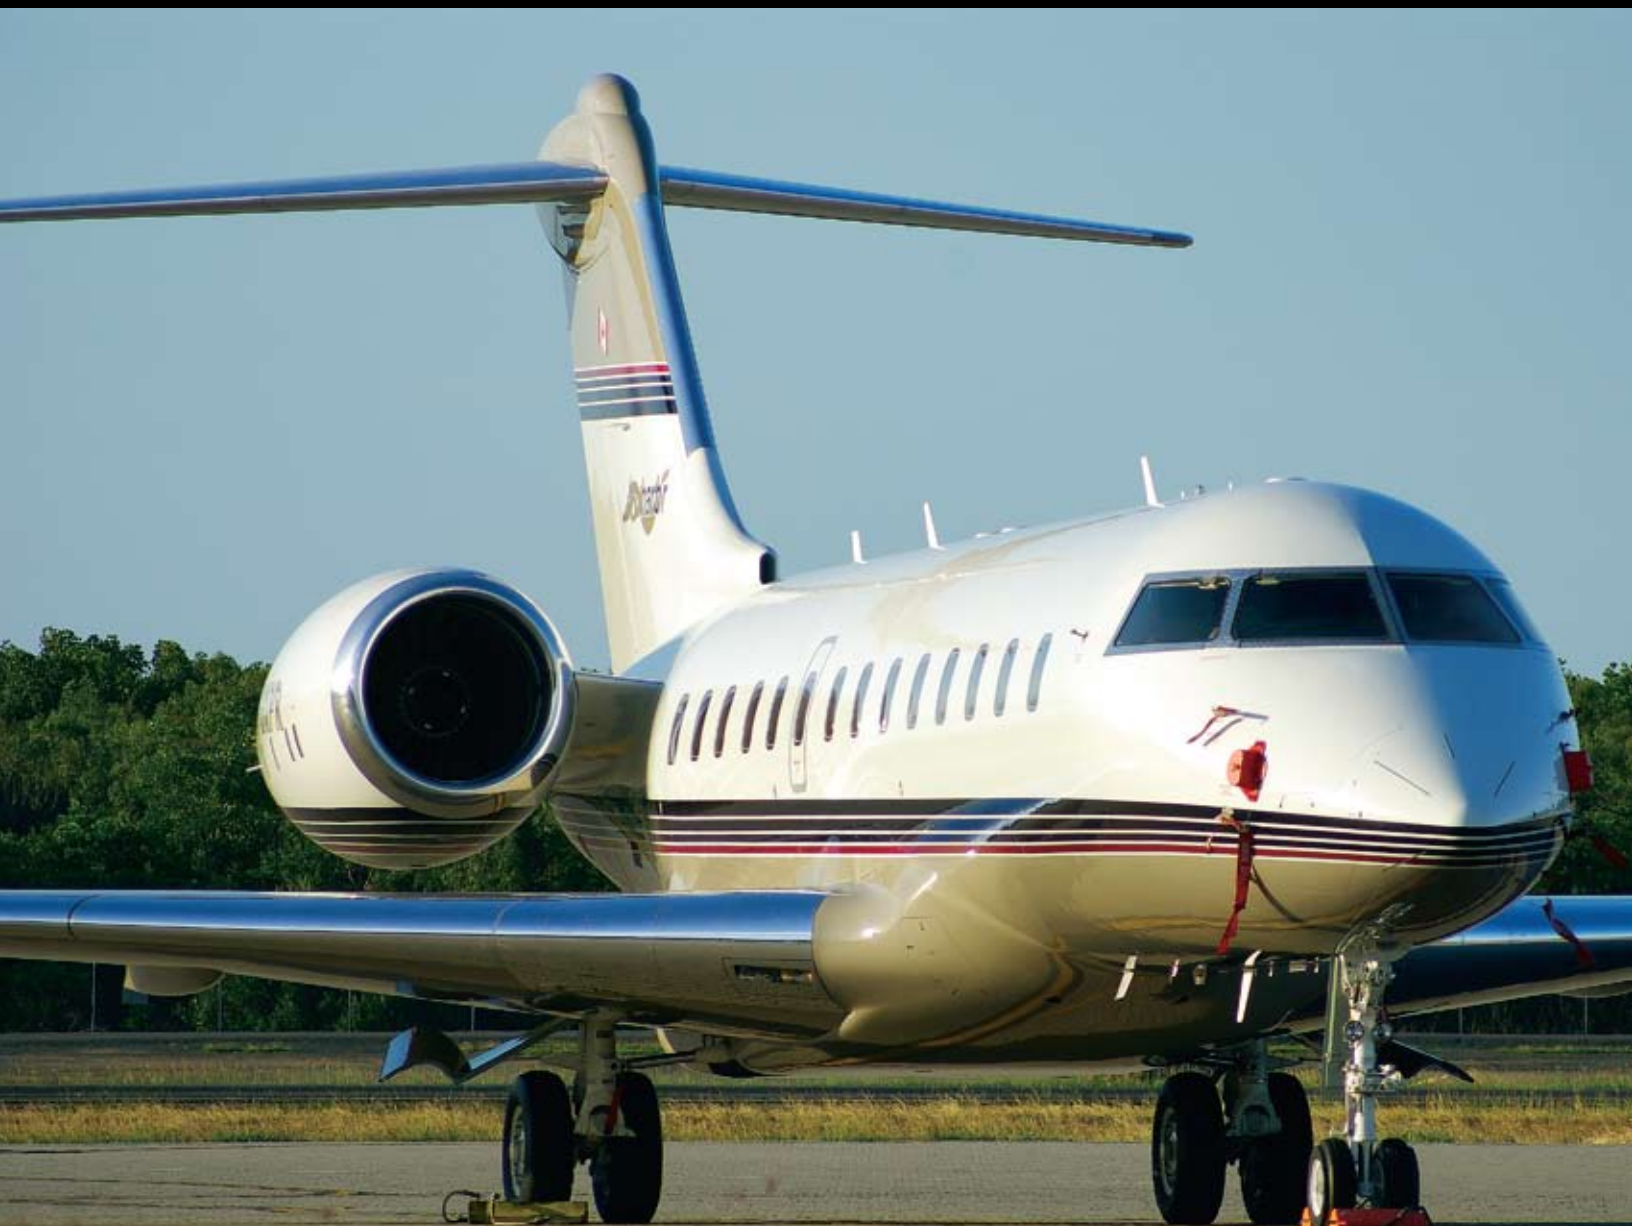
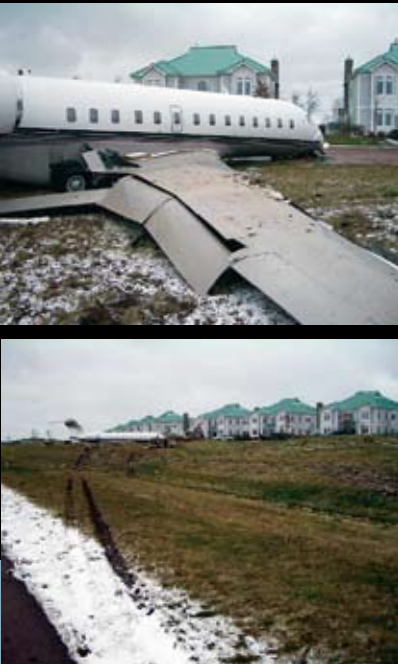
This airplane veered off the runway and came to a stop near a housing complex.

The aircraft continued to sink, and the right main landing gear collapsed when it struck the edge of the runway threshold. After traveling a short distance with the right wing dragging on the runway, the aircraft veered off the pavement, struck mounds of dirt and came to a stop near a housing complex.

The aircraft was substantially damaged, but there was no fire. The first officer and a passenger were seriously injured; the captain and the other seven passengers sustained minor injuries.

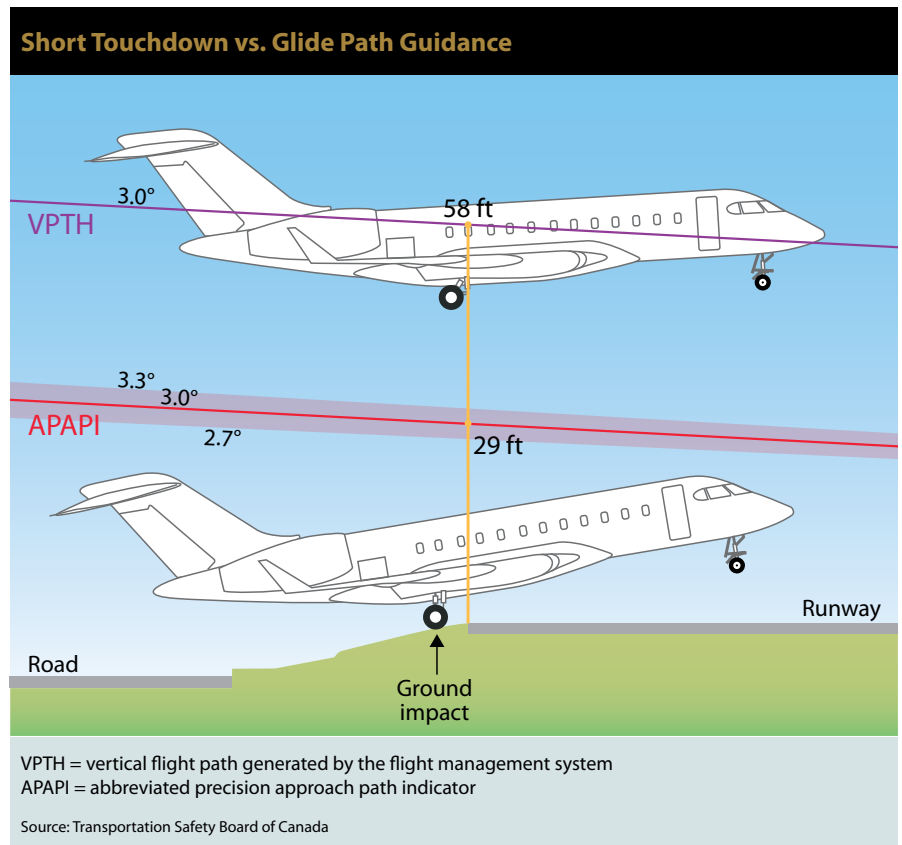
Figure 1

Bombardier determined that the Global 5000’s EWH is 17.2 ft (5.2 m),

which is about 5 ft (1.5 m) greater than the height for the Challenger 604.

The report said that although the APAPI installation at Fox Harbour was not appropriate for the Global 5000, if the crew had followed its guidance to touchdown, the main gear would have cleared the runway threshold by about 8 ft and the aircraft would have touched down about 500 ft (152 m) from the threshold.

Moreover, if they had followed the vertical guidance provided by the on-board flight management system, the aircraft would have crossed the threshold at 58 ft and touched down 1,000 ft from the threshold (Figure 1).

Among the recommendations generated by the investigation, TSB called on Transport Canada to ensure that EWH information is available to transport aircraft pilots and that comprehensive training on VGSI is provided to pilots, “so they can determine if the system in use is appropriate for their aircraft.”
