# Fatal Descent

**Inadequate weather assessment and weak risk management helped set the stage for a HEMS crash in a cloud-covered, wooded area.**

This article is based on NTSB Aircraft Accident Report No. AAR-09/07, *Crash During Approach to Landing of Maryland State Police Aerospatiale SA 365N1, N92MD, District Heights, Maryland, September 27, 2008.*

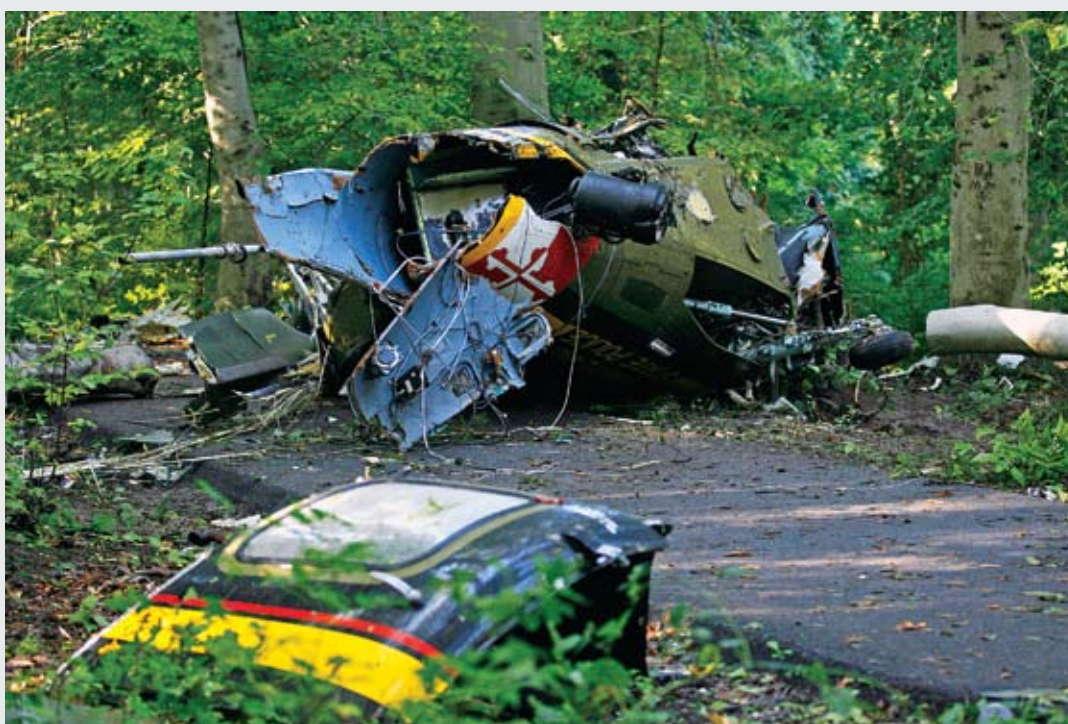
The pilot of the Aerospatiale SA 365N1 was trying to return to visual meteorological conditions when the helicopter crashed in a wooded park.

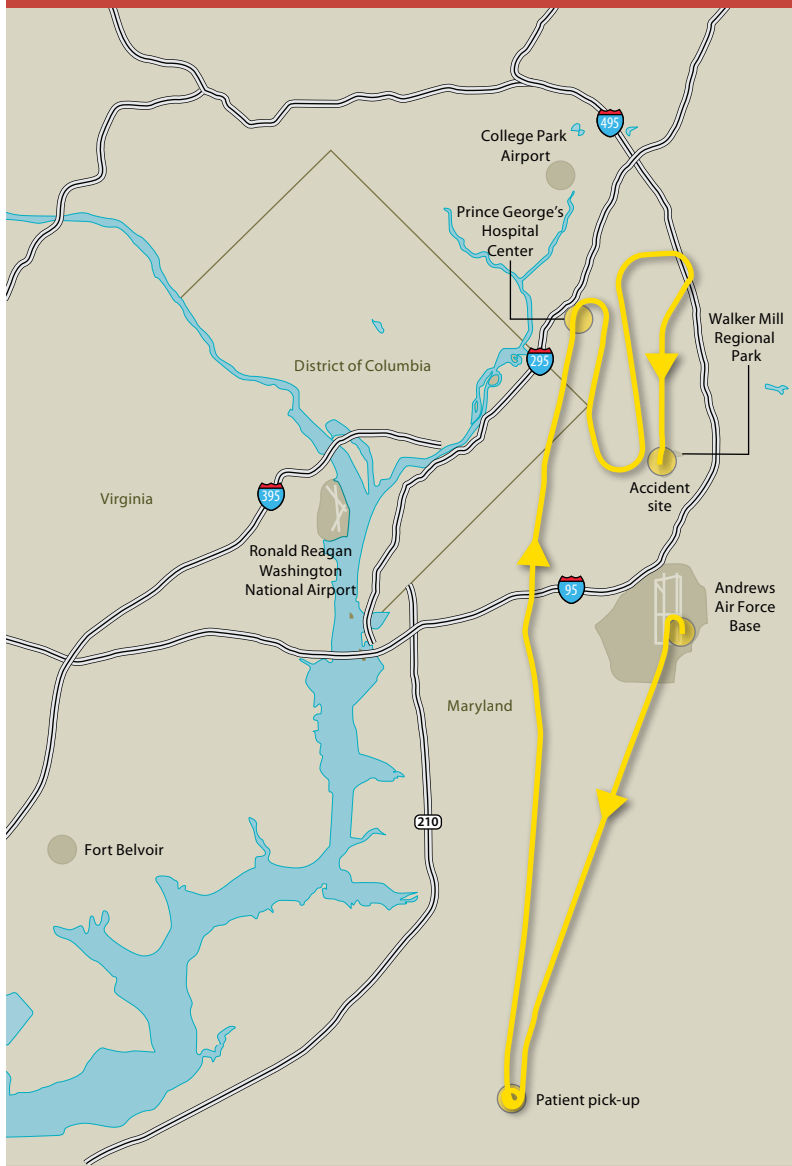
Figure 1

Track of Accident Flight

emergency medical technician who boarded the helicopter with the patients, a flight paramedic and the pilot (Figure 1).

There were no further radio communications. The last radar contact occurred about 2357:50 when the helicopter was at 800 ft above Walker Mill Regional Park, and the last automatic dependent surveillance-broadcast (ADS-B) target was at 2358:04 at 325 ft, near the site where the wreckage was found, in a heavily wooded area of the park at an elevation of 200 ft.
