A buildup of ice came loose during final approach.

SNOWBALLS

in the Fuel System

BY MARK LACAGNINA

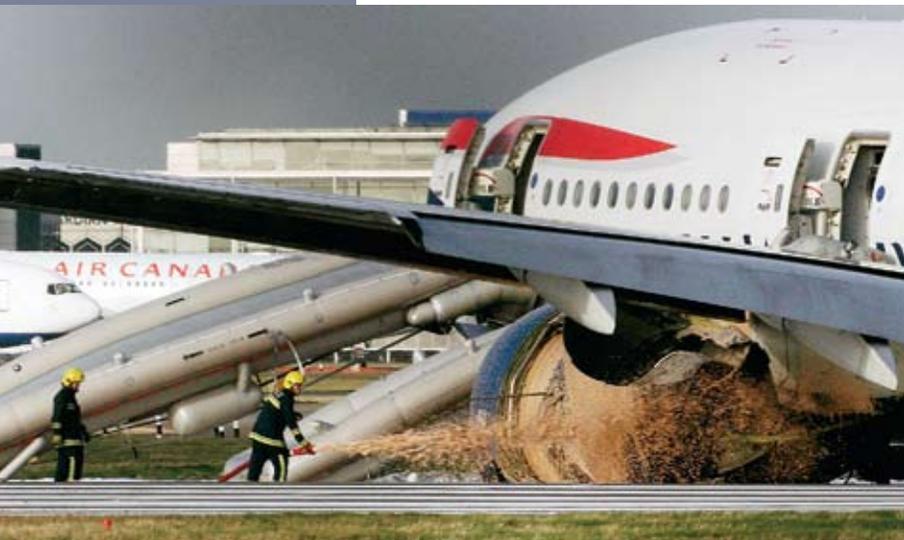
Despite fuel and oxygen leaks, there was no fire.

Descent rate was about 1,400 fpm and peak vertical acceleration was 2.9 g when the aircraft touched down in a grassy area about 330 m (1,083 ft) short of the runway threshold at 1242 UTC. The landing gear collapsed, and the 777 slid, turned right and came to a stop off the side of the runway threshold. Significant leakages of fuel and oxygen occurred, but there was no fire.

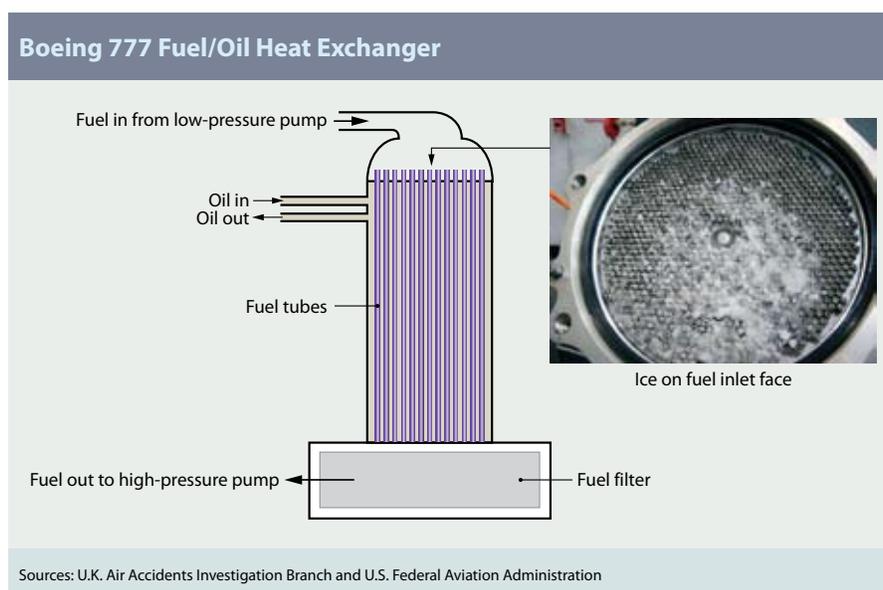
The fuel/oil heat exchangers in most large turbofan engines are designed to prevent ice from forming on sensitive downstream components such as fuel-metering units. Inside the 777's heat exchangers, fuel is pumped through more than 1,000 small tubes, around which hot engine oil flows (Figure 1). The fuel is warmed, and the oil is cooled.

Extensive testing during the investigation showed that the combination of low fuel flow during cruise and the high fuel flow and low fuel temperature during approach fostered an accretion of soft ice in fuel pipes located within the engine pylons. The ice was released by the fuel flow spikes — and possibly turbulence, pitch changes and other factors — during the approach. It then flowed downstream and coated the fuel inlet faces inside the fuel/oil heat exchangers, blocking most of the fuel tubes.

The photograph in Figure 1 shows fuel-inlet icing that occurred during post-accident tests. At the time, the heat exchangers on Rolls-Royce Trents differed from those on other engines in that the tubes protruded slightly from the inlet faces. This was found to have been a factor in the blockage. The engine manufacturer recently modified the fuel inlet faces so that they are smooth.

Accordingly, the AAIB called on the U.S. Federal Aviation Administration and the European Aviation Safety Agency to jointly conduct research on ice formation and release in aircraft fuel systems. The AAIB also recommended research on the feasibility of expanding the use of ice inhibitors in jet fuel. ➤
