FALSE POSITIVE

The gauges showed ‘fat on fuel’ when the tanks ran dry.

BY MARK LACAGNINA

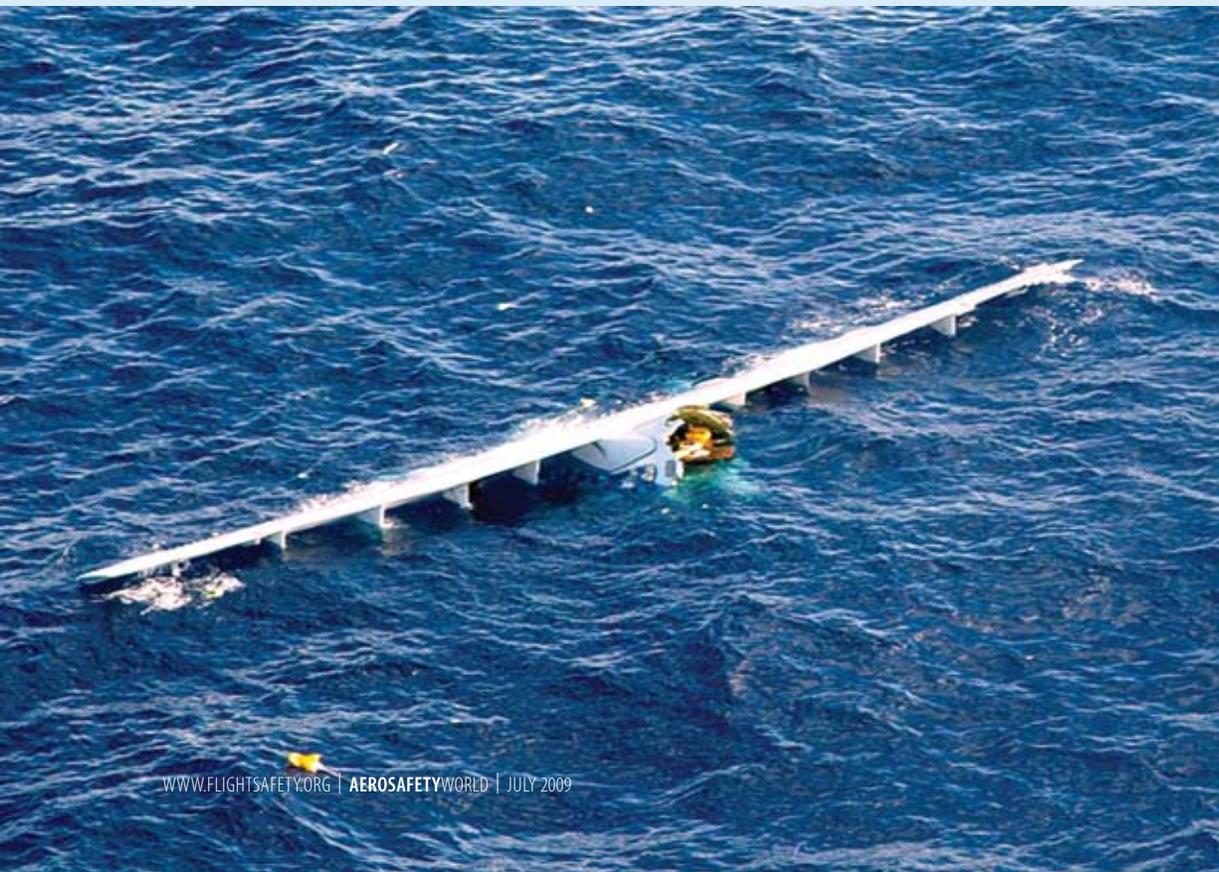
The aircraft broke into three pieces when it was ditched in rough seas off the northern coast of Sicily. Fifteen passengers and the senior flight attendant were killed; 13 passengers, the captain, the copilot and the assistant flight attendant were seriously injured; and seven passengers sustained minor injuries.

The ATR 72 broke into three pieces when it was ditched in rough seas. Some survivors climbed atop the center section to await rescue.

"Although broken in three main parts, the aircraft remained floating for about 20 to 30 minutes after ditching," the report said. The center fuselage section, with the wings and engines attached, remained floating after the front and rear sections sank in nearly 5,000 ft of water.

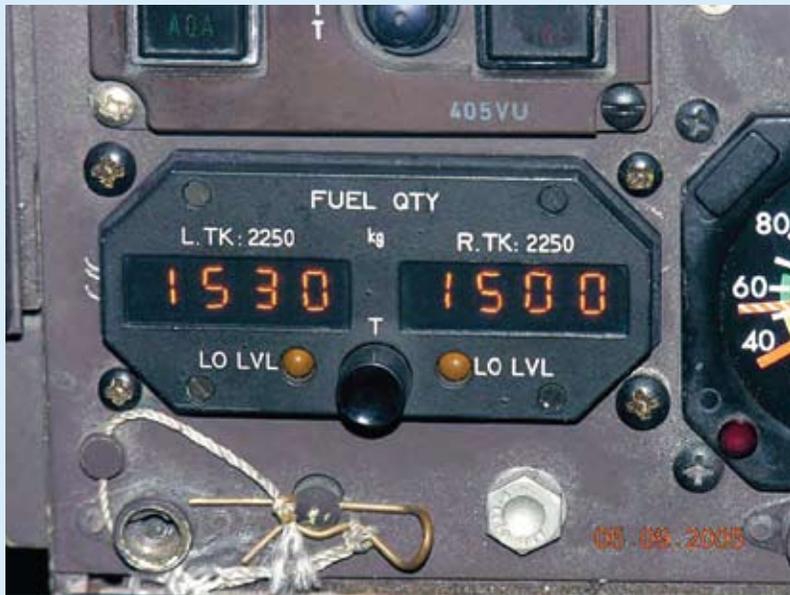
capacitive sensors installed in the wing fuel tanks, based on an algorithm which is specific to each type of aircraft, depending on the shape of the tanks, their sizes and the number of probes,” the report said. “The wing fuel tanks of ATR 42 and ATR 72 aircraft are different in terms of maximum capacity, shape, [and the] number and positioning of the capacitive probes. Therefore, ATR 42 and ATR 72 type FQIs use different algorithms and cannot be interchanged.”

The FQIs for the two ATR models are almost identical in appearance, the only difference being the inscriptions on the gauge faces showing the maximum fuel quantity for each wing tank: 2,500 kg (5,512 lb) for the ATR 72 and 2,250 kg (4,960 lb) for the ATR 42. The installation procedure is the same.

Though it looks almost identical and fits perfectly, this ATR 42 fuel quantity indicator will read high when installed in the larger ATR 72.

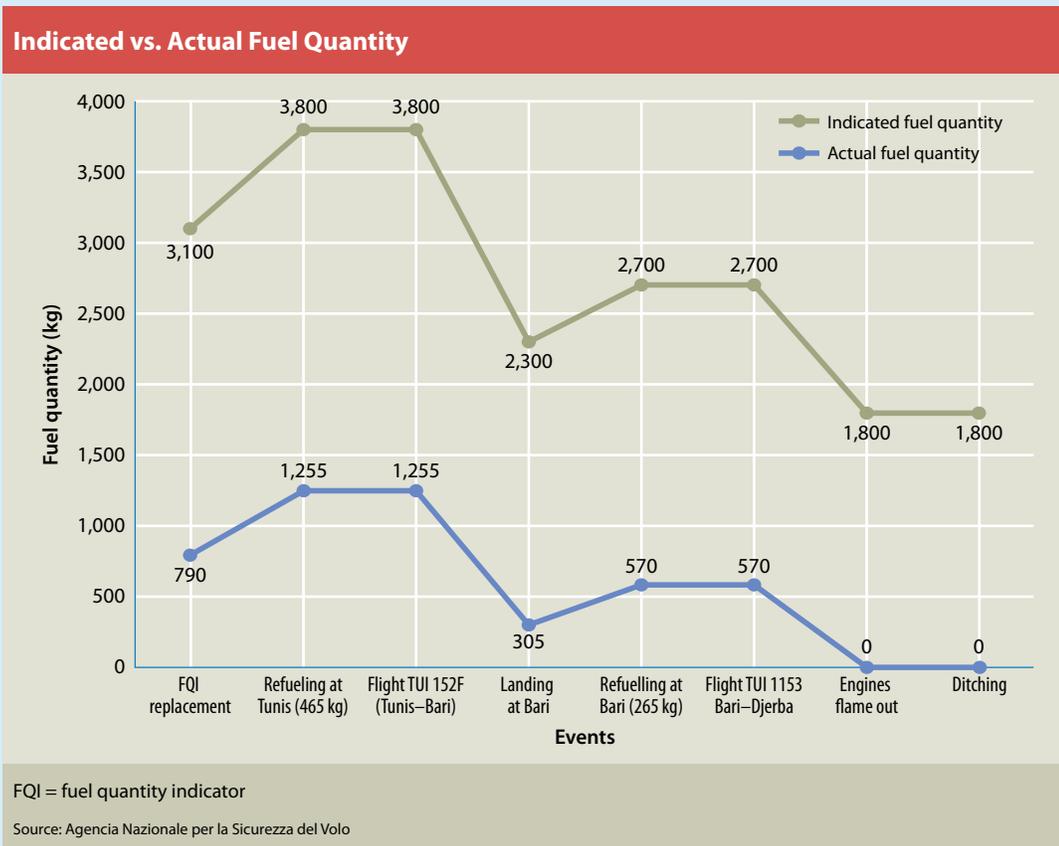
Figure 1

The ATR 72’s tanks actually contained a total of 1,255 kg (2,767 lb) of fuel — about one-third of the quantity indicated — when the engines were started (Figure 1, p. 30). The aircraft departed from Tunis at 1005 coordinated universal time (UTC; 1205 local time) and landed in Bari at 1146 UTC.

The tanks actually held 570 kg (1,257 lb) of fuel when the ATR 72 departed from Bari at 1232 UTC as Flight TUI 1153.
