BY MARK LACAGNINA

# Misgauged Recovery

**An unfamiliar, Western-type attitude indicator was little help to the disoriented Russian captain when an upset occurred.**

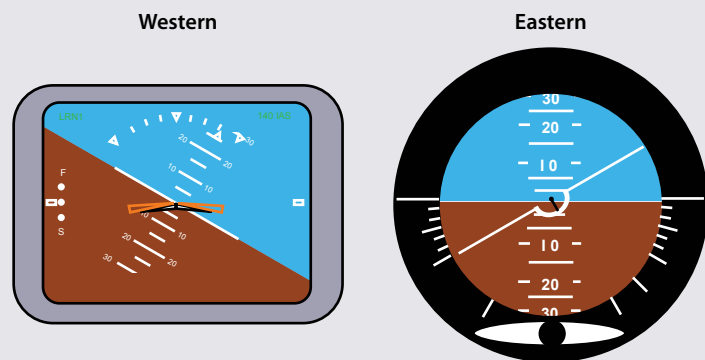
Figure 1

The aircraft that the pilots had flown before transitioning to the 737 — the An-2, a large utility biplane, and the Tu-134, which has fuselage-mounted turbofan engines and a flight deck accommodating two pilots and a navigator — have “Eastern-type” attitude indicators, in which the horizon remains fixed horizontally and the aircraft symbol tilts to show bank angle (Figure 1). Conversely, the horizon line in the 737’s Western-type attitude indicator tilts while the aircraft symbol remains fixed horizontally.

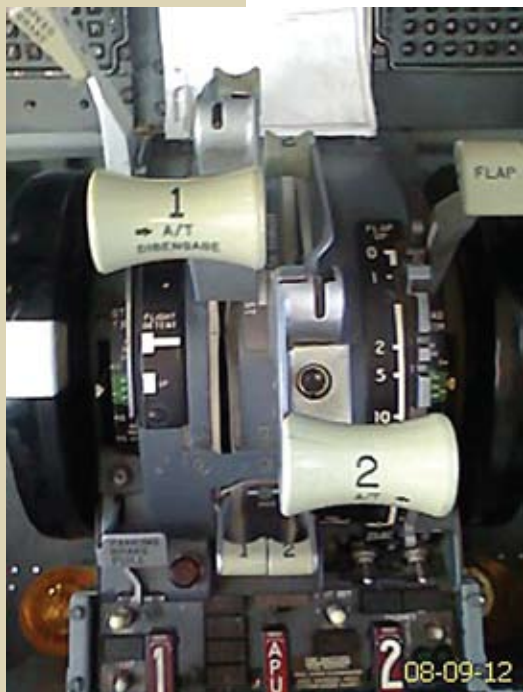
Photo taken on a previous flight shows throttle stagger required to maintain 83 percent fan speed on both engines.

The aircraft had a throttle-stagger condition that exceeded the limits specified in the aircraft maintenance manual (AMM). This condition requires the throttles to be placed in different positions to match engine settings. Recorded flight data showed that during partial-power operations, engine fan speeds varied up

to 20 percent with the throttles in the same position. Setting the engines to produce identical fan speeds resulted in a throttle stagger of up to 15 degrees, with the left throttle ahead of the right throttle. The report noted, however, that there was no throttle stagger at idle and “almost none” at takeoff power.

The report said that the airline’s maintenance personnel did not follow the procedures recommended by the AMM to correct the problem, which initially was identified more than a month before the accident.
