BY WAYNE ROSENKRANS

SURVIVAL ON THE HUDSON

Inattention to safety briefings, life vests and life lines increased risks after US Airways Flight 1549 touched down.

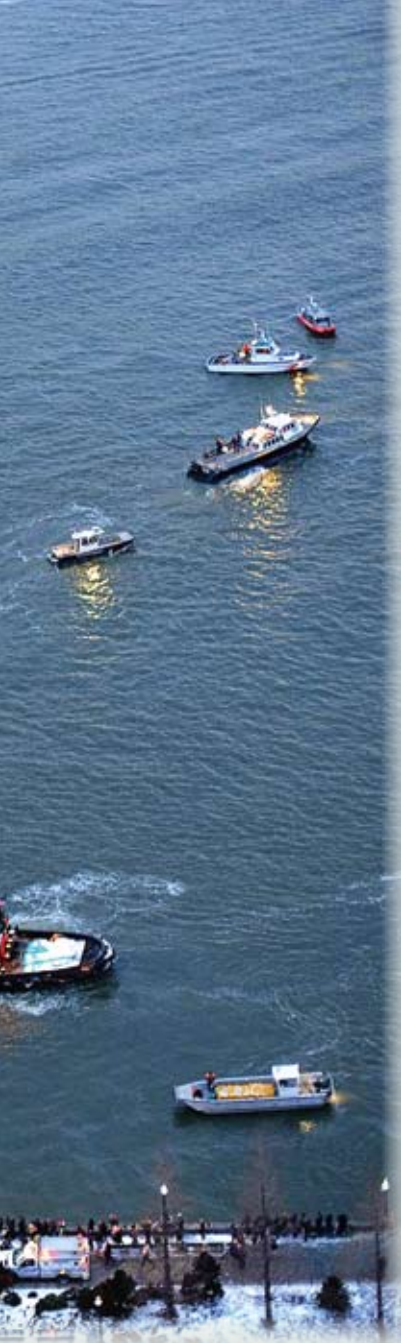
Close proximity of personnel and vessels capable of rescuing Flight 1549 occupants overcame the serious threat of cold water immersion.

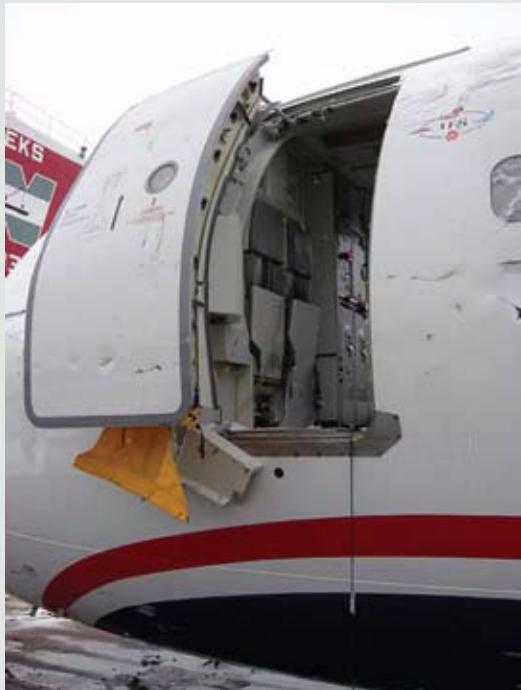
Top, one passenger jumped into the 41° F (5° C) Hudson River from door 1L before the slide/raft was deployed manually; bottom, overwing-exit life line-attachment points were unused, and nine passengers fell into the water.

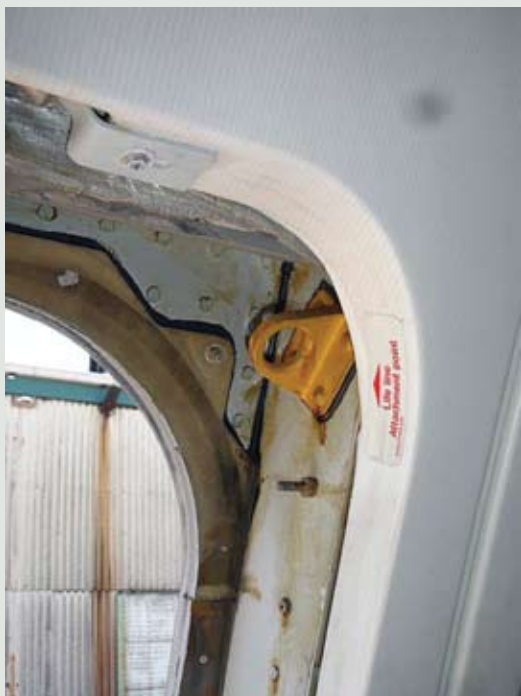
Despite a regulation requiring the life lines at overwing exits — which are intended to be opened by passengers, not flight attendants — circumstances in which they could be used effectively after ditching have been unclear, the report said. The passenger safety information card lacked information about the location of the life lines and how to use them. “Further, no information is provided to passengers about life lines during the preflight safety demonstration or individual exit row briefings,” the report said, and placards above the overwing exit signs only depicted deployed life lines from a pair of overwing exits. The NTSB concluded that life lines could have been used to assist Flight 1549 passengers on both wings, “possibly preventing them from falling into the water.”

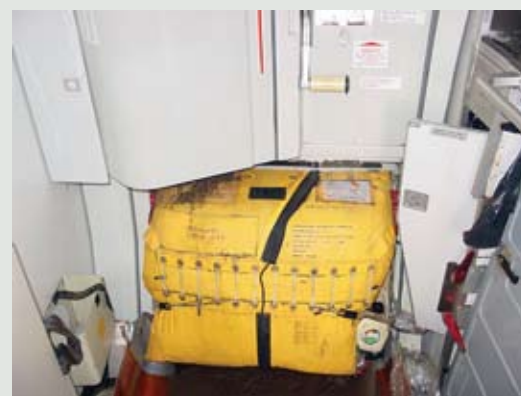
— at door 1L and door 1R — with a combined capacity to carry 110 of the 155 occupants if the airplane had sunk before they were rescued. The NTSB determined that about 64 occupants were rescued from these slide/rafts, while about 87 were rescued from the wings and off-wing ramp/slides.

Top, the detachable door 2L slide/raft was one of two unavailable due to aft water entry; bottom, a manual inflation handle and a ditching release handle were found in the forward galley.

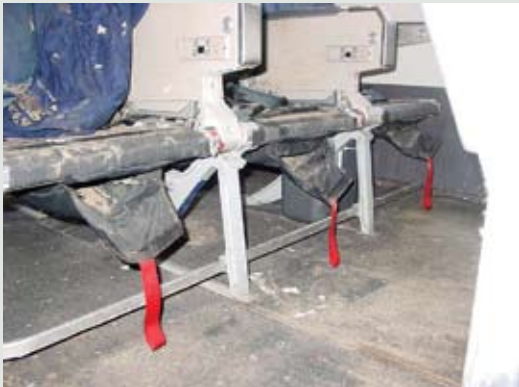
Top, life vest storage pouches were beneath economy-class seats on Flight 1549; bottom, the FAA had tested four underseat stowage configurations.

Overall, 19 passengers attempted to obtain a life vest from under a seat, and 10 of them reported difficulties retrieving it. “Of those 10 passengers, only three were persistent enough to eventually obtain the life vest; the other seven either retrieved a flotation seat cushion or abandoned the idea of retrieving flotation equipment altogether,” the report said.
