# FRACTURED BLADE

Accident investigators traced the fatal crash of an AS 350D to a fatigue fracture in a power turbine blade.

BY LINDA WERFELMAN

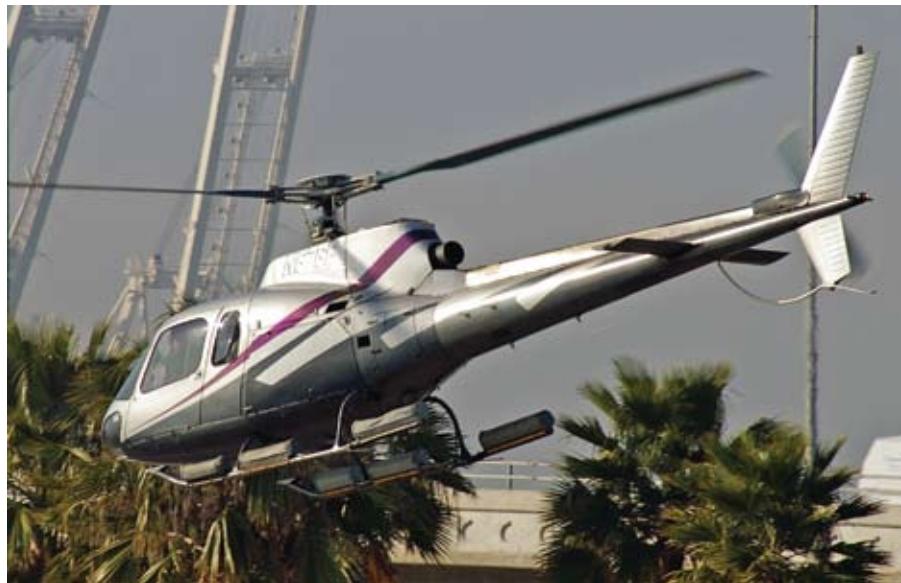
**Passengers said they heard a popping sound just before the pilot of this AS 350D told them he planned an autorotation near the designated landing site on California's Santa Catalina Island.**
