AUTOMATION at Odds

A 737 stalled when a radio altimeter malfunction caused the autothrottle and autopilot to diverge during an approach to Schiphol.

This article is based on the DSB accident report “Crashed During Approach, Boeing 737-800, Near Amsterdam Schiphol Airport, 25 February 2009,” May 2010. The full report is available at <safetyboard.nl>.

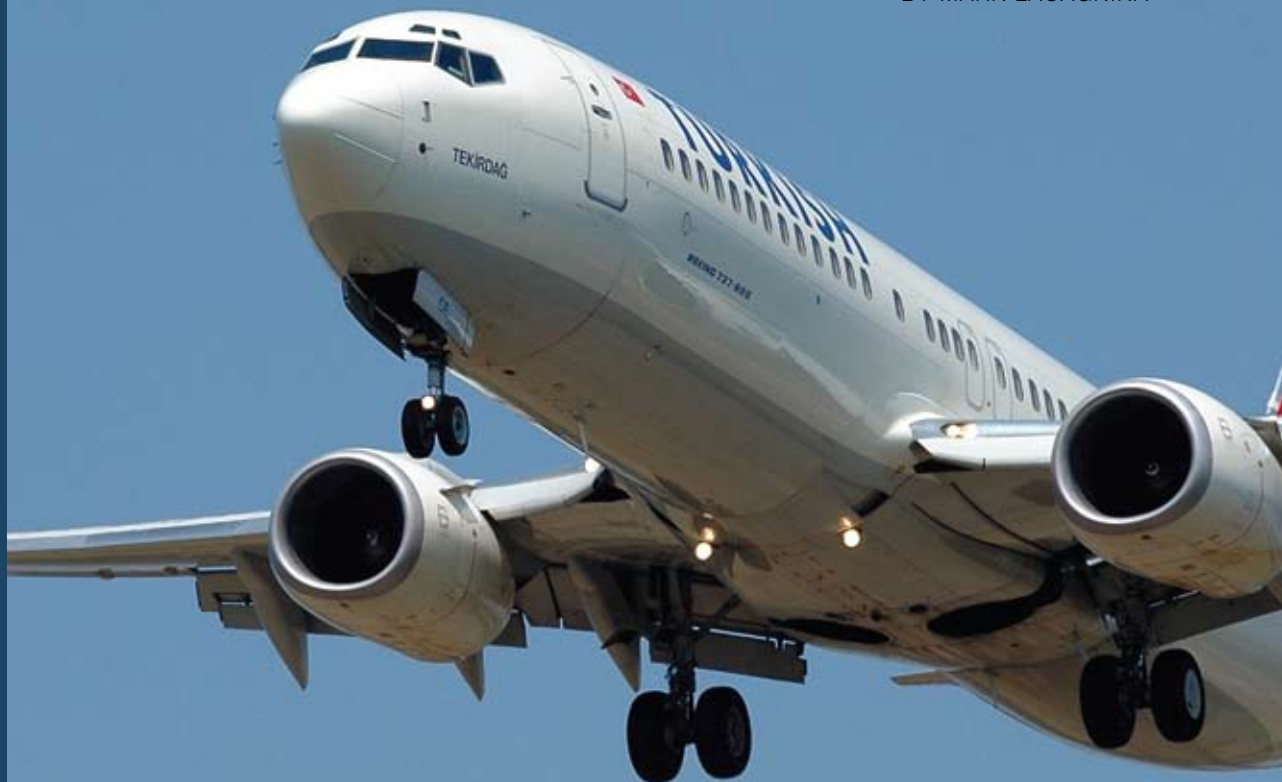
The aircraft broke into three pieces when it struck the ground short of the runway.

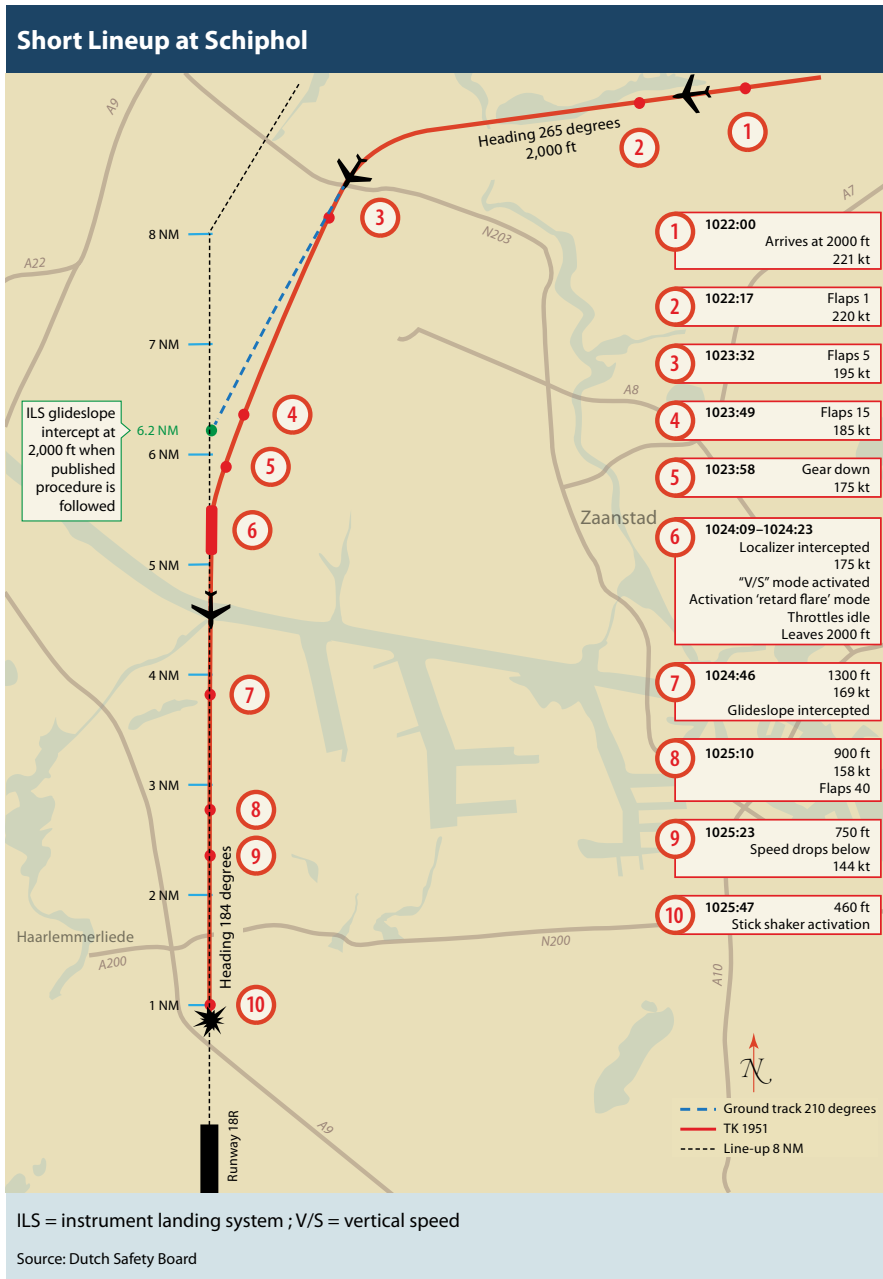
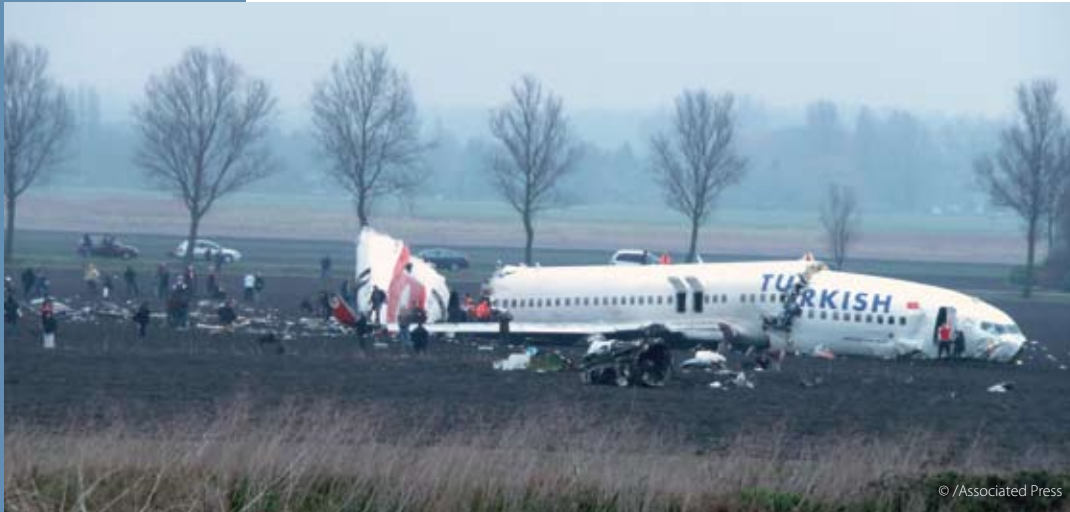
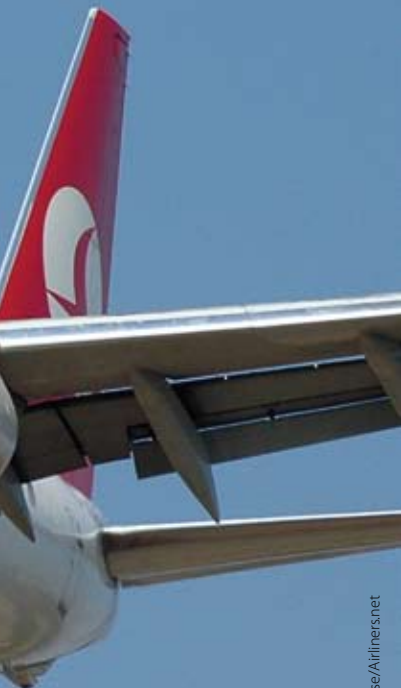
Figure 1

crew to descend to 2,000 ft and to maintain a heading of 265 degrees. The controller then amended the heading to 210 degrees and cleared the crew to conduct the ILS approach to Runway 18R (Figure 1, p. 34).

The report said that the controller did not ask the crew if they could accept a “short lineup” before issuing these instructions, which did not allow the crew to intercept the glideslope from below in level flight, as required by International Civil Aviation Organization (ICAO) standards and by Netherlands ATC standards.

“This heading ultimately resulted in interception of the localizer signal 5.5 nm [10.2 km] from the runway threshold,” the report said. It noted that the aircraft would have had to intercept the localizer course no less than 6.2 nm (11.5 km) from the runway threshold to intercept the glideslope from below while flying level at 2,000 ft. As a result of the short lineup, “the aircraft had to lose speed and descend in order to intercept the glide path,” the report said.

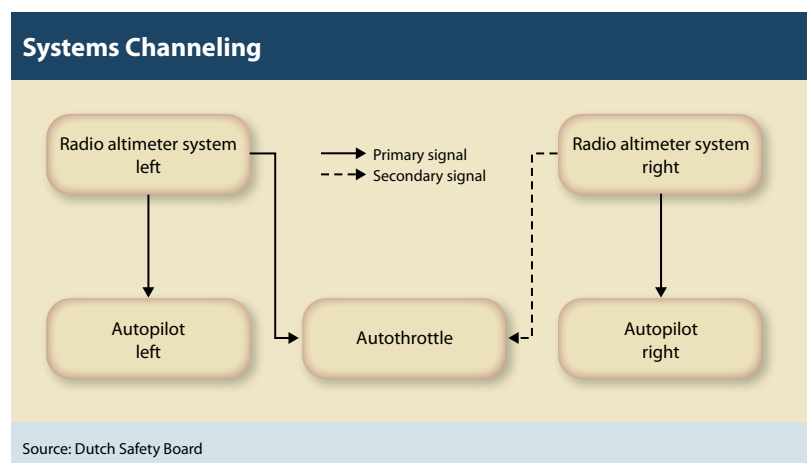
Figure 2

Recorded flight data showed that the left radio altimeter system — the primary source of height measurements for the autothrottle — had begun to provide erroneous data shortly after takeoff from Istanbul. As the aircraft descended from 2,000 ft, the height measured by the left radio altimeter and displayed on the left, or captain's, PFD changed to minus 8 ft.

Investigators were unable to determine why this error occurred or why the radio altimeter computer did not recognize and flag the error, which would have caused the autothrottle to resort to using heights measured by the right radio altimeter system, which was functioning normally (Figure 2). “The only indication of the defect in the left radio altimeter system was the minus 8 ft indication on the left PFD,” the report said. The right PFD, which is channeled to the right radio altimeter system, provided accurate height indications to the first officer.

As the aircraft descended from 2,000 ft, the height measured by the left radio altimeter changed to minus 8 ft.

Based on the findings of the investigation, the DSB recommended improvement of the reliability of the 737-800 radio altimeter system, evaluation of the benefits of installing an aural low-speed warning in the aircraft, and monitoring to ensure that air traffic controllers in the Netherlands adhere to ICAO and national standards for lining up aircraft for approach. ➔
