An Avro 146's nose landing gear failure can be traced to fatigue cracks in its main fitting, investigators say.

GEAR COLLAPSE

BY LINDA WERFELMAN

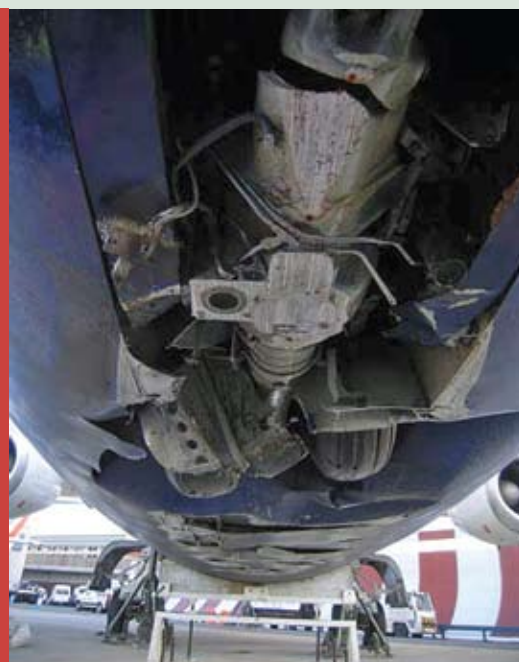
The Avro 146’s lower fuselage was damaged after the landing gear’s collapse. Above, the accident airplane, photographed on another day, at London City Airport.

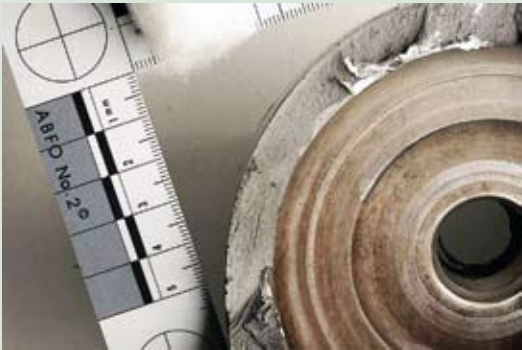
Accident investigators found fatigue cracks on the fracture surface of the landing gear's main fitting.

The examination found no abnormalities in material or microstructure of the main fitting. Nevertheless, the report said that on the fracture surface, there were three fatigue cracks that “had become conjoined to form a single crack extending 23.2 mm [0.9 in] around the circumference of the upper section of the internal bore, with a maximum depth of 2.21 mm [0.09 in].” The fatigue crack was located in the same area where fatigue cracks were found in the two fatigue tests.

The fatigue cracks originated in “the trough of a fine circumferential machining groove” that was in the bore when the fitting was manufactured, and propagated for about 2,800 cycles before the accident, the report said. Smaller

“Examination of the inner bore confirmed that the shot-peening process had been carried out, in accordance with the requirements of SB 146-32-150, but that the surface roughness close to the origin of the fatigue cracks was 9.5 to 10.1 microns, in excess of the finish specified in the service bulletin,” the report said.

In August 2009, Messier-Dowty issued SB 146-32-174, describing a new ultrasonic inspection technique for the nose landing gear main fittings and prescribing a shorter re-inspection interval. The new service bulletin superseded SB 146-32-149. BAE Systems, which holds the Avro 146 type certificate, subsequently issued alert service bulletin A32-180 (Revision 1), which introduced SB 146-32-174 and canceled the requirements of SB 146-32-149, and the European Aviation Safety Agency published AD 2009-0197-E, which mandated compliance with the two new Messier-Dowty and BAE bulletins.

Messier-Dowty also issued SB 146-32-173 to require borescope inspections of nose landing gear main fittings that had been overhauled by its Sterling, Virginia, facility. ➔
