THRUST INTO

Tire debris disabled sensors, causing a Learjet 60 to accelerate during a high-speed rejected takeoff.

AN OVERRUN

This article is based on NTSB Accident Report AAR-10/02: "Runway Overrun During Rejected Takeoff; Global Exec Aviation; Bombardier Learjet 60, N999LJ; Columbia, South Carolina; September 19, 2008." The full report is available at <ntsb.gov/Publictn/A_Acc1.htm>.

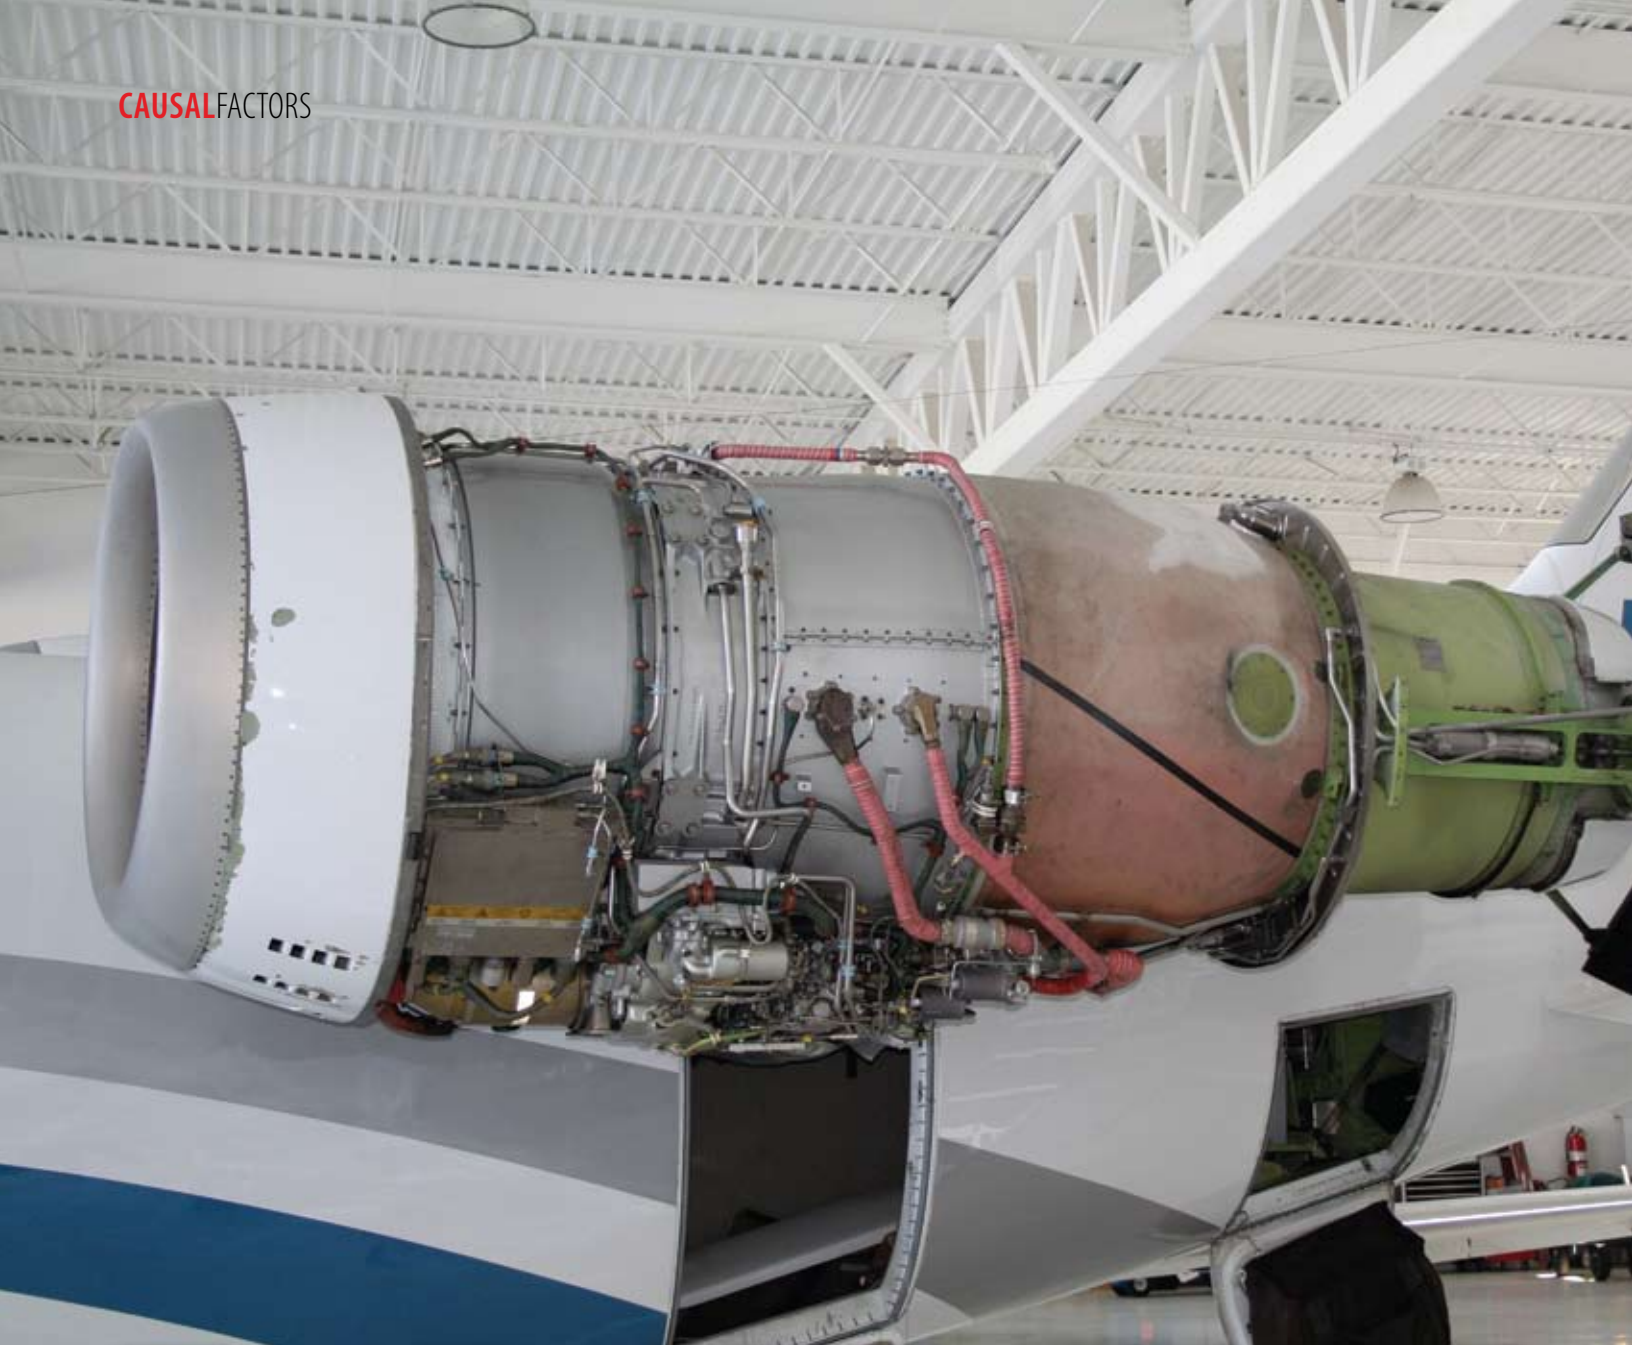
The thrust reverser doors deployed, as shown here, but then were inadvertently stowed, and the engines produced nearly full forward thrust.

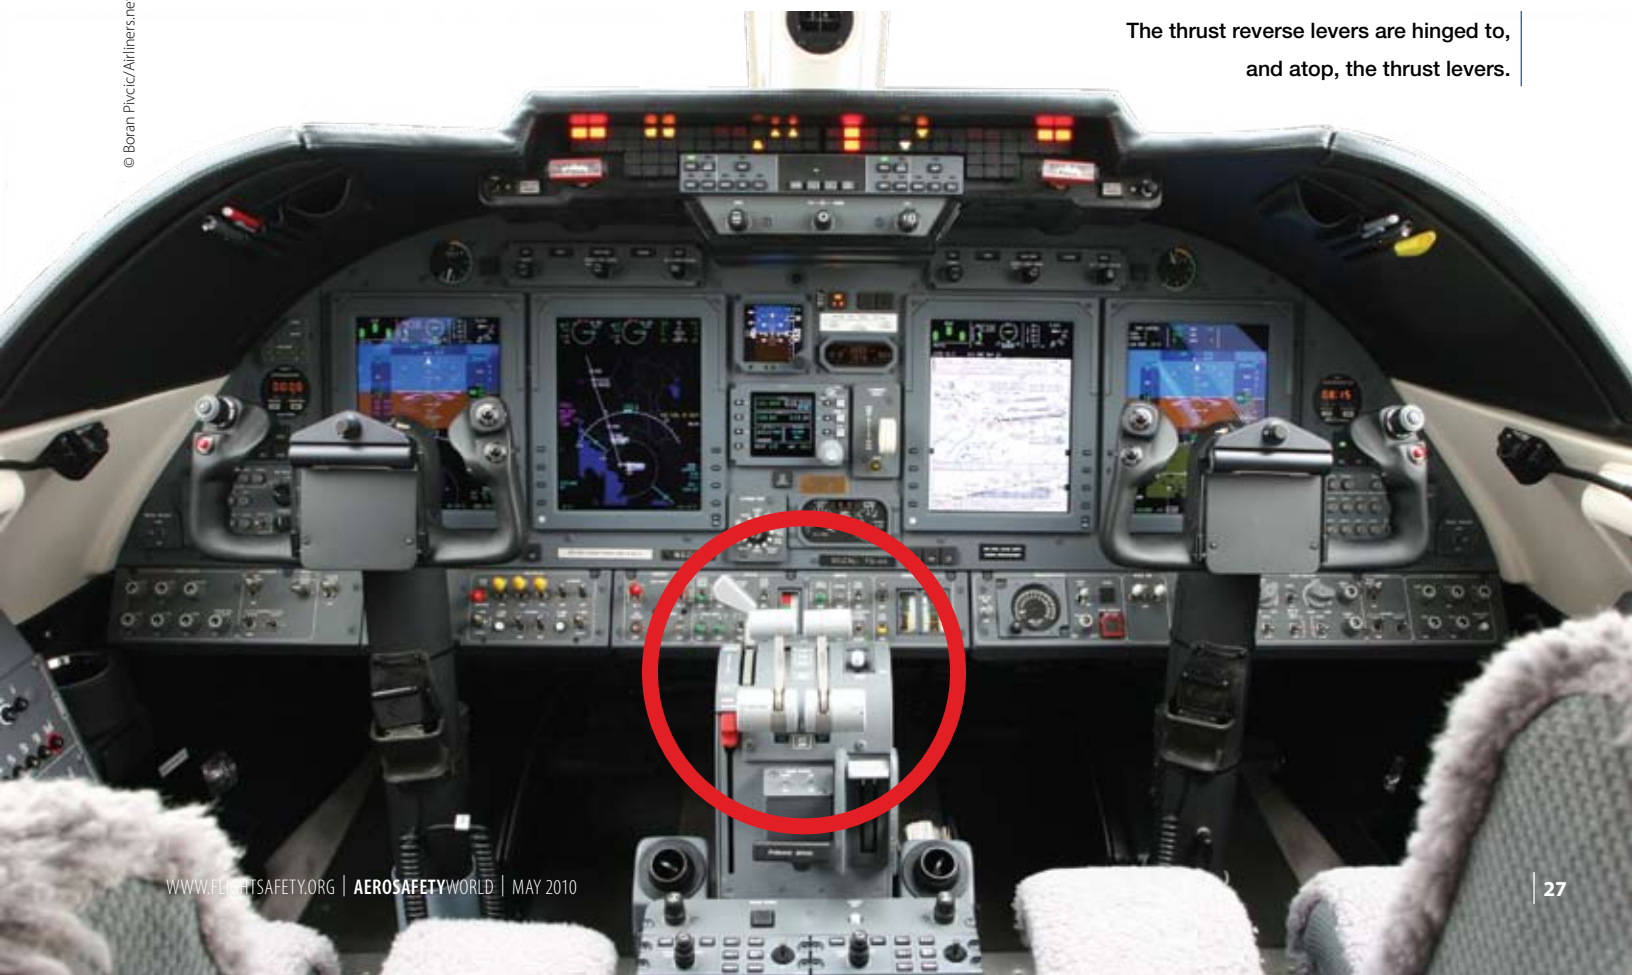
The thrust reverse levers are hinged to, and atop, the thrust levers.

The Learjet 60's engines and thrust reverser system are controlled electronically, with no "mechanical or cable-actuated connection between the cockpit thrust levers and the engines," the report said. To select reverse thrust, the pilot moves the thrust levers to the idle stops and then lifts and pulls the thrust reverse levers, which are hinged to, and atop, the thrust levers.
