Lack of CRM training factored in a muddled approach and go-around.

# Teamwork Fades in a BLACK HOLE

*This article is based on TSB Aviation Investigation Report A07C0001, "Collision With Terrain: Transwest Air Beech A100 King Air, C-GFFN; Sandy Bay, Saskatchewan; 07 January 2007." The full report is available from the TSB Web site, <tsb.gc.ca>.*

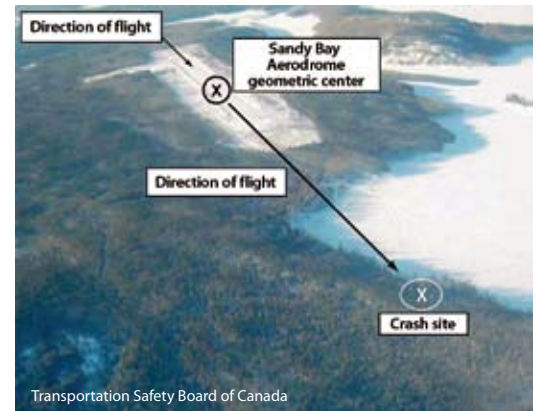
The report noted that the pilots likely were not aware that the GPS waypoint they were using for distance information was located 1,440 ft (439 m) beyond the approach threshold of Runway 05. Thus, they were aiming to touch down at a point on the runway that was 440 ft (134 m) beyond the normal touchdown point for a three-degree glide path.

Causal factors included a misunderstood GPS waypoint and somatogravic illusion during an attempted go-around.

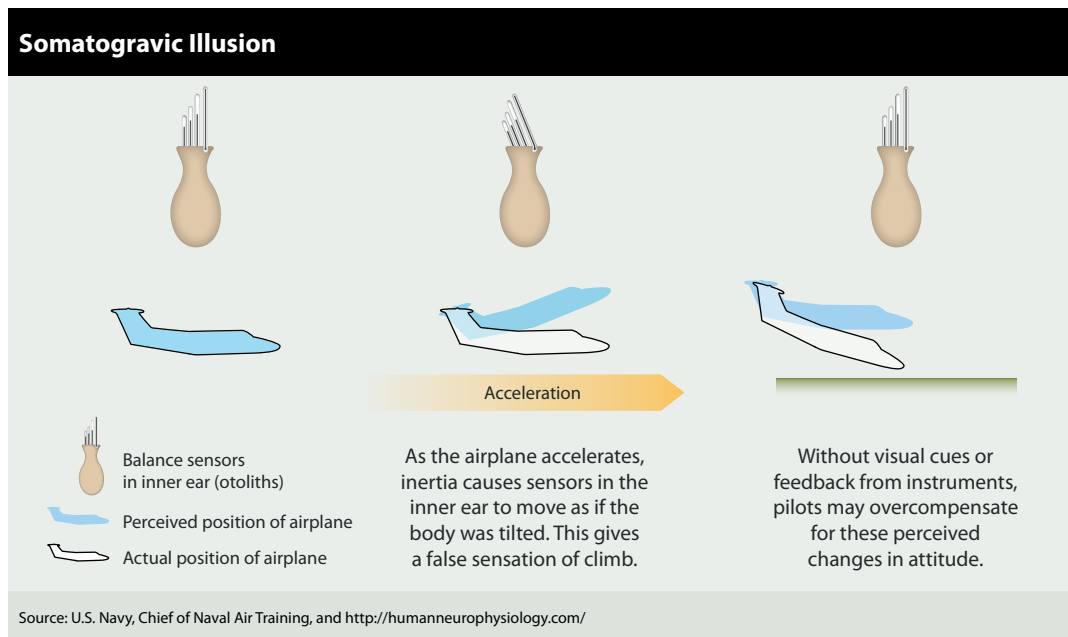
**Figure 1**

The first officer's perceptions were typical of the *somatogravic illusion*. "Instrument-rated and experienced pilots are not immune to this illusion, which is a subtle and dangerous form of disorientation," the report said. "The illusion occurs because the body relies on sensory organs in the inner ear to maintain balance; and, in the absence of visual cues, signals from these organs can produce a very powerful disorientation (Figure 1).

"In the case of an aircraft that is accelerating during a go-around, the sense organs of the inner ear of the pilot send a signal to the pilot's brain that is interpreted as tilting backward instead of accelerating forward. ... The pilot has a very strong sensation of climbing. The illusion of false climb tends to lead the pilot to lower the nose and descend. The aircraft then accelerates, and the illusion can intensify."

The report said that it is likely that the captain also experienced the somatogravic illusion and lowered the aircraft's nose.
