BY MARK LACAGNINA

Check Flight

Goes Bad

The crew was unaware that the A320's angle-of-attack sensors were frozen.

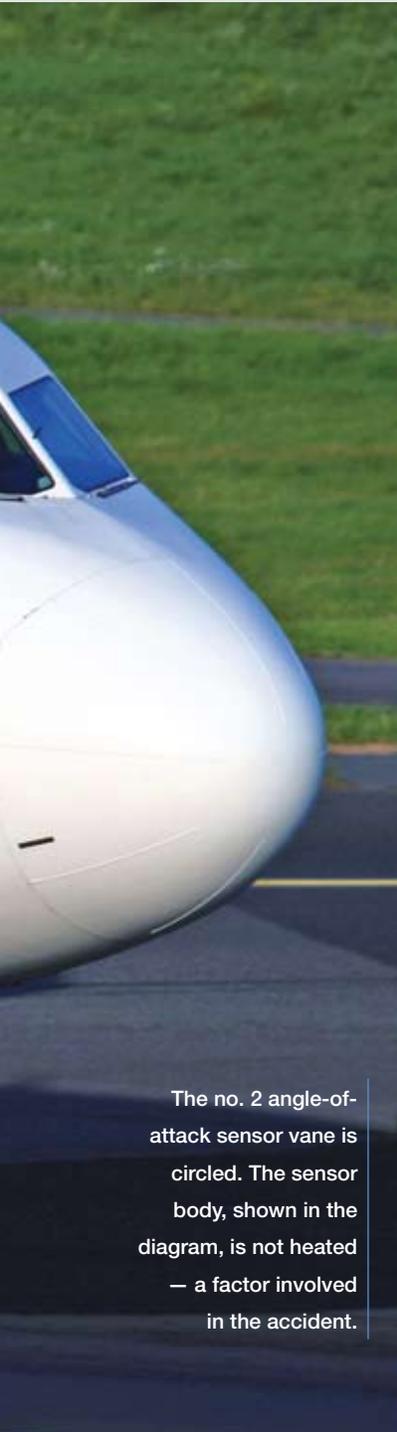
The no. 2 angle-of-attack sensor vane is circled. The sensor body, shown in the diagram, is not heated — a factor involved in the accident.

Among the factors that contributed to the accident was the flight crew's lack of training and experience in performing functional check flights, the report said.¹ Investigators also found that the angle-of-attack sensors had not been shielded properly when the airplane was rinsed to remove accumulated dust, which resulted in water entering at least two of the three sensors and later freezing during the accident flight.

The no. 1 and no. 2 angle-of-attack sensors are part of the air data system for the captain’s and copilot’s instruments, respectively. The no. 3 sensor is part of the standby air data system. The external vanes, which align in flight with the relative wind, are heated automatically with alternating electrical current when the engines are running; the interiors of the sensor bodies are not heated.

directly to high-pressure water, even when the sensors are properly masked. The report said that the sensors on the accident airplane likely were not masked properly before the airplane was rinsed with water delivered under high pressure.

The A320 maintenance manual requires the application of adhesive tape to mask the gaps between the bases of the sensors and the fuselage plates to which they are attached before the airplane is washed or rinsed. This helps prevent water from entering the sensor bodies and causing corrosion, faulty electrical connections or icing in flight. Airbus warns that the sensors must not be exposed

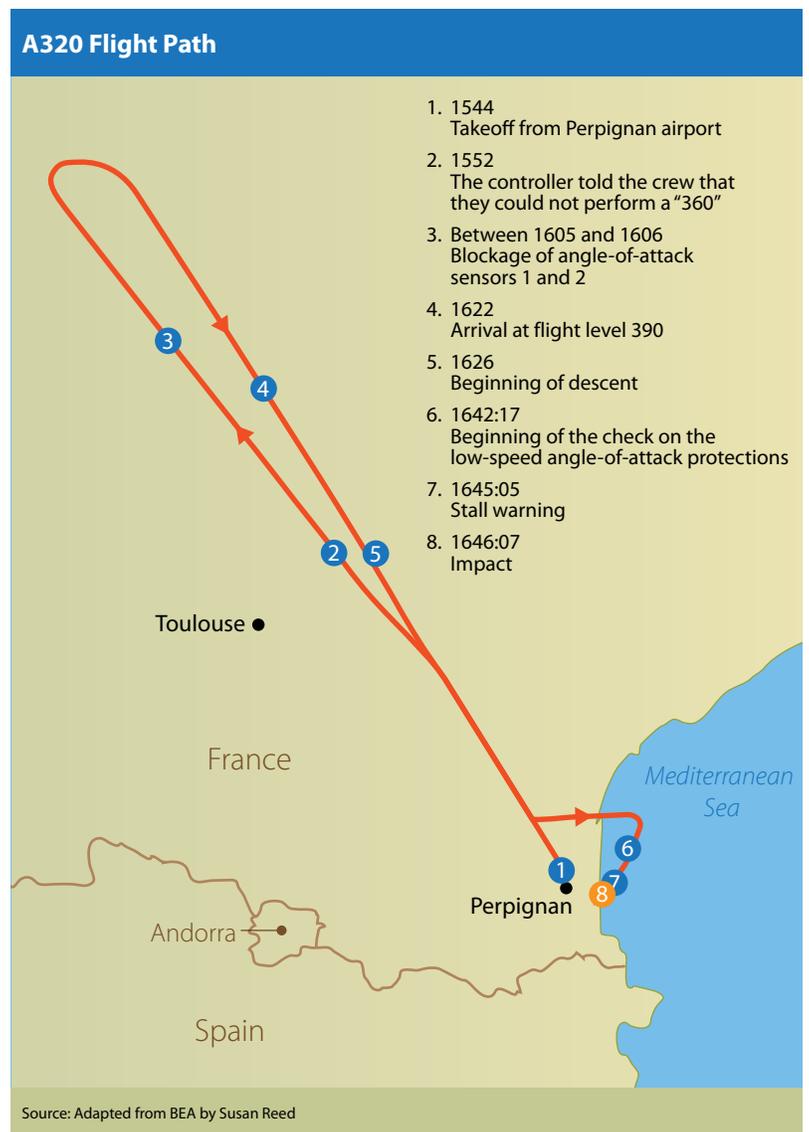
Figure 1

The airplane was flown northwest, into airspace controlled by a regional air traffic control center (Figure 1). When the center controller received the A320’s flight plan, he called the Perpignan approach controller. “He wanted to ensure that the crew had the necessary authorizations to undertake what he described as a ‘disguised test flight,’” the report said. “He thought this flight had not been the subject of an appropriate request by the operator.”

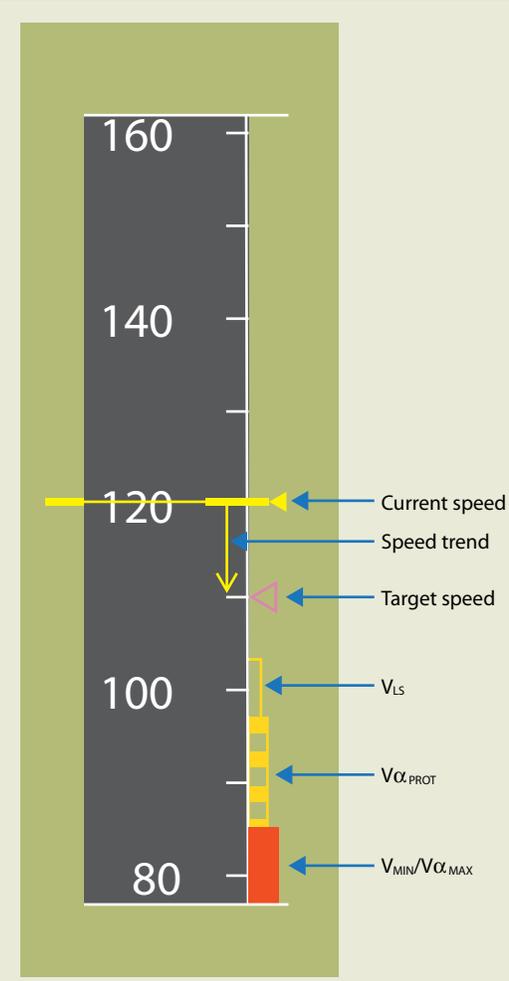
Figure 2

called *alpha prot*, which corresponds to the indicated airspeed $V\alpha_{PROT}$ near the bottom of the PFD speed strip (Figure 2). At this point, the crew should notice that the autotrim system has been inhibited and/or that the speed brakes, if deployed, have been retracted — both protections again exceeding *alpha prot*. “With no input on the sidestick, the angle-of-attack remains at this value,” the report said.

The airplane was descending through 4,080 ft over the sea when the crew began the low-speed checks. Airspeed decreased rapidly from 167 kt, and the captain pulled his sidestick all the way back, anticipating the activation of the angle-of-attack protections. However, the angle-of-attack protections never activated. “The blockage of the angle-of-attack sensors made it impossible for these protections to trigger,” the report said.
