BY LINDA WERFELMAN

The U.K. Air Accidents Investigation Branch (AAIB) has recommended design reviews and modifications of emergency exits on public transport aircraft following an emergency landing in which passengers in an Embraer 195 became confused about how to use an overwing exit.

# where's the **EXIT?**

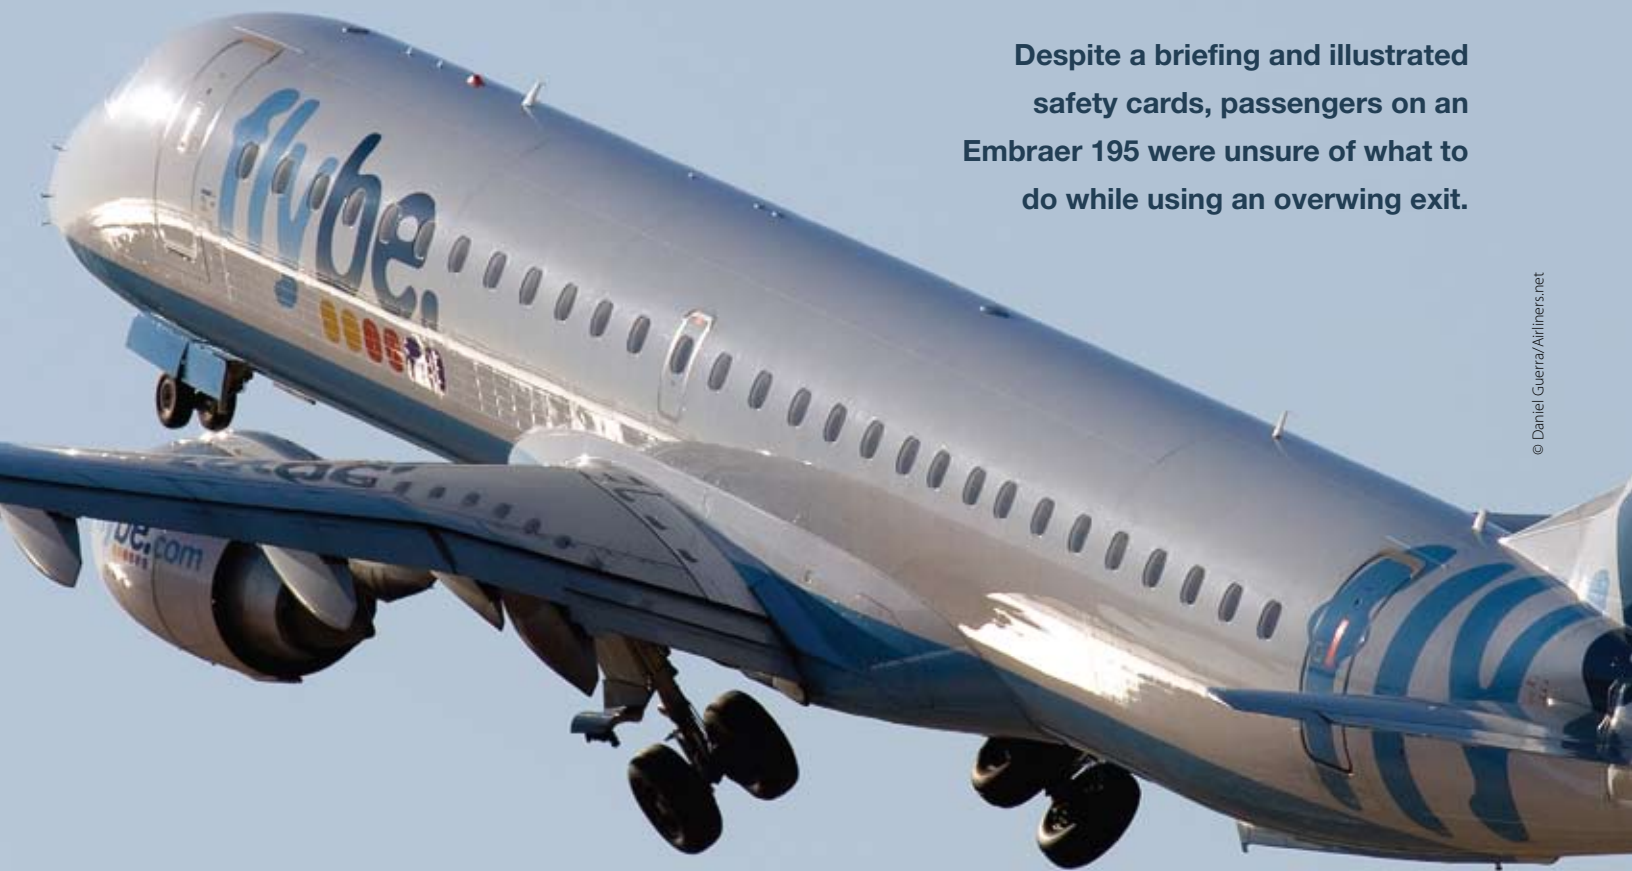
Despite a briefing and illustrated safety cards, passengers on an Embraer 195 were unsure of what to do while using an overwing exit.

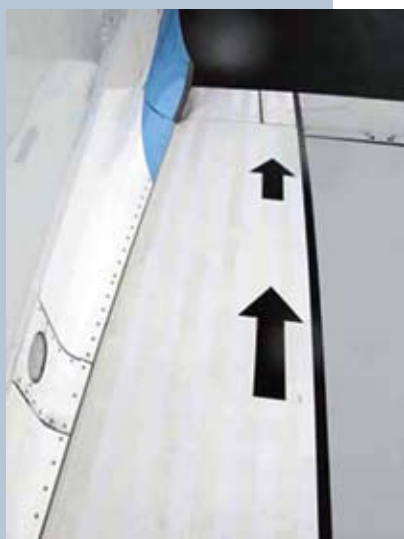
“A 61-cm-wide [2-ft-wide] walkway was demarcated at the wing root in black paint, with arrows pointing towards the trailing edge,” the report said. “This was not noticed by some passengers; one passenger thought that the markings denoted an engineers’ walkway rather than an escape route. The overriding comment from passengers who evacuated onto the wing was that it was not obvious to them that they were meant to climb off the wing via the trailing edge.”

Passengers did not realize that the arrows on the wing denoted an evacuation route.

After the incident, the operator modified the safety briefing for passengers seated next to the overwing exits “to make them aware that the arrows on the wing indicate direction of evacuation (i.e., aft over trailing edge of the wing),” the report said.

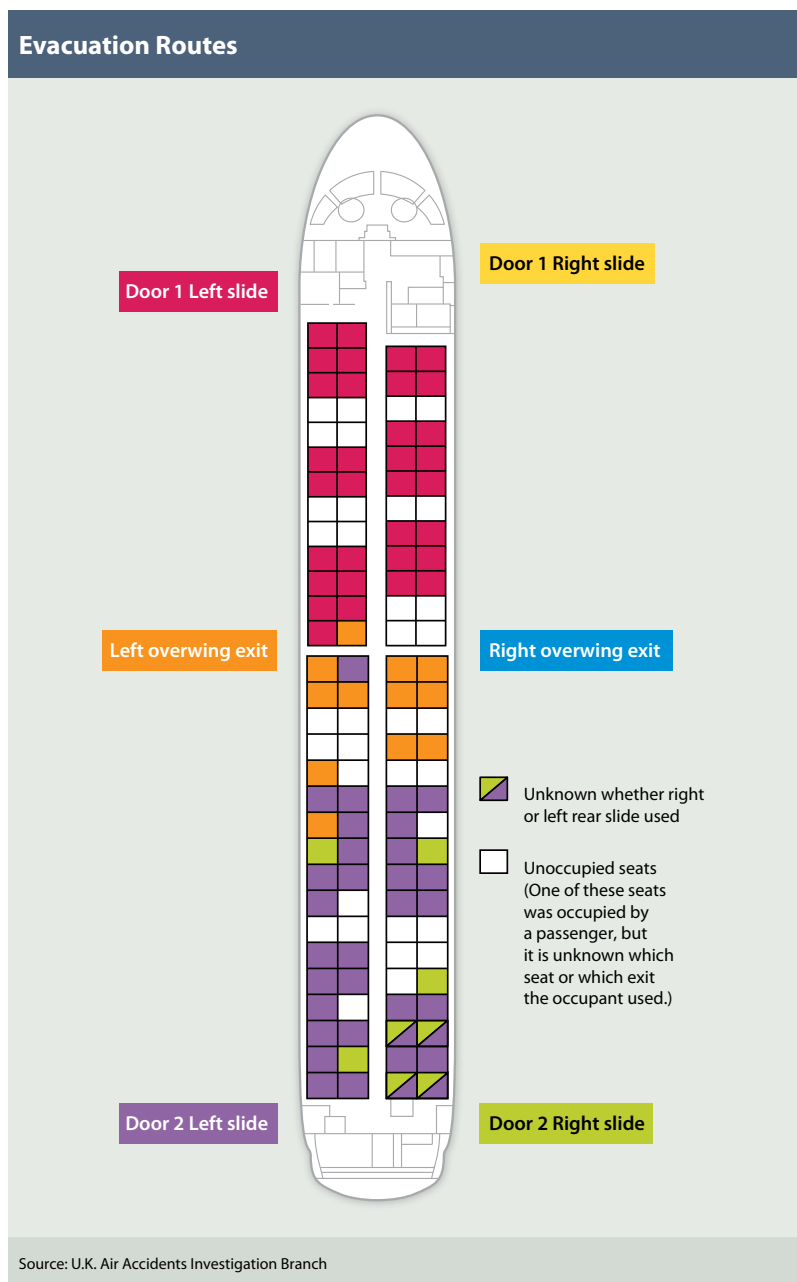
Figure 1

After completing the approach and landing on Runway 26, the commander turned the airplane into the wind and stopped at a runway intersection, telling the cabin crew first to stand by and, seconds later, to evacuate (Figure 1, p. 48).

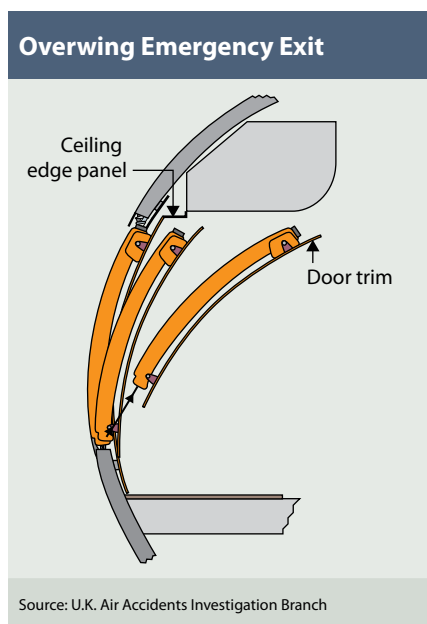
**Figure 2**

Cabin crewmembers responded by opening their assigned doors. Passengers opened the left overwing exit door; the right overwing exit door could not be opened because the forward upper part of the door trim was jammed beneath the ceiling edge panel (Figure 2, p. 49).

A post-incident examination of the right overwing emergency exit door found insufficient clearance between the top edge of the door trim and the ceiling edge panel. “Over most of its length, the clearance was just sufficient to accommodate insertion of a credit card, but near the forward corner of the door, where the door trim had jammed, the clearance was only 0.003 in [0.076 mm],” the report said.

The AAIB’s subsequent evaluation of the SB’s effectiveness found that a 2-mm clearance was insufficient to prevent jamming of the door trim behind the ceiling edge panel “if the door was lifted during the initial stages of opening or if it was opened energetically, such as might be the case in an actual emergency,” the report said. “It was concluded that [although] the SB reduced the probability of a jam, the potential for a jam had not been eliminated.”

However, the report added, “during Embraer 195 development, the ceiling edge panel manufacturer introduced changes to the configuration and dimensions of the cutouts around the overwing exit aperture, reducing the clearance between the ceiling panel and the door trim. These changes were not notified to the aircraft manufacturer.”

No clearance had been specified, but after the AAIB informed the manufacturer of the incident, Embraer issued Service Bulletin (SB) 190-25-0092, calling for inspections and replacement of the ceiling edge panel if the clearance is less than 2.00 mm (0.08 in). Similar inspections were introduced during manufacturing to ensure a minimum 2-mm clearance.

The AAIB recommended that the manufacturer “modify the overwing emergency exits ... to eliminate the possibility of the exit door jamming due to interference between the door trim panel and the ceiling edge panel.”
