# Blown Away

In its final report on the accident, which occurred at Denver International Airport the

*This article is based on NTSB Accident Report NTSB/AAR-10/04, "Runway Side Excursion During Attempted Takeoff in Strong and Gusty Crosswind Conditions; Continental Airlines Flight 1404; Boeing 737-500, N18611; Denver, Colorado; December 20, 2008." The full report is available at <[nts.gov/Publictn/A-Acc1.htm](http://nts.gov/Publictn/A-Acc1.htm)>.*

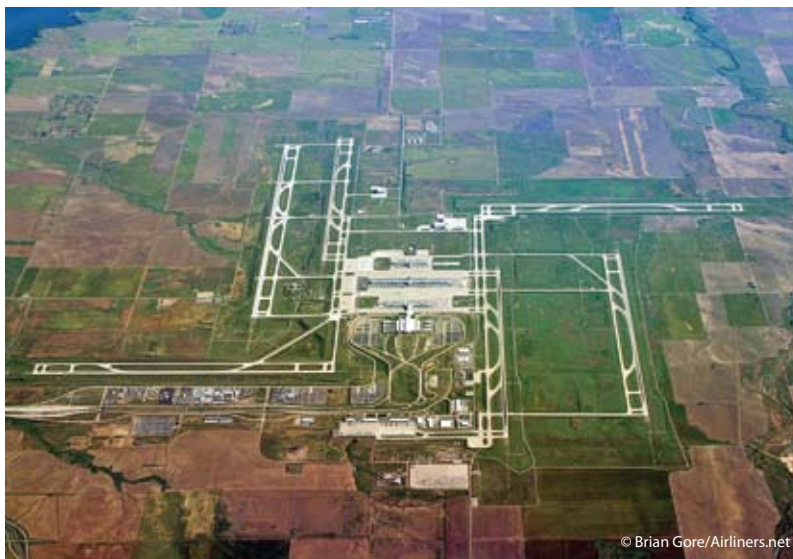
The 737 veered off Runway 34R, the inner runway of the parallel pair on the northwest side of the airport.

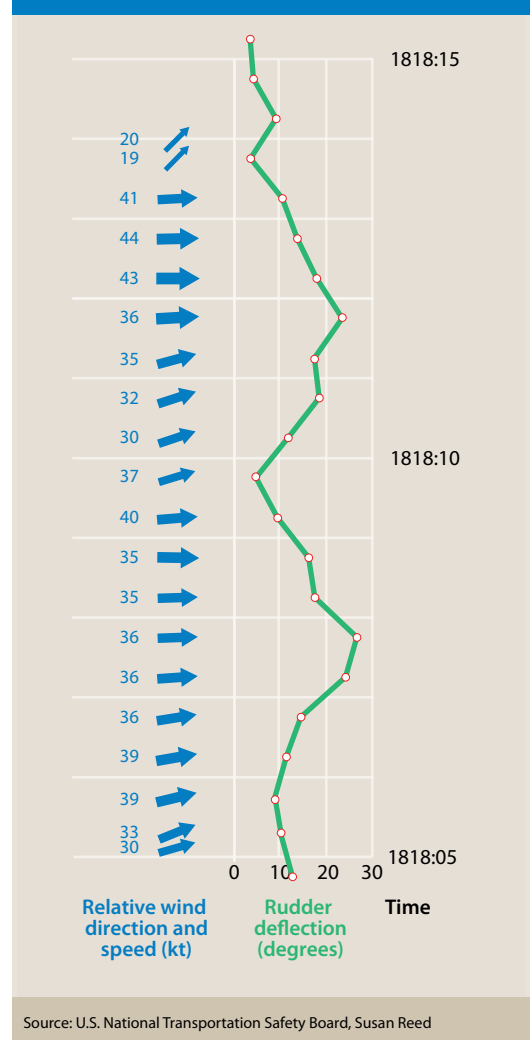
Figure 1

Wind and Rudder Deflection

Investigators estimated that the 737 encountered direct crosswind components ranging from 29 kt to 45 kt during the takeoff roll. The peak gust of 45 kt occurred about the same time that the captain relaxed pressure on the right rudder pedal. The report said that the captain likely would have been able to maintain directional control if he had maintained or rapidly reapplied right rudder input. "Performance calculations indicated that the airplane's rudder was capable of producing enough aerodynamic force to offset the weathervaning tendency created by the winds the airplane encountered during the accident takeoff roll."

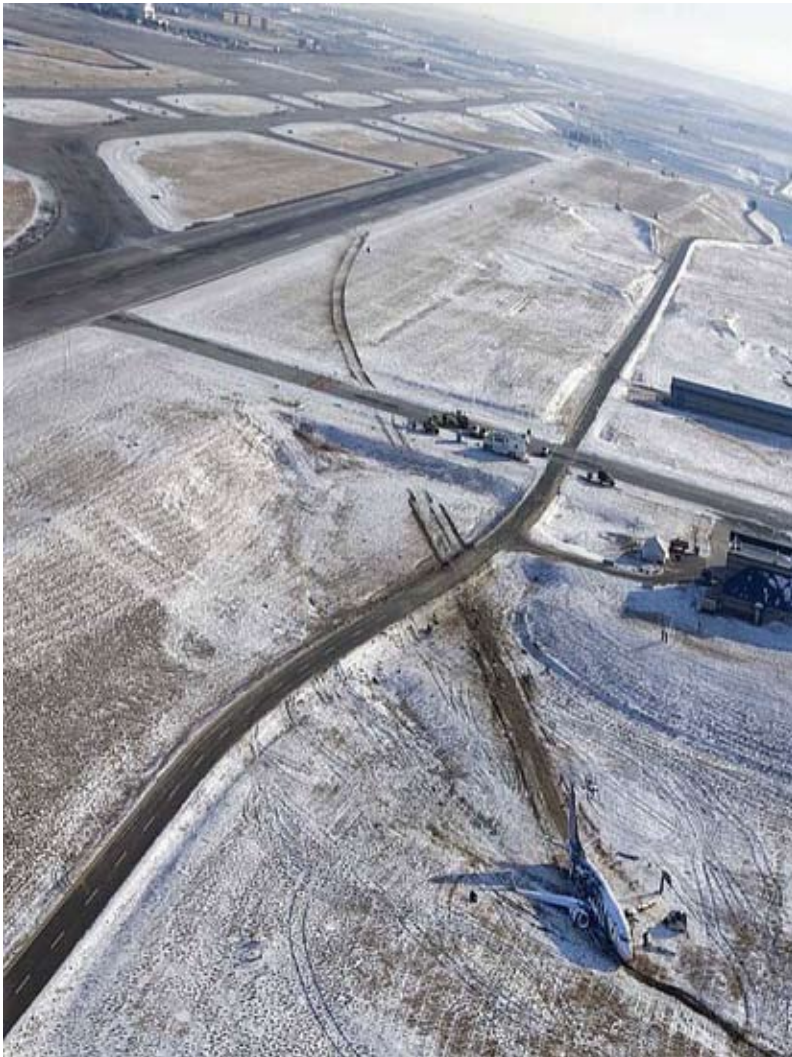
The airplane had a rough ride on uneven terrain after leaving the runway at 110 kt.

“Postaccident interviews with passengers and crewmembers, as well as evidence from the crash site, indicated that as the airplane crossed the uneven terrain before coming to a stop, it became airborne, resulting in a jarring impact when it regained contact with the ground,” the report said.
