A business jet was in clouds when the pilots initiated a steep descent, following a spurious navigation signal toward high terrain.

# False Localizer Signal

In its final report, the Irish Air Accident Investigation Unit (AAIU) said that the probable cause of the serious incident — which occurred at (County) Kerry Airport (EIKY) in Killarney the morning of July 13, 2009 — was that “the crew suffered a serious loss of navigational and

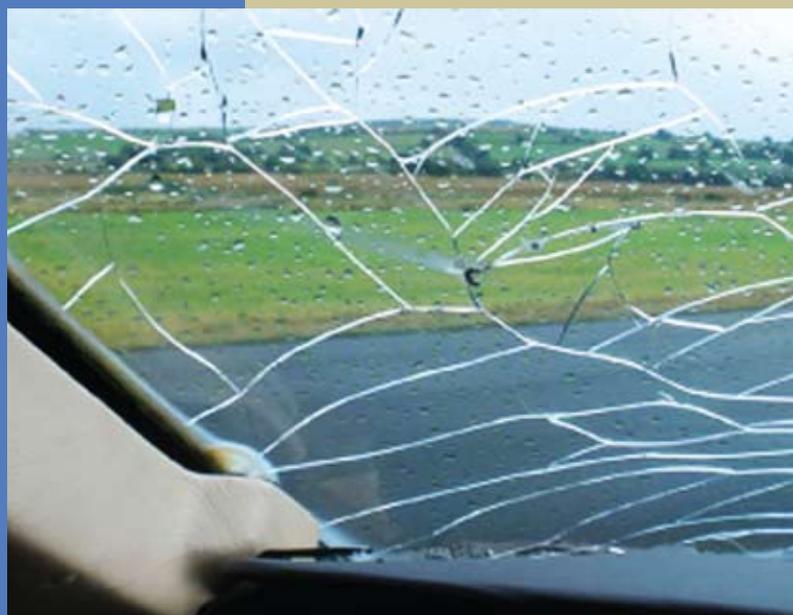
Electrical arcing caused the GIV’s windshield to crack on takeoff.

Investigators determined that the outer ply of the windshield had cracked because of electrical arcing between a heating system bus bar and the anti-icing film covering the inner surface of the outer ply. “The electrical arcing resulted when moisture ingress was absorbed by the interlayer and caused degradation of the bus bar at the bottom forward corner of the windshield,” the report said.

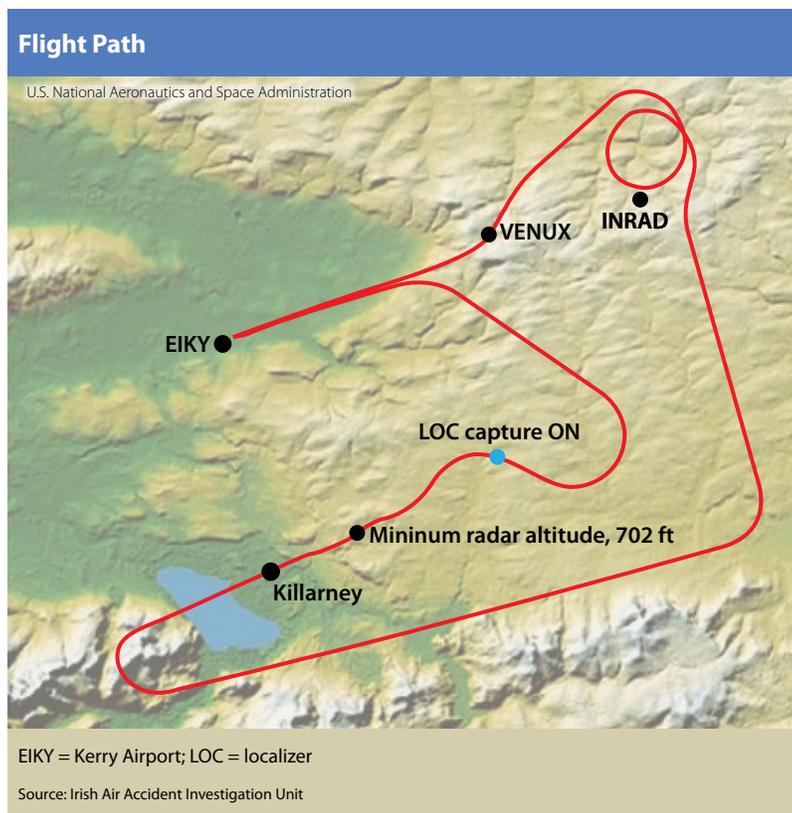
Figure 1

The captain was initiating a right turn to a southeasterly heading, in compliance with the standard instrument departure procedure (SID), when the first officer radioed, “Sir, we have a cracked windshield. We’re leveling off at three thousand. We’d like to come back to Kerry.” The control tower at Kerry Airport was not equipped with radar, and the airport traffic controller asked for a position report. The first officer erroneously replied that the aircraft was 35 nm [65 km] southeast of the airport. The report said that he likely mistook the indicated distance to Cork, the next navigational fix on the SID, for the distance from Kerry. The GIV actually was about 10 nm [19 km] southeast of the airport (Figure 1, p. 18).

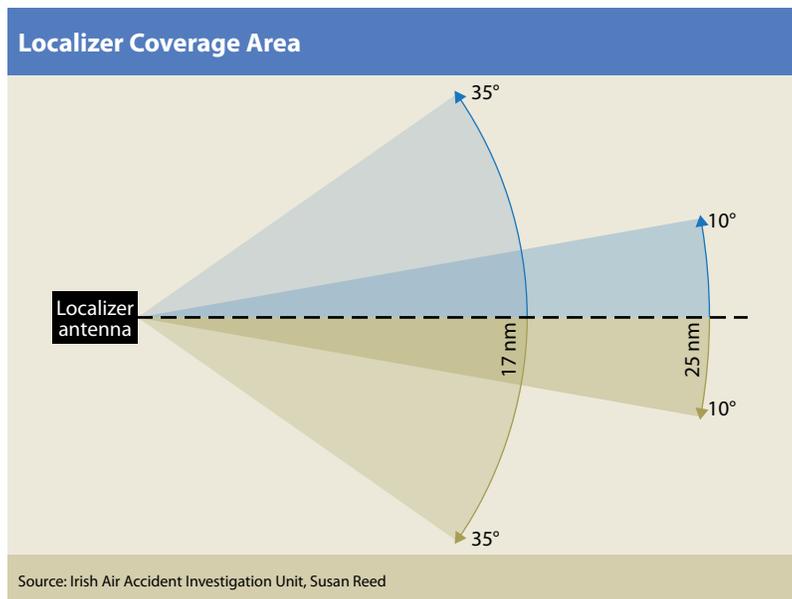
Figure 2

The localizer coverage area, as specified by the International Civil Aviation Organization, extends to a maximum of 35 degrees of the localizer centerline (Figure 2). The aircraft was at an angle of 43 degrees from the centerline when it intercepted the false localizer signal. Such signals — also called “false courses” — are normal byproducts of ILS signal generation and are created at various angles outside the coverage area.<sup>1</sup> False localizer and glideslope signals also can be generated inside the coverage area during ILS maintenance and testing.
