A small child's fall reminds adults of the need for close supervision and reveals inadequate updates to operators.

Airstair Vigilance

A 3-year-old girl's fall from the forward integral airstair of a Ryanair Boeing 737-800 — an approximate height of 8.5 to 9.0 ft (2.6 to 2.7 m) — has prompted the U.K. Air Accidents Investigation Branch (AAIB) to issue several safety recommendations, including one for airstair modification. She was released from a hospital after a 24-hour assessment and treatment of minor injuries.

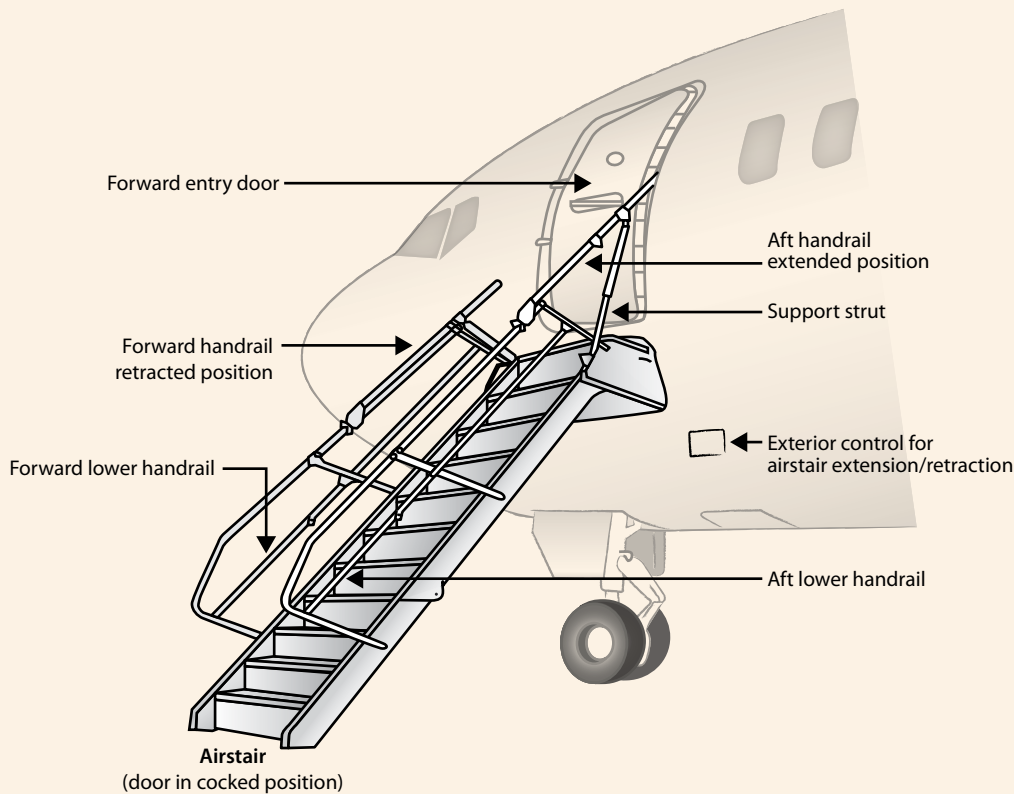
Figure 1

Forward Integral Airstair on Boeing 737s

Notes: The upper handrail extensions, when secured to the inside of the door opening, are designed to provide a continuous support from the ground to the airplane cabin. However, an FAA special airworthiness information bulletin (SAIB NM-07-47) in September 2006 advised 737-series owners and operators of four occurrences in which, during the process of disembarking or entering the airplane, unattended small children fell through or over the handrails or lost their balance and fell from the airstair.

are intended to provide protection against people falling sideways off the upper section of the airstair,” the report said. “While these handrails appear to provide adequate protection for adults, a gap exists between the handrail and the airstair platform which is large enough to allow a small child to pass through it and fall onto the [ramp pavement] below.”

Investigators concluded that the absence of a barrier that specifically protects small children also should be addressed. “The gap between the extendable handrail and the upper platform of the Boeing 737 airstair represents a hazard to small children boarding or disembarking the aircraft,” the report said. “Four previous events resulted in [amended guidance or safety bulletins that] do not provide physical protection against a child falling through the gap. The modification proposed by the operator provides a significant visual cue to the lack of a rigid barrier in this area, but provides only a limited physical protection against falling.”

The AAIB said that Ryanair also analyzed this incident and instituted measures to reduce the risk. “As a result, the operator raised a modification which introduces a roller-tensioned, high-visibility tape between the door aperture and the extendable handrail strut,” the report said. “After approval by the relevant airworthiness authorities, this modification will be embodied on the operator’s fleet as a matter of priority.”

- “Boeing establish a process to inform the operators of all Boeing commercial aircraft of changes to the relevant flight attendant manual;
- “Ryanair review their current passenger boarding and disembarking procedures so that assistance is made available to passengers accompanied by children, and those with special needs; [and,]
- “Boeing review the design of the Boeing 737 forward airstair with the intention of adding a removable barrier to minimize

the possibility of a child falling through the gap between the extendable handrail and its upper platform.”
