Departure from THE NORM

The pilot flew the R44 low and slow on the Western Australia sightseeing flight.

This report is based on ATSB Transport Safety Report AO-2008-062, Collision With Terrain, 6 km NE of Purnululu ALA, Western Australia, 14 September 2008, VH-RIO, Robinson Helicopter Company R44 Raven.

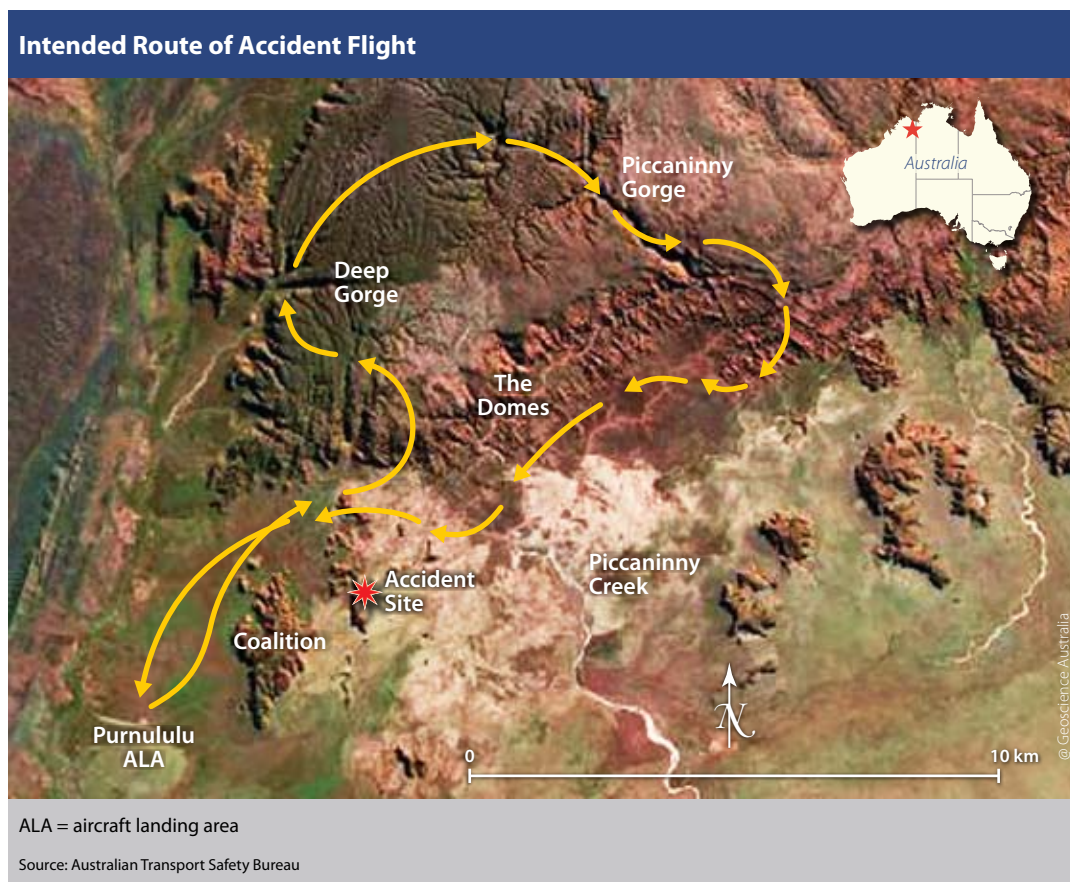
Figure 1

The wreckage was found in a flat site at the base of a rocky, upsloping area. The helicopter was "seriously damaged" by the impact and a subsequent fire, the report said, noting that it had struck the ground upright, with the right skid low and at a high vertical speed but little or no forward speed.
