FLIGHT SAFETY FOUNDATION

JULY 2002

Erroneous ILS Indications Pose Risk of Controlled Flight Into Terrain

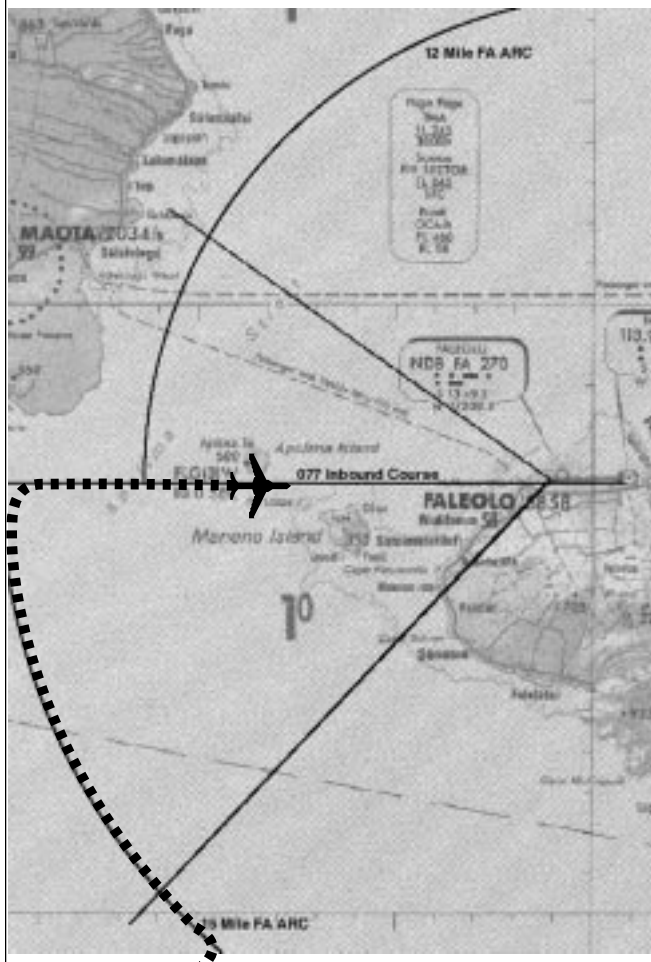
Figure 1

The captain flew the aircraft with the automatic flight control system (AFCS [i.e., autopilot and autothrottles]) engaged. The first officer observed runway lights before the aircraft intercepted the localizer at 2,800 feet and about 13 nautical miles (24 kilometers) from the runway threshold (see Figure 1). The report said that when the captain armed the AFCS approach mode, the autopilot “almost immediately” captured the glideslope. Airspeed increased as the aircraft began to

Air New Zealand Flight NZ 60; Initial Instrument Landing System Approach; Faleola, Samoa; July 29, 2000

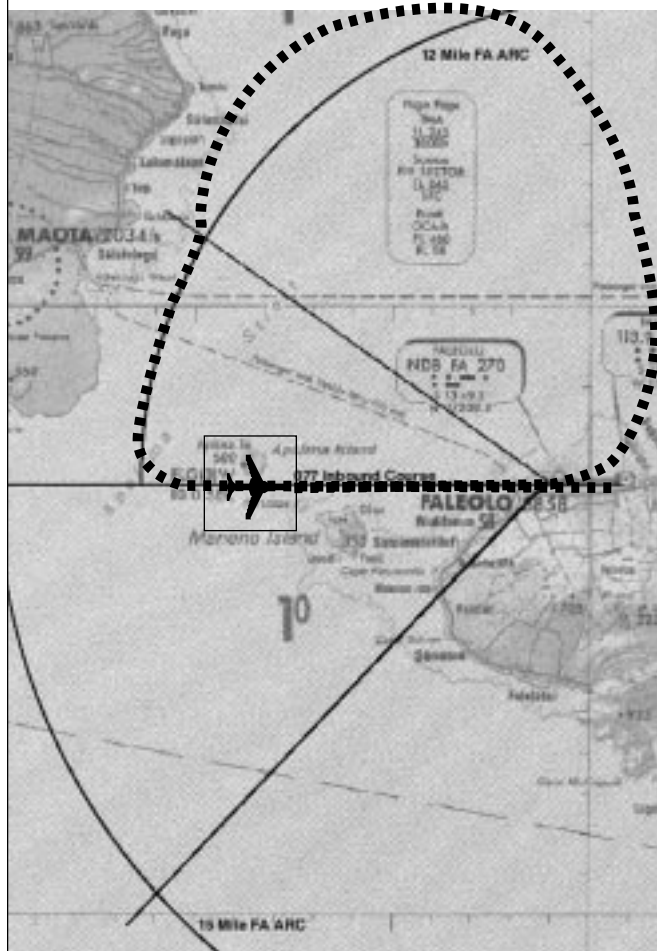
The captain then observed that the DME readout was “inappropriate” in relation to the on-glideslope indication and began a missed approach. At the same time, both the first officer and the supplementary pilot, who also had detected anomalies, called for a go-around.

Air New Zealand Flight NZ 60; Missed Approach, Localizer Approach and Landing; Faleola, Samoa; July 29, 2000
