# Search for the Lurking Glitch

Flight data monitoring case studies provided by Flight Data Services, with permission of the operators concerned.

## Case Study #1: Low Speed After Takeoff

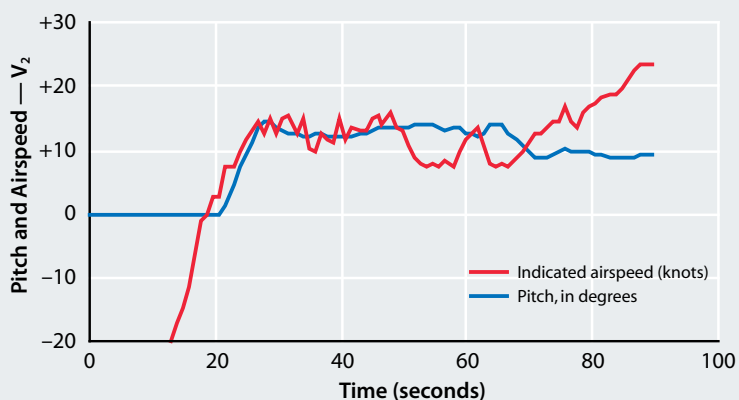
Figure 1

Typical takeoff data from another operator (Figure 1) show the airspeed increase during the takeoff roll to the 20-second mark, when the aircraft rotates. The 15-degree nose-up attitude in the initial climb ensures the climb-out is at about  $V_2$  plus 15 kt, before the nose is lowered and the aircraft accelerates.

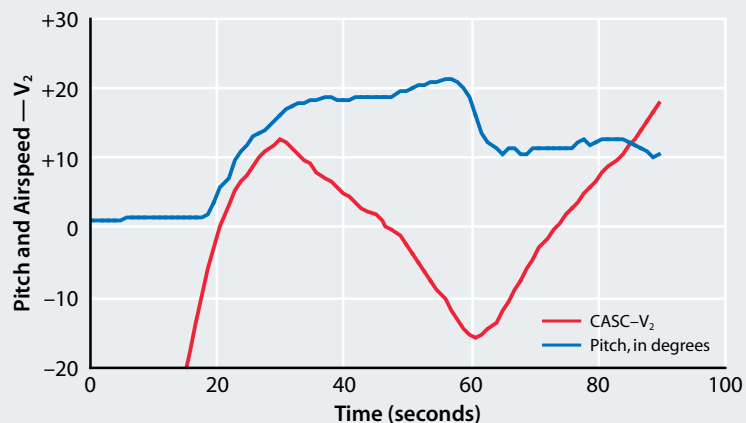
Figure 2

Data from the operator with the speed loss problem, however, create a far different speed/pitch plot (Figure 2). As the pitch attitude passes 15 degrees nose-up, the airspeed is beginning to fall, but the nose continues to rise to more than 20 degrees while the airspeed slows to  $V_2$  minus 15 kt.

While it might be suggested that the aircraft was not being flown correctly, the flight path modelling work undertaken by FDS demonstrated that the technique described in the training manual was being followed. In fact, the pilots who followed the flight director slavishly and without reference to other

instruments were most likely to experience this problem.

Ultimately, the aircraft manufacturer issued a software update, stating, “It has been reported that the takeoff crossbar was moving instead of standing still at the desired pitch during rotation and subsequent takeoff. Changes have been made to avoid this pitch guidance

movement.” For the operator concerned, this change, together with training that reinforces the need to maintain scan of all of the flight instruments, has nearly eliminated this sort of event.
