Failure of a business jet's lift-dump system was the last ingredient in a spoiled landing.

BY MARK LACAGNINA

Streaking into

Vegas

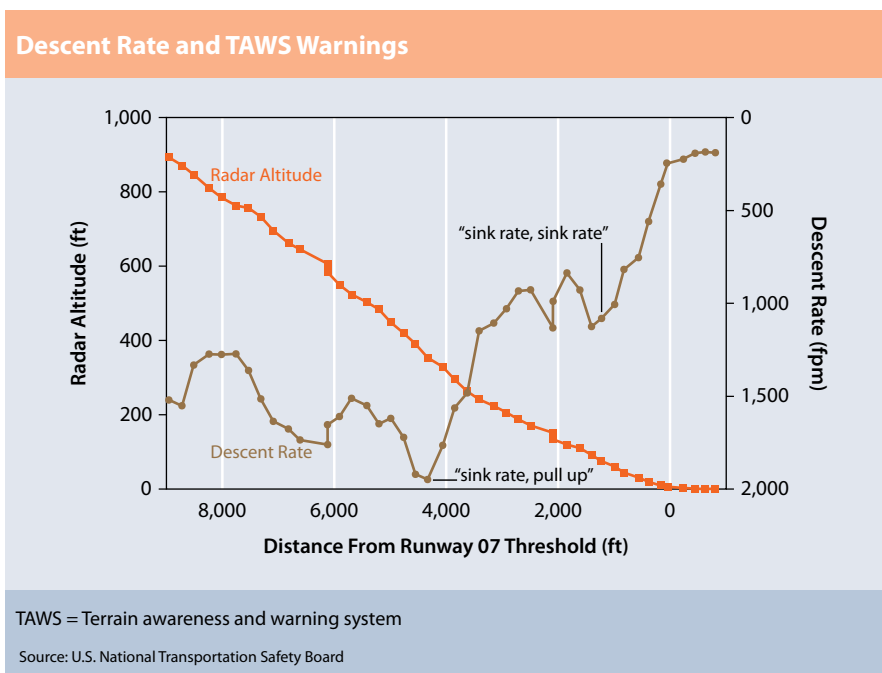
Figure 1

The airplane was descending at nearly 2,000 fpm through about 350 ft AGL when the terrain awareness and warning system (TAWS) generated a “SINK RATE, PULL UP” warning (Figure 1). The CVR did not record a discussion of the warning.

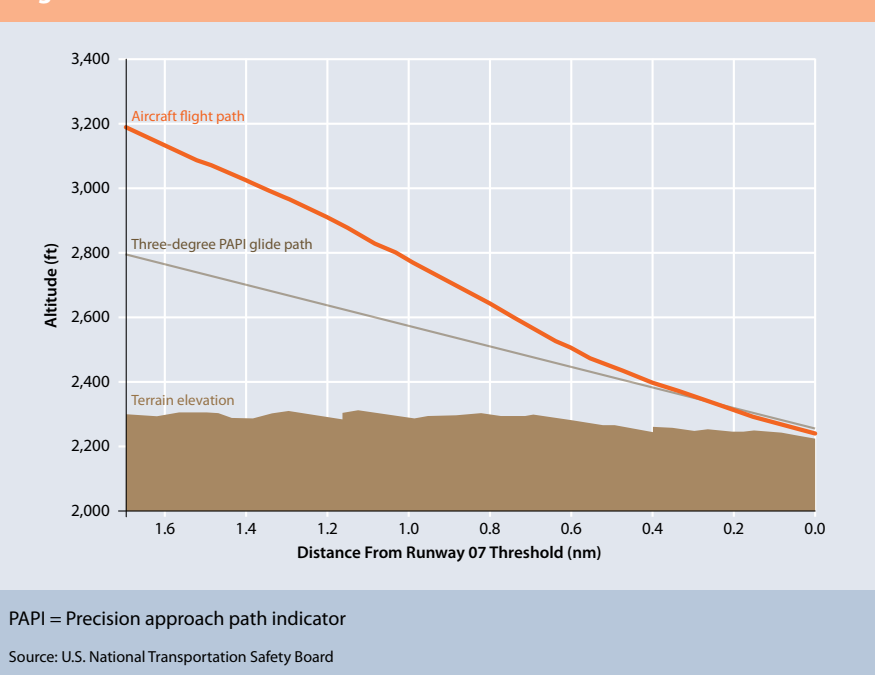
Figure 2

Figure 2, which was derived from TAWS data, shows that the airplane’s flight path was above the three-degree glide path indicated by the PAPI until the airplane was about 0.2 nm (0.4 km) from the runway. “The flight’s unstabilized approach and excessive speed should have prompted the pilot to initiate a missed approach,” the report said.
