# FIRE in the HOLD

The DC-8 flight crew received little warning of the impending conflagration.

*This article is based on NTSB Accident Report NTSB/AAR-07/07: “Inflight Cargo Fire; United Parcel Service Company Flight 1307; McDonnell Douglas DC-8-71F, N748UP; Philadelphia, Pennsylvania; February 7, 2006.”*

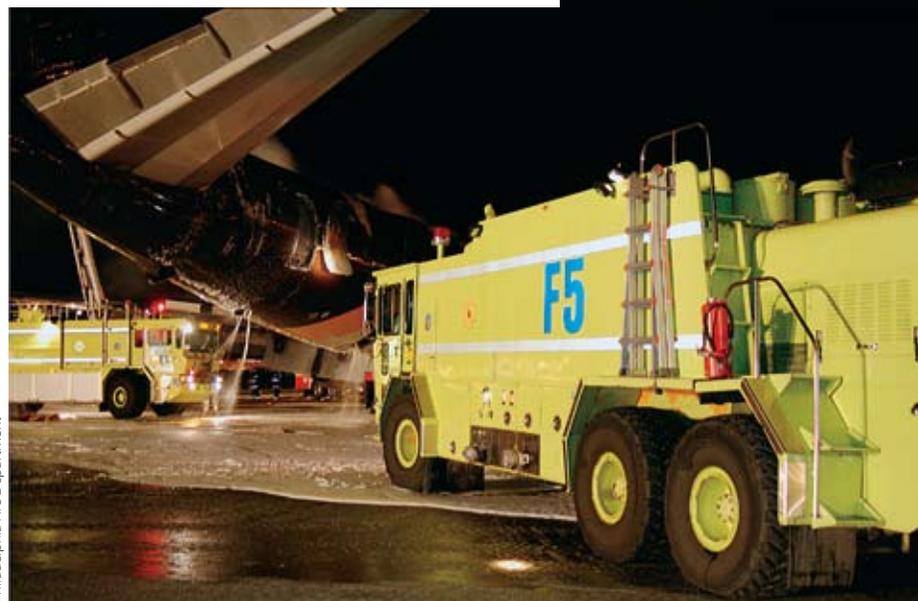
**The smoke had become so dense that the pilots could not see each other.**

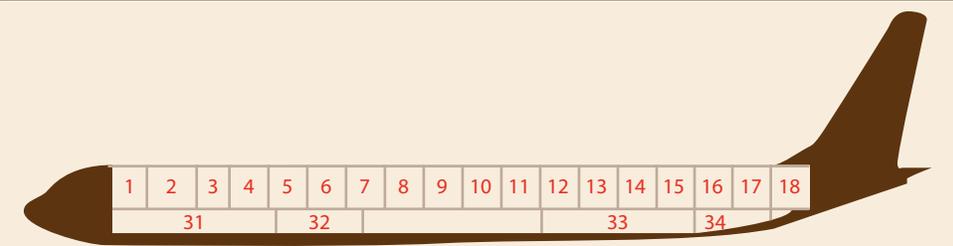
**Figure 1**

Investigators determined that the fire likely began inside cargo container 12, 13 or 14

(Figure 1). Among the items that had been shipped in these containers were electronic devices, including laptop computers, with rechargeable lithium batteries. Several lithium batteries of the same type also were found loose in the accident debris.

**Note:** The numbers 1 through 18 designate cargo container locations in the main cargo compartment. The numbers 31 through 34 designate lower cargo compartments.
