# KNOCK YOURSELF OUT

Overreaction to a shattered windshield led to loss of consciousness and control.

BY MARK LACAGNINA

*This article is based on NTSB accident report no. CHI07LA063, issued on Nov. 20, 2008, and on public docket no. 65268.*

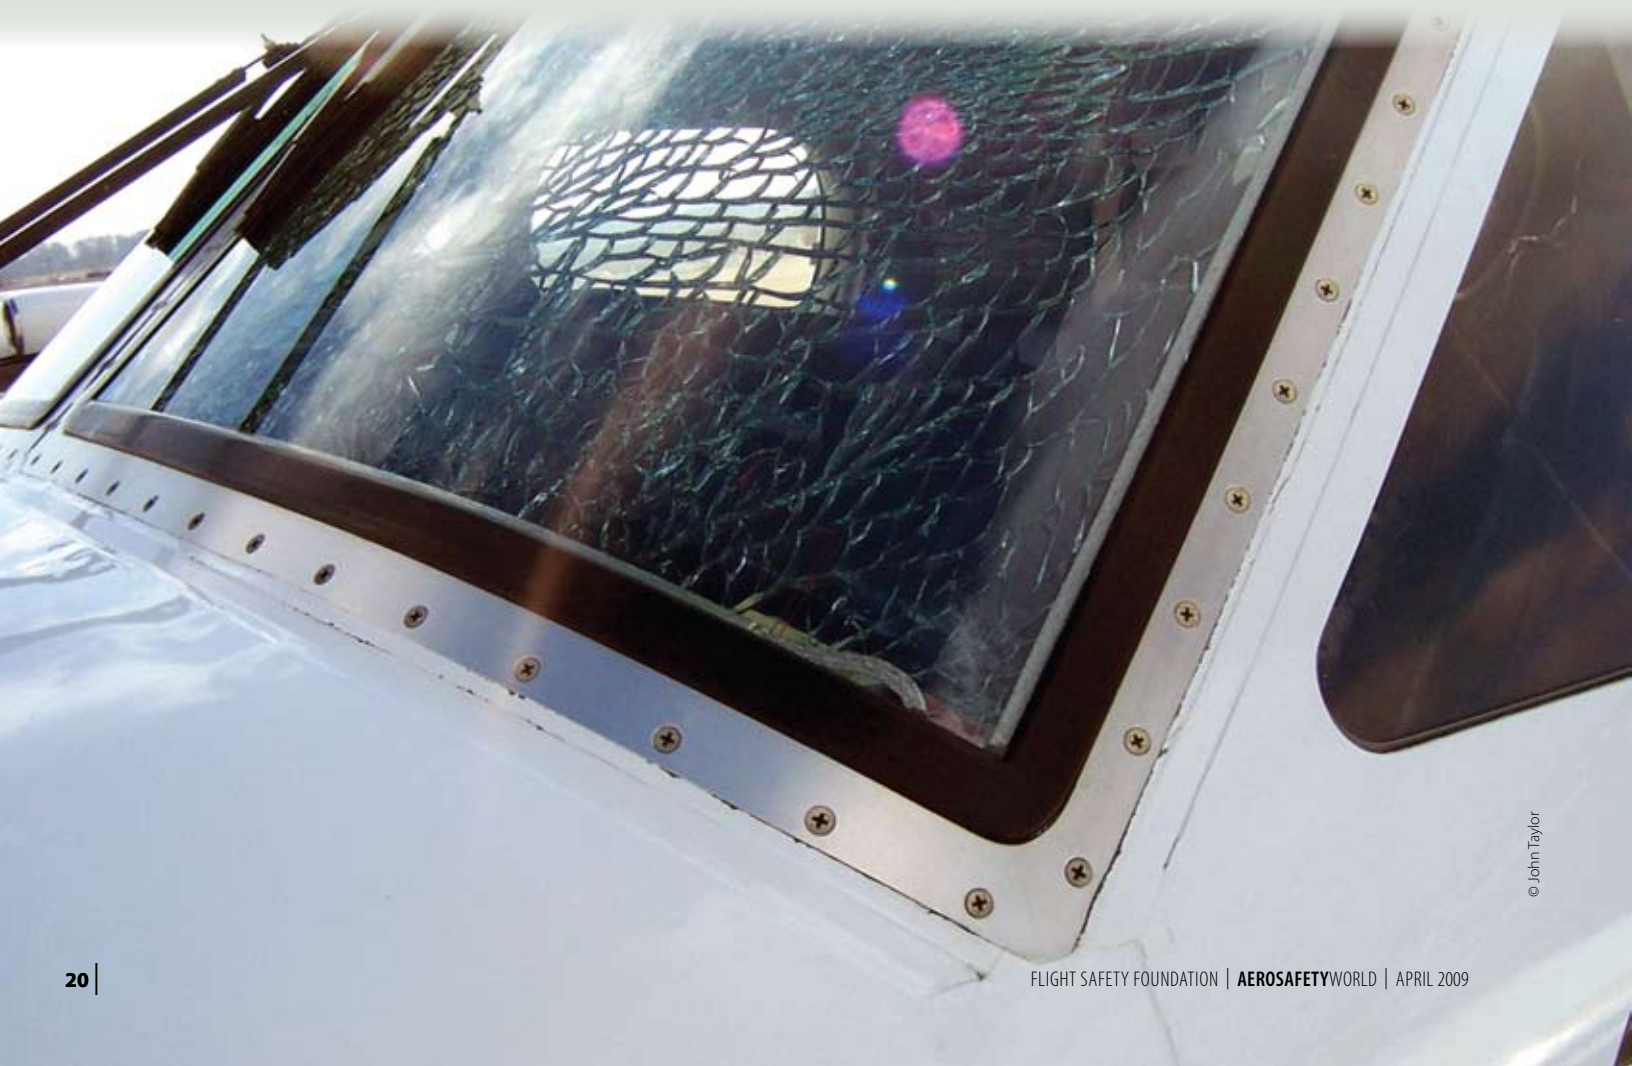
The shattering of the inner ply of the left windshield was traced to a fracture within the glass.

The shattering of the inner pane was traced to a “peel chip fracture” at the bottom center of the pane. “Scanning electron microscope examinations conducted of the glass fracture at the peel chip initiation revealed evidence of the initiation at a possible anomaly in the glass,” the report said.

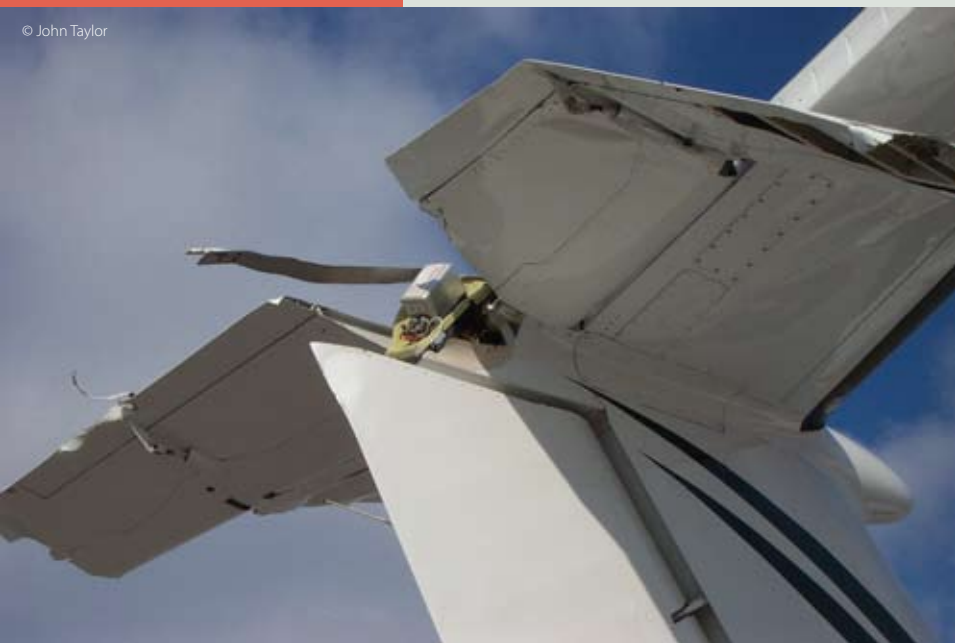
The King Air's tail was extensively damaged during the uncontrolled descent and the pilots' recovery from the upset.

“On-scene examination of the airplane noted that approximately two-thirds of the left horizontal stabilizer and elevator were separated from the

airplane, and two-thirds of the right elevator was separated but attached at the inboard hinge,” the report said. “The left and right wing [skins] were wrinkled. The left pilot windshield outer and inner plies were intact. The inner ply exhibited a shattered appearance with a crack at the lower right-hand corner of the windshield.” In addition, the rear fuselage was buckled.

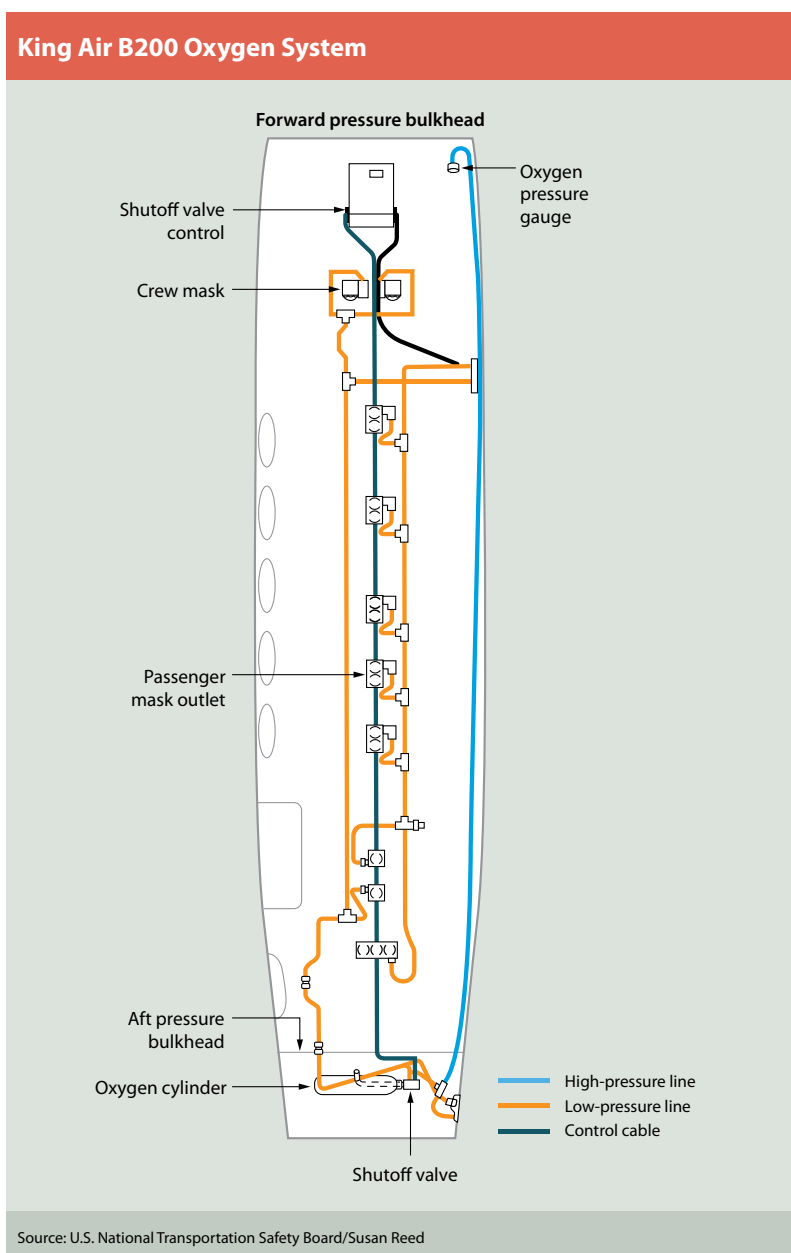
**Figure 1**

The oxygen cylinder is located behind the aft cabin firewall. The oxygen system shutoff valve on the cylinder is connected to the cockpit control knob by a cable (Figure 1). Opening the shutoff valve is among the actions specified by the “Before Start” checklist — as well as by several emergency checklists — in the AFM, but it was not included in the truncated “Before Start” checklist that the pilots were using.

“Oxygen will flow to each mask only if the oxygen tank shutoff valve is in the ‘OPEN’ position,” the report said.

After the accident, the oxygen shutoff valve control knob was found in the “OFF” position. “Functional testing of the oxygen system revealed normal operation,” the report said. “The unapproved-checklists document did not include the instruction to leave the oxygen system on. Regardless, the pilot stated that he knew the approved checklist stated to leave the oxygen system on but that he still chose to turn it off. The pilot exhibited poor judgment by using an
