Every Trip Has a Story

Resetting a circuit breaker without knowing why it opened can be deadly.

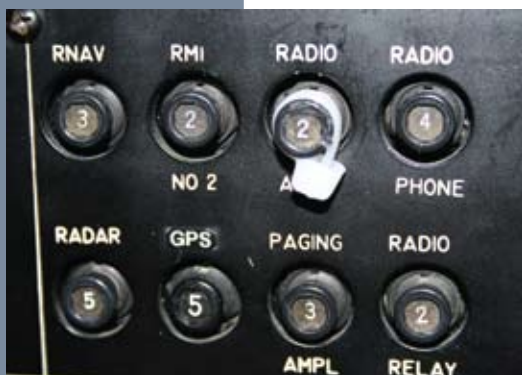
Collaring a CB with a tie wrap helps to prevent a defective electrical component from being reactivated.

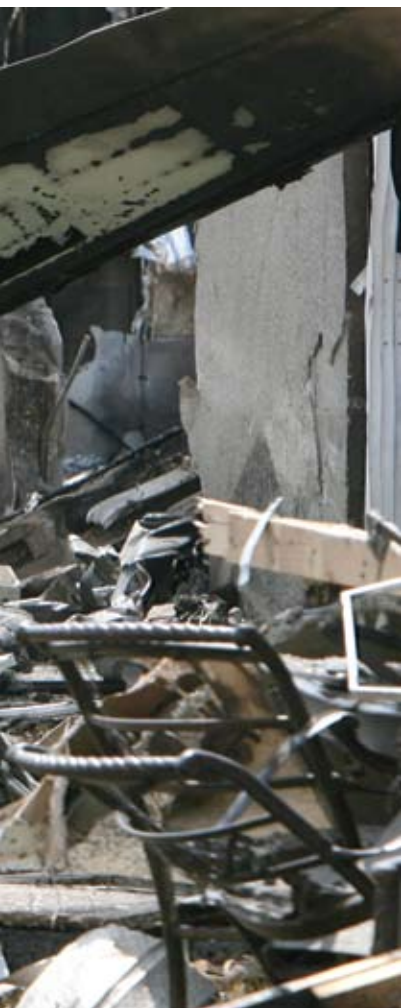
Examination of the wreckage revealed signs of an in-flight fire. Thermal damage and soot deposits were found on components that came to rest outside the area of the postcrash fire. The cabin door, for example, was found relatively intact about 60 ft (18 m) from the main wreckage. “The undamaged latching pins and the location and existence of the observed trailing soot deposit are consistent with the pilots having opened the cabin door to vent smoke during an in-flight fire,” the report said.

NTSB investigators found signs of an in-flight fire.
