# Missed Identified Fix

**Second in a series focusing on approach and landing incidents that might have resulted in controlled flight into terrain but for timely warnings by TAWS.**

BY DAN GURNEY

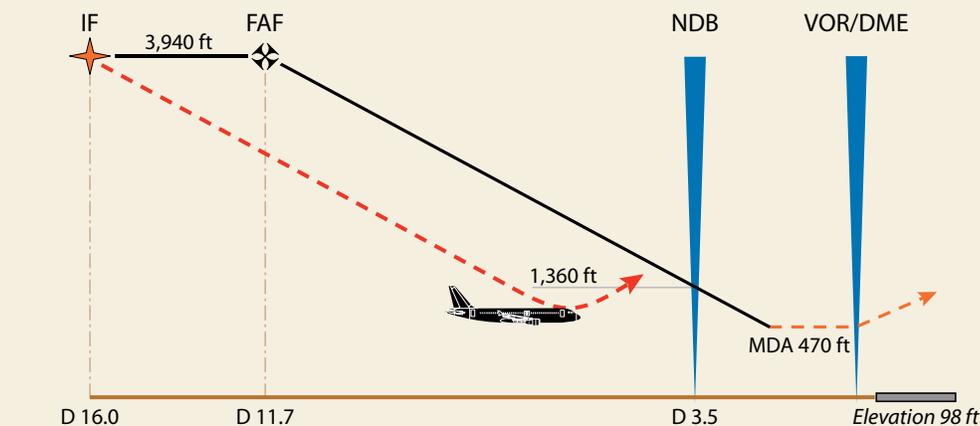
**Figure 1**

should be maintained until reaching the FAF, 11.7 nm DME from the VOR/DME station. However, TAWS data indicate that the descent was begun 16.0 nm from the station — 4.3 nm before reaching the FAF (Figure 1, page 26).

The aircraft was 540 ft above ground level and 4.5 nm (8.3 km) from the runway threshold when the TAWS generated a “TERRAIN, PULL UP” warning. The crew stopped the descent and conducted a missed approach, climbing away safely.

A likely explanation for the premature descent is that the crew mistook the intermediate fix for the FAF. The intermediate fix is 4.3 nm from the FAF.

After the premature descent was begun, the aircraft was flown below the usual flight path. Before reaching the nondirectional beacon (NDB) 3.5 nm from the VOR/DME station, the

aircraft descended below 1,360 ft, the minimum altitude for crossing the NDB. (The aircraft did not descend below the minimum descent altitude, 470 ft.)

Flight crews should ensure that the airport or runway is displayed on the EFIS map before beginning a descent for the final segment of an approach. During descent, altitude/range checks should be conducted using a published table, a table prepared before flight or mental calculations, using 300 ft per nm for a three-degree glide path.

Moreover, one of the most important lessons to be learned from this incident is that *altitudes* should be the basis for altitude/range checks during descent. If the crew waits until crossing a specific fix or reaching a specific range, the aircraft might already have descended below the required check altitude, resulting in reduced terrain clearance. ●

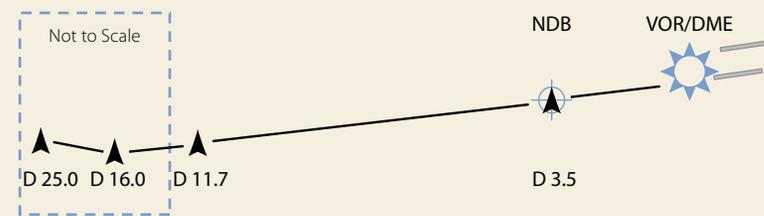
**Figure 2**

- The location of the FAF at 11.7 nm DME results in a long final descent.
- The approach procedure includes an initial approach fix at 25 nm DME and an intermediate fix at 16 nm DME. Both fixes are shown in a dotted box in the plan view of the approach procedure with a note that the ranges are not to scale (Figure 2); the initial approach fix and the intermediate fix are not shown in the profile view of the published approach procedure.
