During a fatal night flight over the Gulf of Mexico, the pilots of the Sikorsky S-76A failed to detect cockpit indications of their descent to the water.

CAUSES MISSED

The flight crew of a Sikorsky S-76A failed to “identify and arrest the helicopter’s descent” before it struck water in the Gulf of Mexico, killing all 10 occupants, the U.S. National Transportation Safety Board (NTSB) said in its final report on the accident.¹

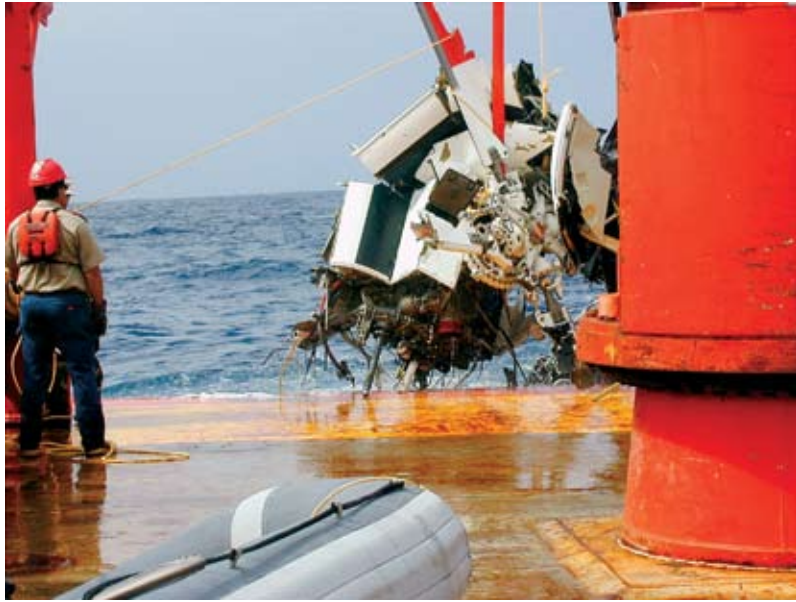
The wreckage of the helicopter was found March 25 in waters about 186 ft (57 m) deep.

Wreckage of the S-76A is pulled from the Gulf of Mexico.
