Two's Too Many

Angled taxiways limiting the pilots' view of the runway, clearances issued and read back hastily and incorrectly, and crossed radio transmissions¹ were among the common factors involved in two "critical runway incursions" that occurred two months apart last year at Auckland International Airport, said the New Zealand Transport Accident Investigation Commission (TAIC).

This article is based on TAIC Aviation Occurrence Report 07-005.

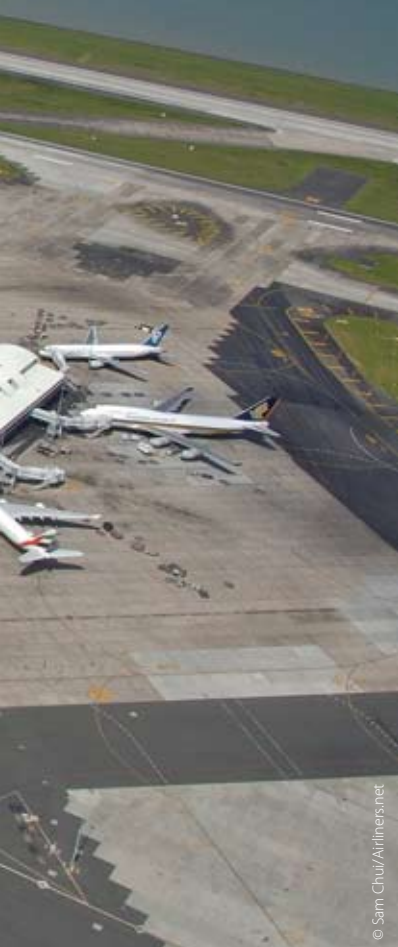
The pilots' limited view of the runway while holding on angled taxiways at Auckland International was a factor in two critical incursion incidents.

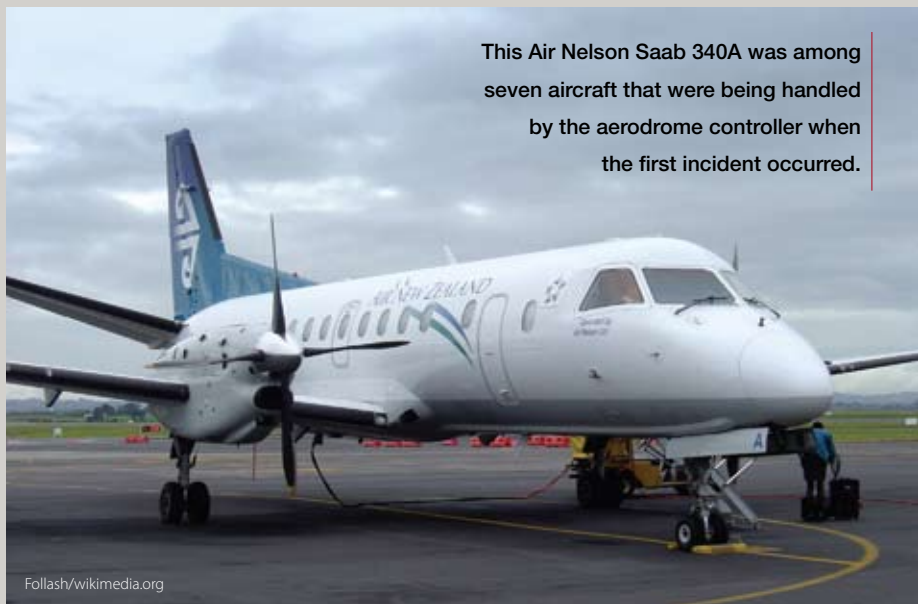
This Air Nelson Saab 340A was among seven aircraft that were being handled by the aerodrome controller when the first incident occurred.

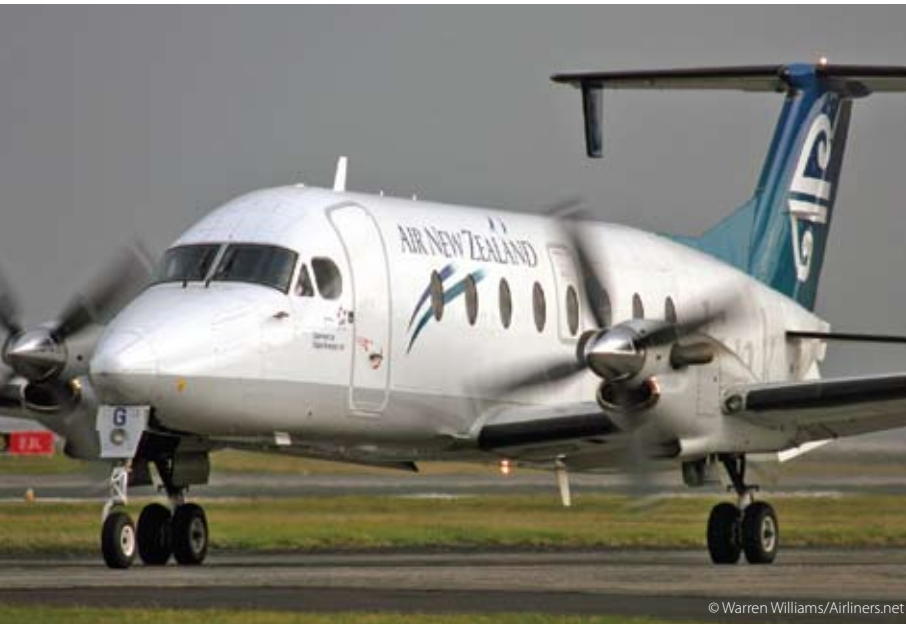
The second incident involved two Eagle Airways Raytheon Beechcraft 1900D flight crews who accepted a takeoff clearance meant for only one of the airplanes.

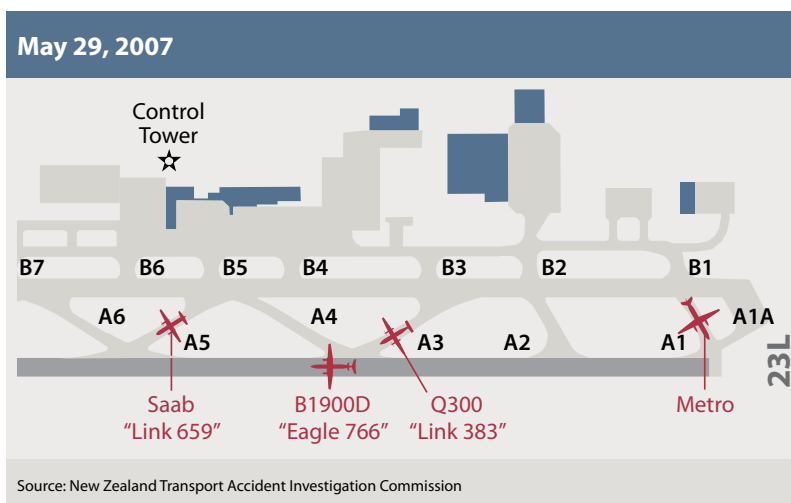
Figure 1

The events leading to the first incursion began when the ground controller cleared the flight crew of an Air Nelson Saab 340A, call sign Link 659, to taxi from the ramp via Taxiway B5 to the runway holding point on Taxiway A5 (Figure 1, p. 39). “The Saab pilots had completed their pre-takeoff checks and had changed to the aerodrome controller’s radio frequency (Tower) as they approached the holding point,” the report said.

However, the aerodrome controller used the wrong call sign in the takeoff clearance. Instead of addressing Link 383, she radioed, “659, if you can take an immediate, line up Runway 23L.”

“Pilots seated on the left side of aircraft holding on Taxiway A3 or A5 have to look back over their shoulders through almost 150 degrees in order to see the runway threshold and can see less of the runway and approach area when holding on Taxiway A5 than when holding on Taxiway A3,” the report said.

again and saw the landing [1900] bearing down as it turned off the runway towards Taxiway A6,” the report said. “Both aircraft were braked hard and came to a stop ... about 10–15 m [33–49 ft] apart.”

Based on these findings, TAIC concluded that the first runway incursion “was initiated when the aerodrome controller mistook the call sign of the aircraft she intended to line up for takeoff and thereby inadvertently instructed another aircraft to line up in front of the aircraft that was landing.”

Among actions taken after the two incidents was a revision by Airways New Zealand of its traffic management plan for Auckland, requiring that departures from Runway 23L be conducted only from Taxiways A1A, A1 or A2. The runway-entry point for A1A and A1 is at the approach threshold, and A2 is angled toward the approach end of the runway.²

In addition, the layout of the flight progress board in the Auckland control tower and procedures for placing flight progress strips on the board were revised. The board has separate bays for the takeoff-holding points, and ground controllers are required to place strips in the bays corresponding to the assigned holding points. The revision is a temporary measure, pending implementation of an electronic flight progress strip system that “should give all aerodrome controllers earlier advice of impending departures,” the report said. 🌀

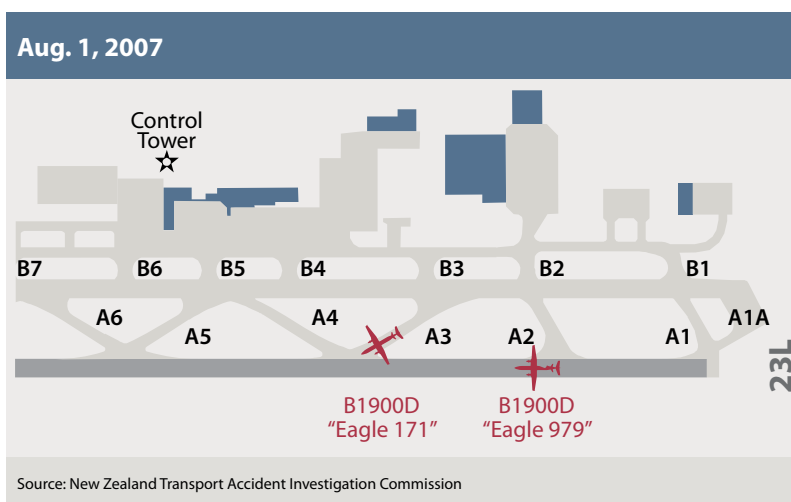
Figure 2

None of the aircraft, pilots or controllers involved in the first incident was involved in the second incident the morning of Aug. 1, 2007. Three aircraft were on the aerodrome controller’s radio frequency: an aircraft on departure, another on arrival but not yet on final approach, and an Eagle Airways 1900D, call sign Eagle 979, that was holding for takeoff on Taxiway A2 (Figure 2).

The first officers of both Eagle 979 and Eagle 171 read back the clearance at the same time. “The aerodrome controller contributed to the holding pilots mistaking the call sign by issuing the takeoff clearance immediately after the pilots of [Eagle 171] had called ready and by not using phonetic pronunciation for the call sign numbers [of Eagle 979],” the report said. The report did not specify how the controller pronounced the call sign but said that it was not “niner seven niner” and noted that the numbers “71” and “79” are similar.

“The captain of Eagle 979 had already initiated a rejected takeoff from a speed of about 60 kt,” the report said. “He swerved left almost to the runway edge, while the captain of Eagle 171 veered his aircraft to the right. Each aircraft was stopped on its respective half of the runway.” The wing tips were about 8 m (26 ft) apart.

The second incursion “was initiated when the pilots of the aircraft holding on a taxiway mistook the clearance for another aircraft to take

off as being for them and entered the runway in front of the aircraft that was taking off.”
