A mechanic had performed a routine preflight check, and, as captain of the Boeing 737-200 Advanced, I had conducted a walk-around inspection before departure. No abnormalities were observed. As we began the takeoff roll, the first officer and I sensed that acceleration was not as brisk as normal; then, at about 130 kt, we noticed that the aircraft seemed to be “shivering” sideways. A quick look at the attitude director indicator showed that the aircraft was tilting slightly to the left. Something apparently was wrong with the left main landing gear. A tire failure!

*Oddvard Johnsen is a retired Braathens captain with more than 21,000 flight hours. He has served for the past 35 years as an adviser to the Norwegian Accident Investigation Board on runway conditions and installations, and is former vice chairman of the IFALPA Airworthiness Study Group.*

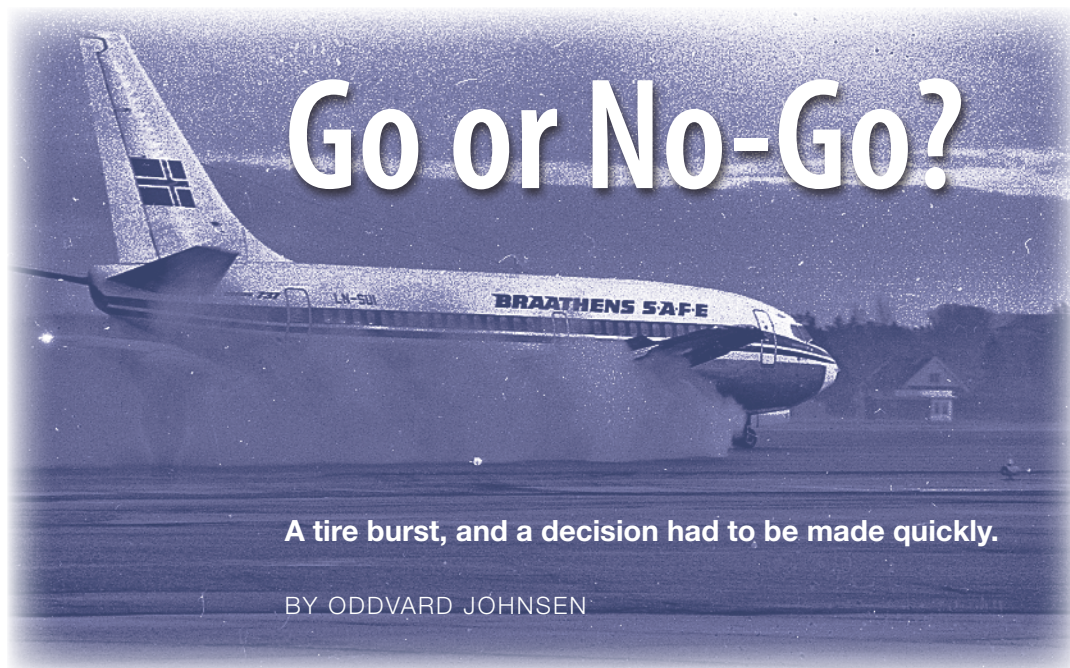
The emergency landing at Stavanger was conducted with the fuel imbalance within allowable limits. We touched down gently on the intact right main gear and carefully lowered the damaged-wheel side. Maximum allowable reverse thrust was applied (see photo p. 28), but braking was performed only on the intact wheel pair. The remaining left tire served its duty well, until we stopped after turning off the runway; the temperature fuse in the tire popped, causing the tire to collapse.

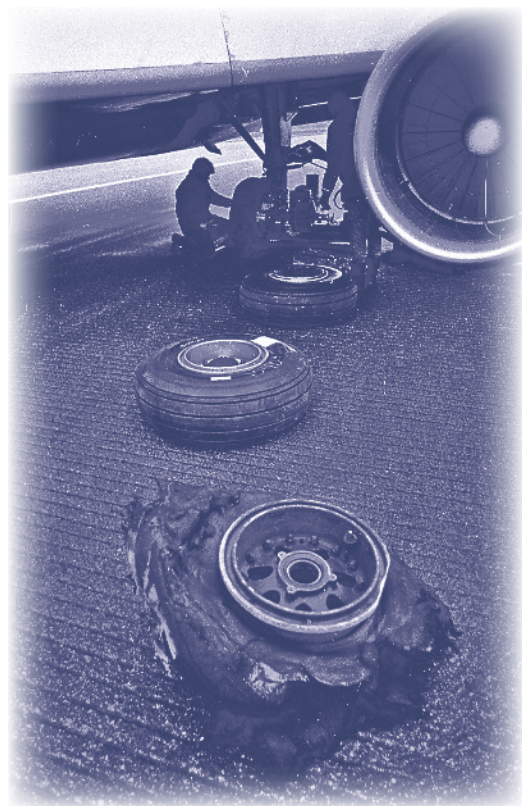
During the flight, an air force fighter pilot offered to join up and visually inspect the landing gear. He confirmed what we had suspected: The left outboard tire had burst and was torn to pieces. There was no related damage, no hydraulic leaks or fuel leaks.

In retrospect, the tire failure at Bergen, a seemingly minor occurrence, could have had a disastrous outcome if an RTO had been performed. The damaged tire and wheel would have reduced the effectiveness of the antiskid braking system. Moreover, an RTO would have meant full brake pressure, which would have put enormous force on the damaged gear's torque link, possibly causing the intact wheel to twist 90 degrees. The tire would have been torn off,
