Helicopter operators should be required to do more to make passengers aware of life raft operations, the NTSB says.

Watery **WARNINGS**

BY LINDA WERFELMAN

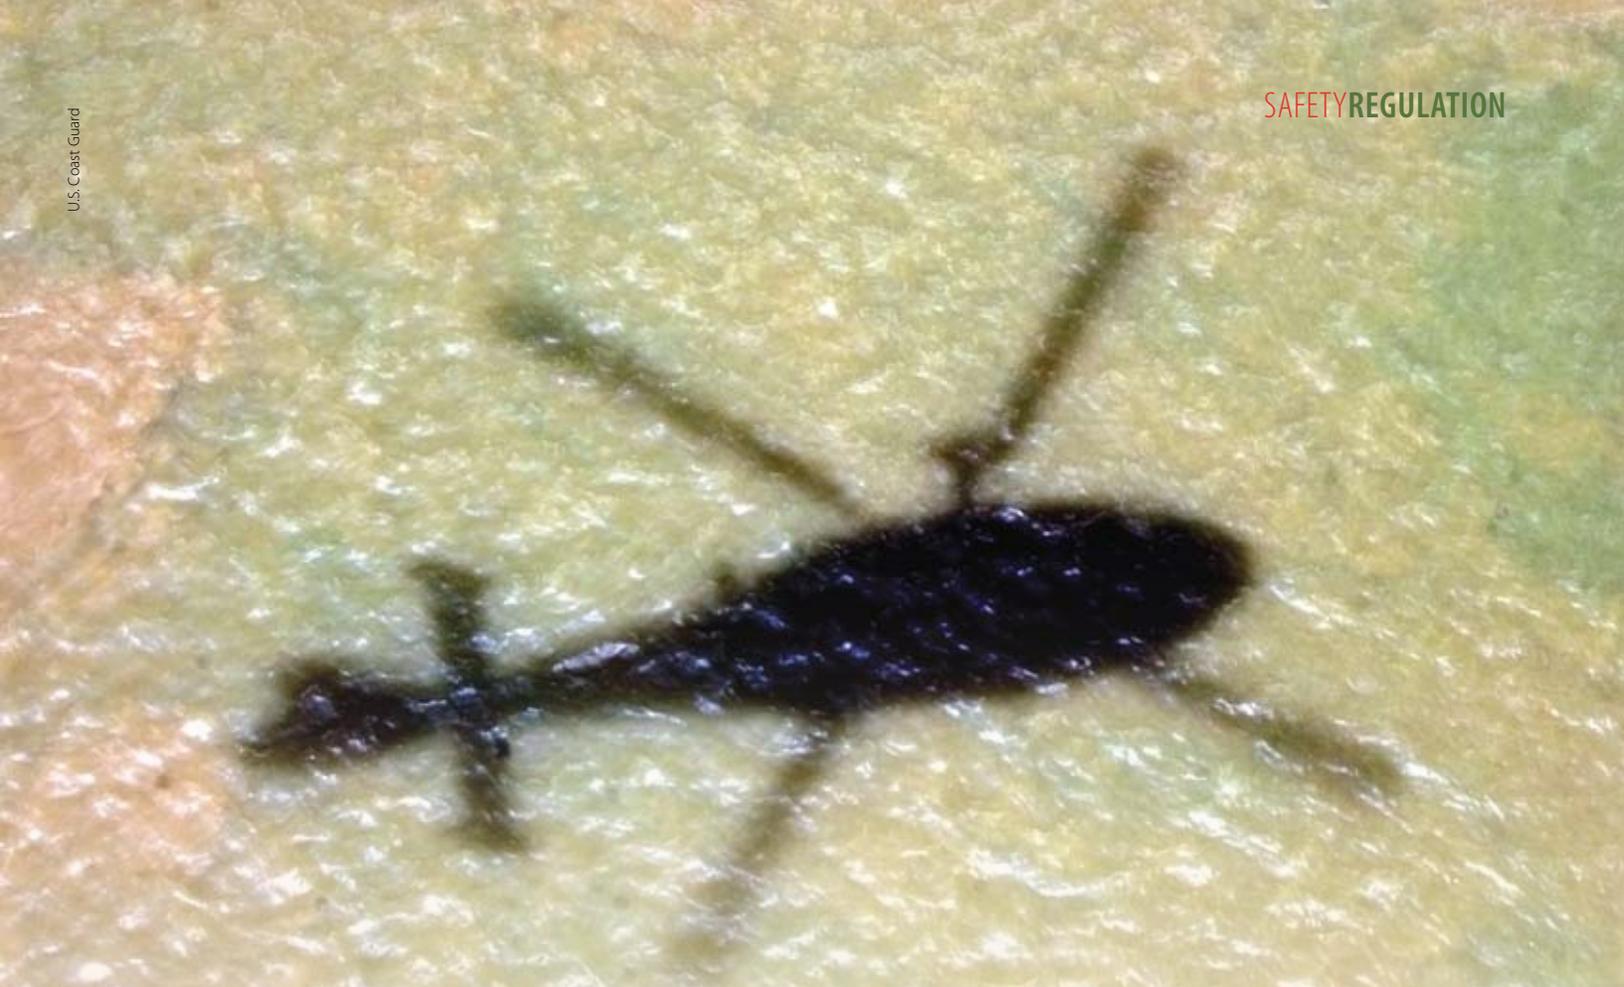
The NTSB letter that accompanied its safety recommendations said that the helicopter was in an “inadvertent descent, which was not arrested before the helicopter impacted the water and rolled to an inverted position.

“Because of the inadvertent descent, the pilot was likely not aware that the helicopter was about to contact the water, and the skid-mounted floats were not activated or deployed before the helicopter entered the water.”

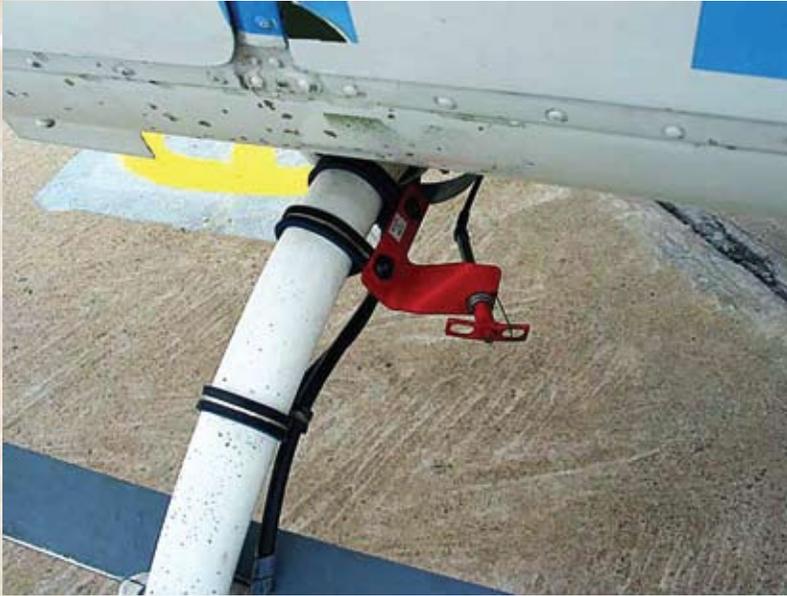
Life rafts on the Bell 206L1 could be activated from inside the helicopter or by pulling either of two red external T-handles.

The helicopter’s float assembly consisted of six floats — forward, center and aft floats on both the left and right skids — that were inflated by activation of a float-inflation handle on the pilot-side cyclic. The life rafts were “integral to the center floats” and were designed to inflate when any one of three T-handles — one located inside the helicopter on the pilot’s console and the other two outside, on the forward cross tubes — was pulled.

Instructions for operating the T-handle in the cockpit were printed on a placard on the ceiling above the pilot’s seat, but there were no placards outside the helicopter describing where the external T-handles were located or how to operate them.

Nevertheless, because SAIBs are not mandatory and only float/life raft systems from one manufacturer would be affected, the NTSB issued a safety recommendation in October calling on the FAA to “require operators of turbine-powered helicopters with externally mounted life rafts to install a placard for each external T-handle that clearly identifies the location of and provides activation instructions for the handle.”
