The report on the March 17, 2007, Citation 500 accident, published in August, is brief, a product of what NTSB calls a “limited” investigation, but highlights the board’s decade-long effort to change the way deice boots are operated.

Deice Disconnect

Myth and habit are hindering efforts to encourage pilots to cycle boots early and often in icing conditions.

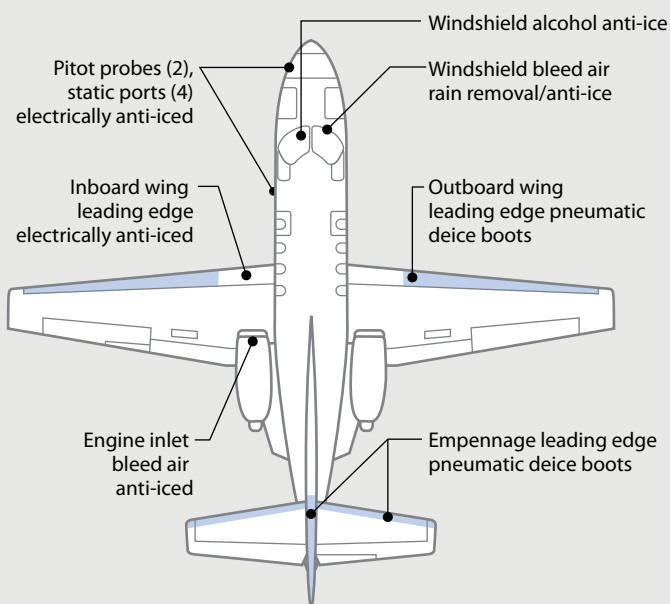
Figure 1

The pilots activated the anti-ice systems when the airplane entered clouds at 3,500 ft (Figure 1). “Moments later, the copilot noticed that they were picking up a trace amount of rime ice on the windscreen,” the report said. “However, since neither pilot saw any ice on the wings, the deice boots were never activated.”

Citation Ice Protection Systems

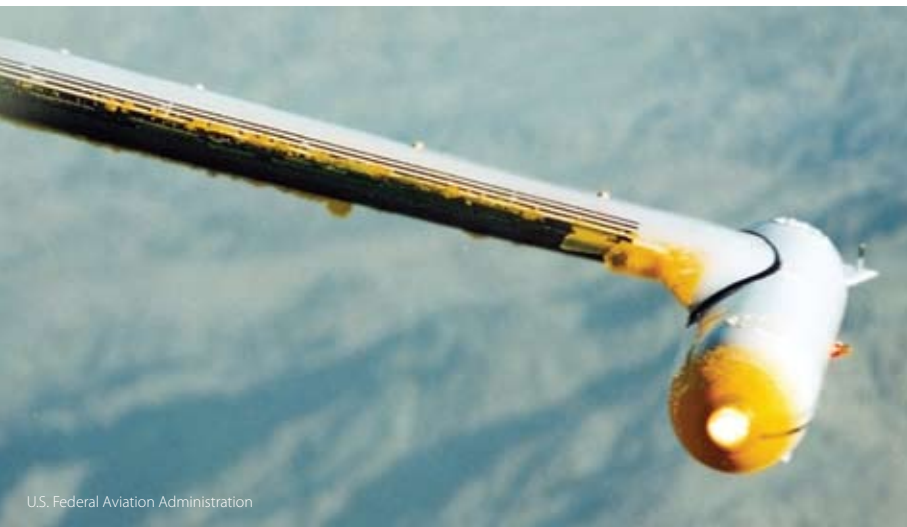
Residual ice remains on a Mitsubishi MU-2 deice boot after the first cycle during flight tests conducted behind a tanker airplane dispensing colored water.

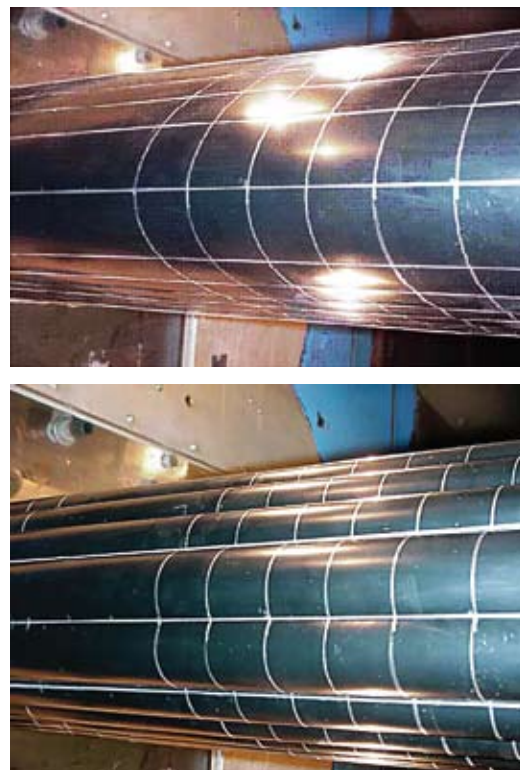
The results of extensive icing wind tunnel tests in 2006 supported activation of deice boots at the first sign of ice.

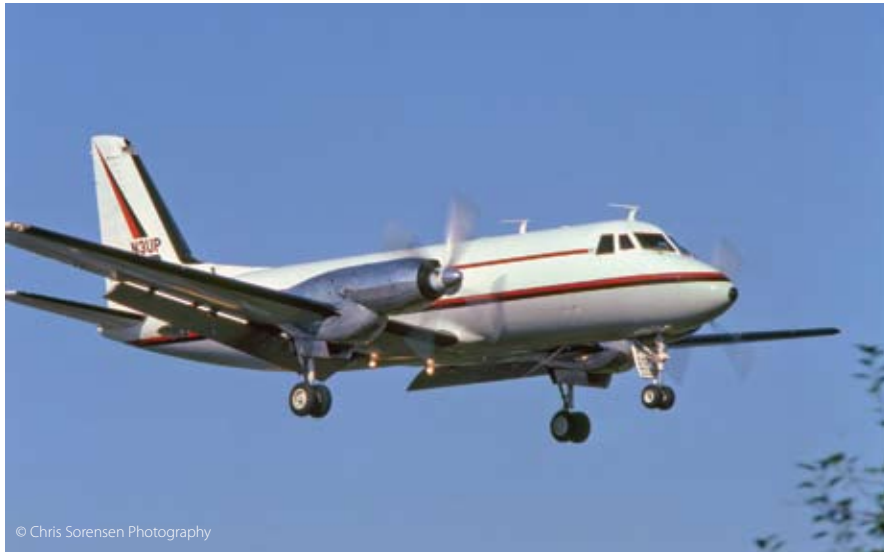
Old-design deice boots, like those on the Gulfstream I, have longer and larger tubes that cycle much more slowly than those in modern boots.
