# Outside the Window

**The Gulfstream III was flown below the glideslope on an unstabilized approach. There were no GPWS warnings, and only one MSAW warning just before impact.**

*This article is based on U.S. National Transportation Safety Board Accident Brief NTSB/AAB-06/06, “Crash During Approach to Landing, Business Jet Services, Ltd., Gulfstream G-1159A (G-III), N85VT, Houston, Texas, November 22, 2004.” The 27-page report contains illustrations.*

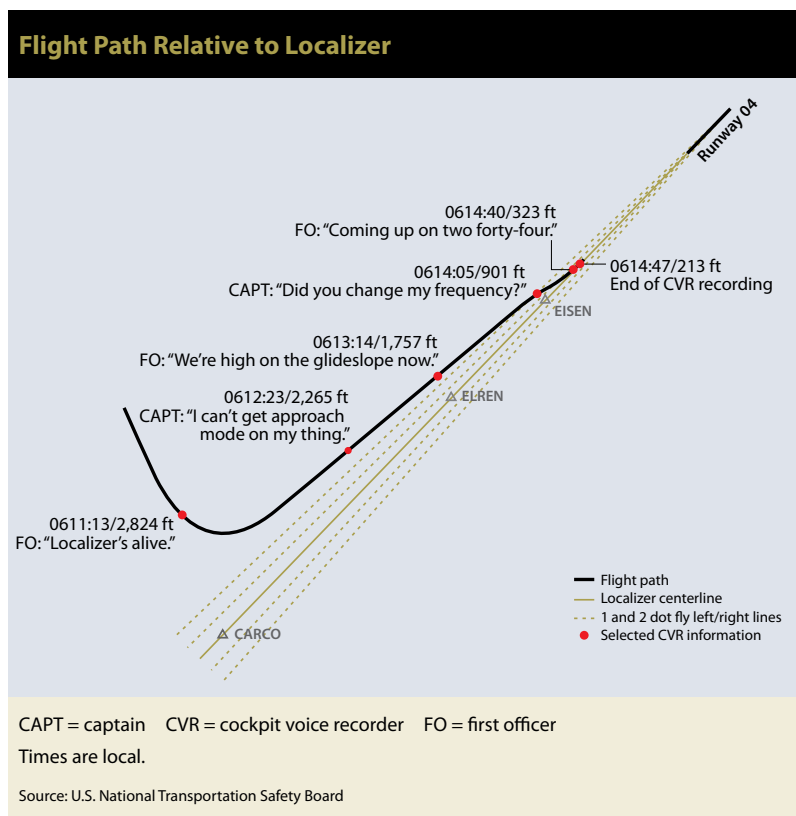
**Figure 1**

The airplane was descending through 2,900 ft at 0611 when the first officer said, “Localizer’s alive” (Figure 1). Neither pilot was aware that the navigation receivers were still tuned to the VOR. The captain began a left turn and asked the first officer to obtain a current RVR report. The tower controller told the crew that RVR was 1,600 ft.

The report said that the approach mode could not be selected because the navigation receivers were not tuned to a valid ILS frequency and were not receiving ILS signals.

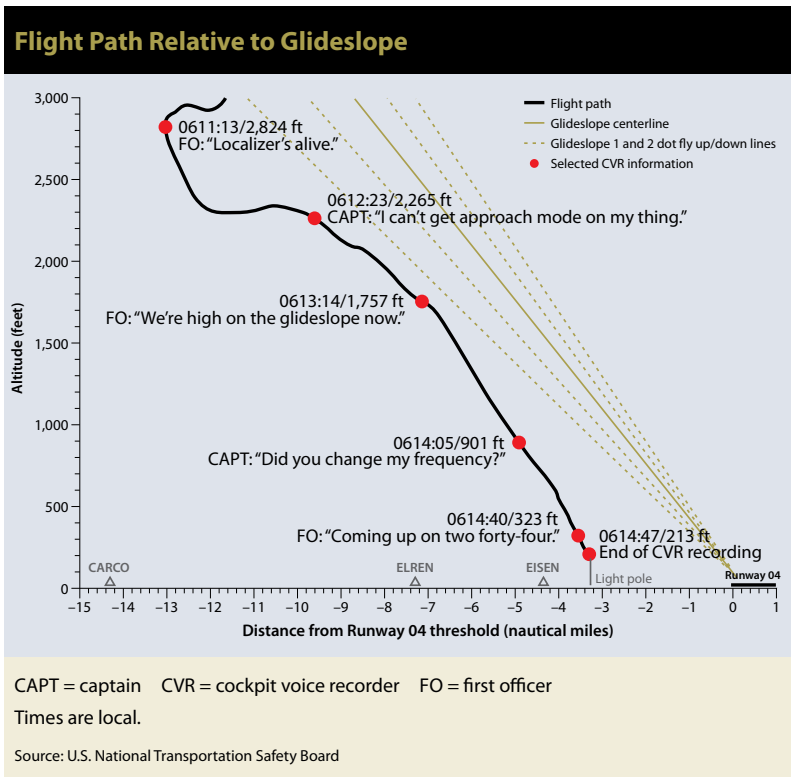
Figure 2

When the airplane descended through 2,000 ft at 0613, it was about 1,000 ft below the glideslope (Figure 2, page 32). Nevertheless, the first officer told the captain, “We’re high on the glideslope now.” Later, while descending through 1,700 ft, 700 ft below the glideslope, the first officer said that the airplane was “on the glideslope now.”

Both pilots likely misidentified the airspeed fast/slow indicators on their electronic attitude director indicators (EADIs) as glideslope indicators. “The fast/slow indicator shows airspeed guidance relative to a target airspeed,” the report said. “The glideslope and fast/slow indicators are the same color and about the same size. Each indicator consists of a moving pointer on a rectangular display, and

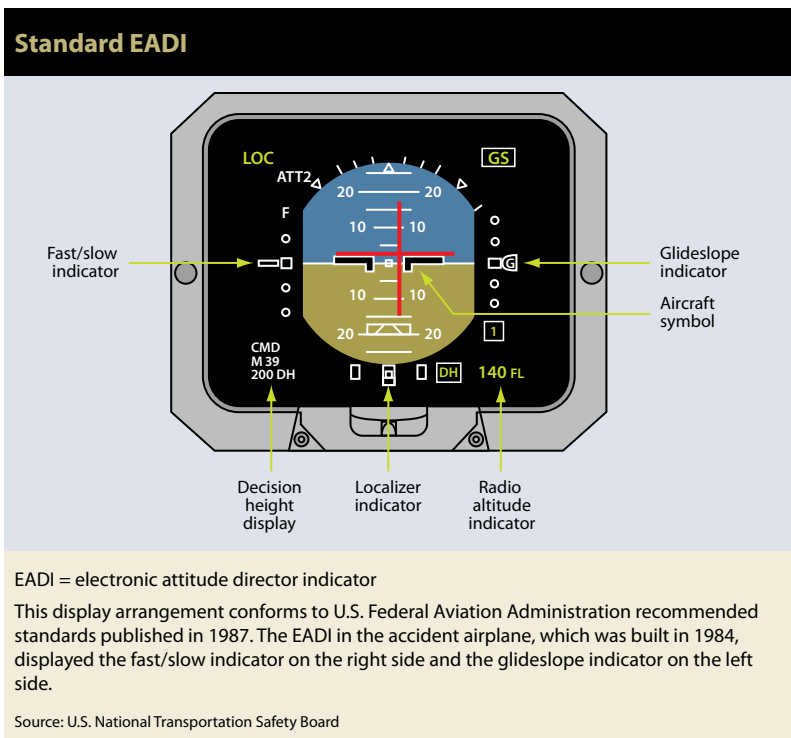
According to standards recommended by the U.S. Federal Aviation Administration (FAA), glideslope indicators should be displayed on the right side of electronic instruments, as shown in Figure 3 (page 32).<sup>1</sup> However, the standards were published in 1987, three years after the accident airplane was manufactured. The EADIs in the accident airplane were configured to display the glideslope indicator on the left side.
