BLINDSIDED

The pilots of an Airbus A340 did not anticipate the 'severe deterioration' of weather as they approached the runway threshold at Toronto.

This article is based on TSB Aviation Investigation Report A05H0002, “Runway Overrun and Fire, Air France, Airbus A340-313 F-GLZQ, Toronto/Lester B. Pearson International Airport, Ontario, 02 August 2005.”

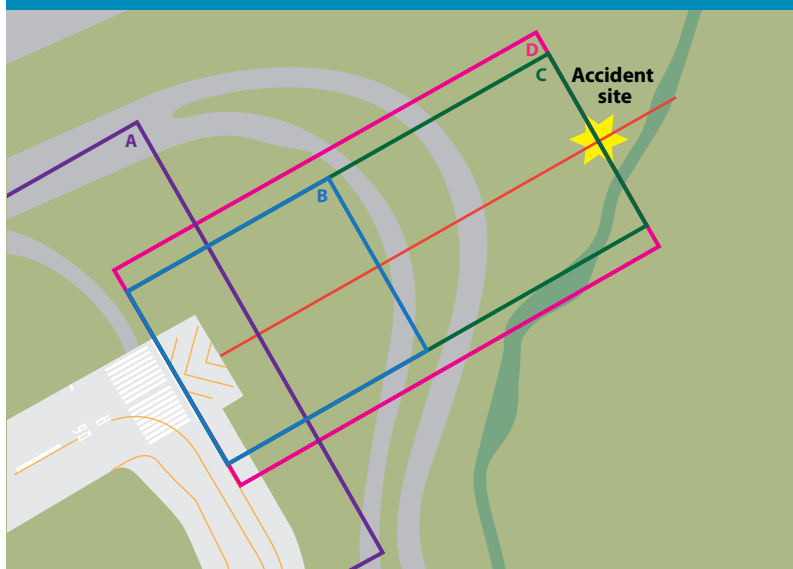
Figure 1

The crew did not calculate the landing distance required and “consequently, they were not aware of the margin of error available ... [or] that it was eliminated once the tailwind was experienced,” the TSB said. In addition, “there were no landing distances indicated on the operational flight plan for a contaminated runway condition” at the airport, and although the first 500 ft/150 m beyond the departure end of the runway complied with Transport Canada (TC) standards, “the topography of the terrain beyond this point, along the extended runway centerline, contributed to aircraft damage and to the injuries to crew and passengers,” the TSB said (Figure 1).

Runway 24L Safety Areas, Actual and Recommended

The asphalt blast pad and grassy area beyond the departure end of Runway 24L extend for 200 ft/60 m, the minimum length required by TC but shorter than the 1,000-ft/300-m runway end safety area (RESA) recommended by the International Civil Aviation Organization (ICAO), the report said. If the Runway 24L RESA had been constructed in accordance with the ICAO recommendation, “an obstacle-free overrun area, free of hazardous ruts, depressions and other surface variations, would have extended to ... approximately 75 m [246 ft] beyond Convair Drive [about the point where the accident airplane stopped]. Similarly, if the requirement had been the same as those established by the U.S. Federal Aviation Administration (FAA) — calling for either a 1,000-ft/300-m RESA or a 600-ft/200-m engineered materials arresting system (EMAS) — “the damage to aircraft and injuries to the passengers may have been reduced,” the report said.

After the accident, TC said that, after a review of RESA specifications and related information, it would require all airports to construct RESAs. The TSB issued a safety recommendation calling on TC to require construction of a 1,000-ft/300-m RESA at the end of all runways longer than 2,400 m (7,874 ft), or an alternative means of “stopping aircraft that provides an equivalent level of safety.” ●

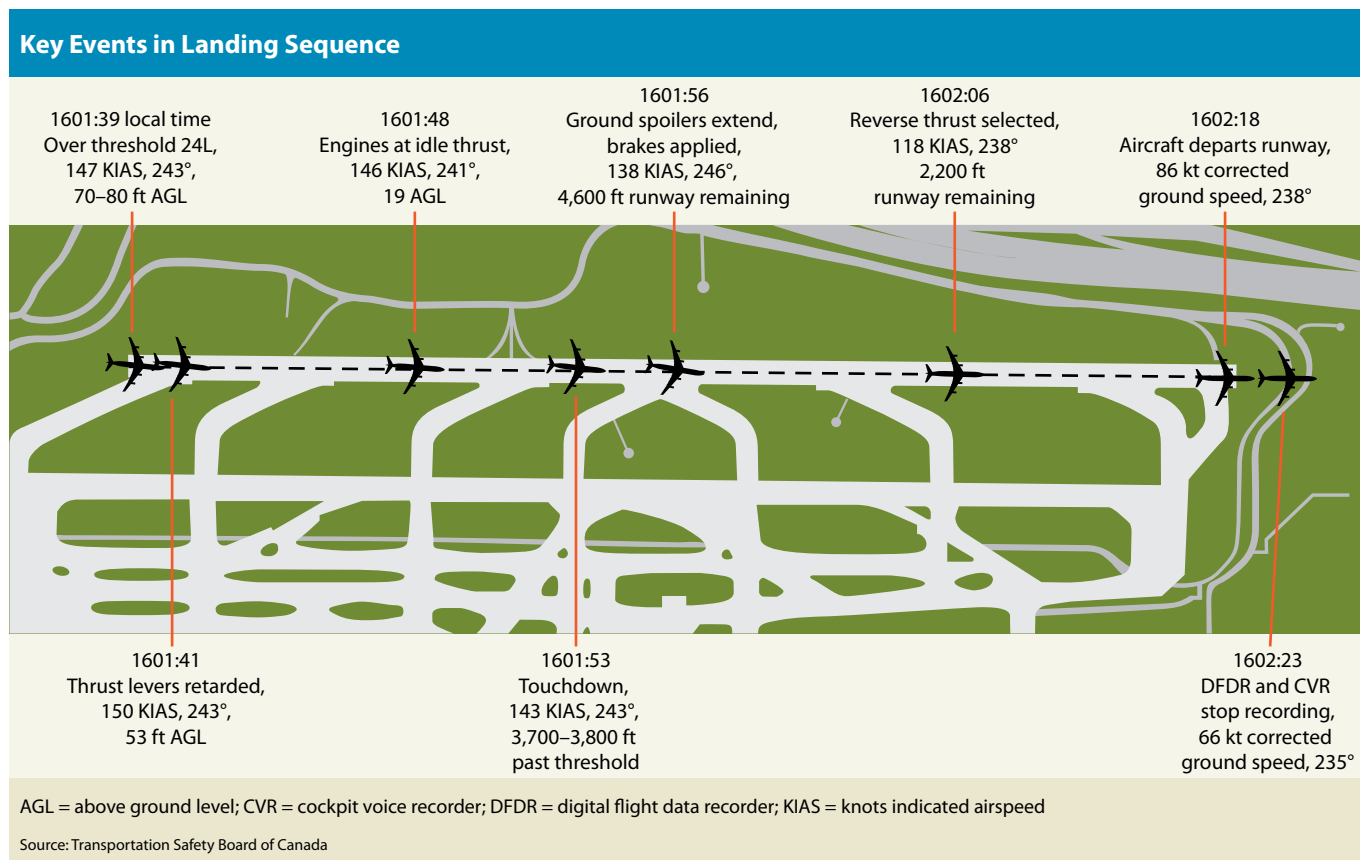
Figure 2

The airplane was 40 ft above the glideslope when it crossed the runway threshold and entered an area of heavy rain and lightning strikes; visual contact with the runway environment was “severely reduced,” the report said. The PF began the flare when the airplane was 40 ft above the runway (Figure 2).

“From this point to touchdown, there were numerous and sometimes significant pitch inputs made on the PF side stick, and the aircraft leveled off at approximately 25 ft for a period of 2 ½ seconds,” the report said. “There were also regular and sometimes large
