NTSB recommendations — issued after a canyon helicopter crash that killed seven people — aim to discourage ‘aggressive flying.’

an ‘e-ticket’ ride

Disregard of safe flying procedures by a helicopter pilot sometimes called “Kamikaze” and inadequate surveillance of canyon air tour operations by his employer and the U.S. Federal Aviation Administration (FAA) were probable causes of the fatal crash of an Aerospatiale AS 350BA in Arizona’s Descent Canyon, the U.S. National Transportation Safety Board (NTSB) says.

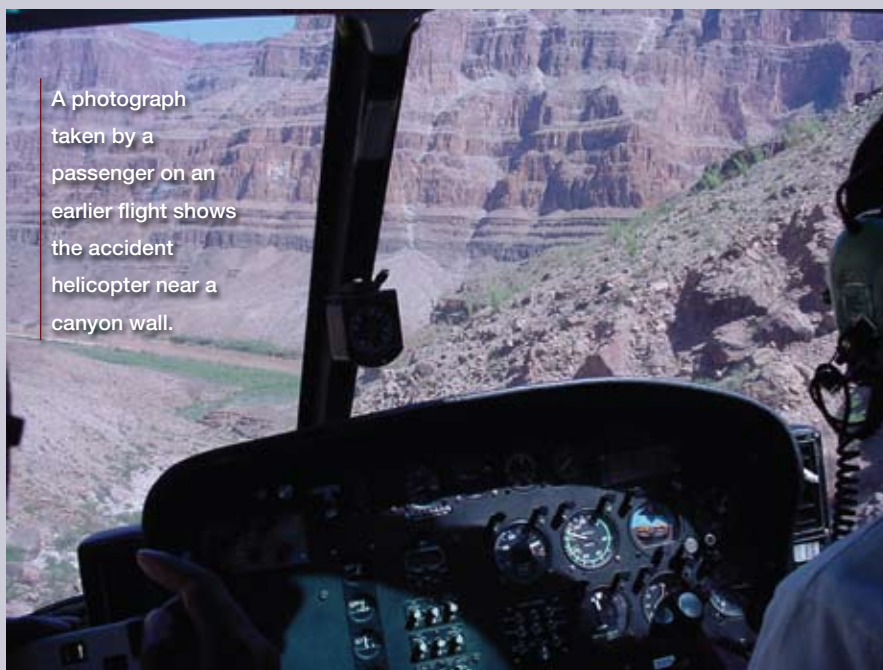
A photograph taken by a passenger on an earlier flight shows the accident helicopter near a canyon wall.

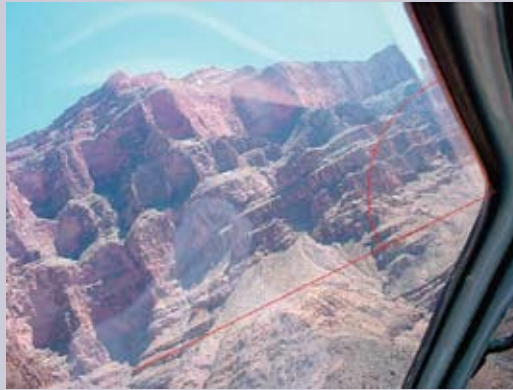
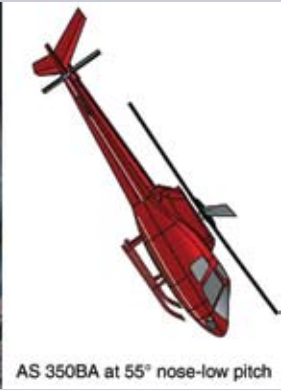
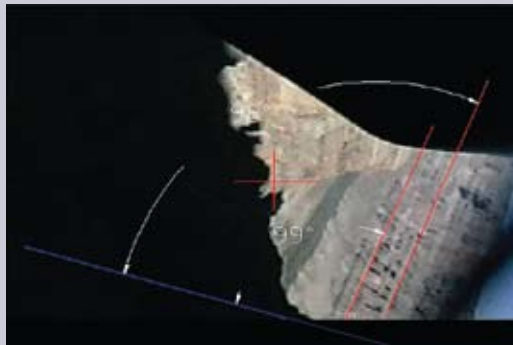
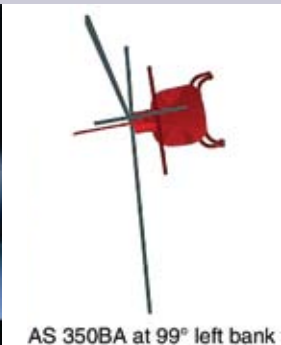
A former Sundance pilot described the accident pilot as “extremely good” and “more qualified in the helicopter than the job demanded.” The accident pilot “pushed the aircraft and pushed the rules of flight in Descent Canyon,” he said; those rules included limits of 30 degrees of bank and 10 degrees to 15 degrees of nose-down pitch.

The Sundance director of operations said that most pilots flew between 100 and 110 kt, with descent rates into the canyon averaging 1,000 fpm but possibly as high as 2,500 fpm. Another Sundance pilot on the Descent Canyon route the day of the crash estimated that the accident pilot was flying 120 to 140 kt, the report said.

Passenger photos show the accident helicopter on an earlier flight; graphics depict pitch and bank angles.
