# HIGH, HOT and FIXATED

Despite several warnings, the Garuda 737 pilot stayed focused on landing.

*This article is based on NTSC Aircraft Accident Investigation Report KNKT/07.06/07.02.35: “Boeing 737-497, PK-GZC, Adi Sucipto Airport, Yogyakarta, Indonesia, 7 March 2007.”*

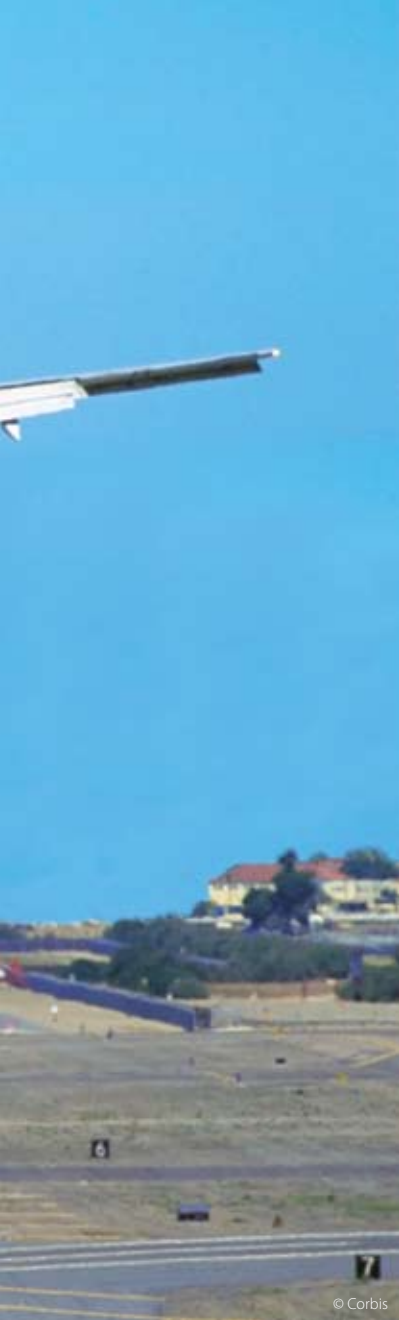
The GPWS provided 15 alerts and warnings during the approach.

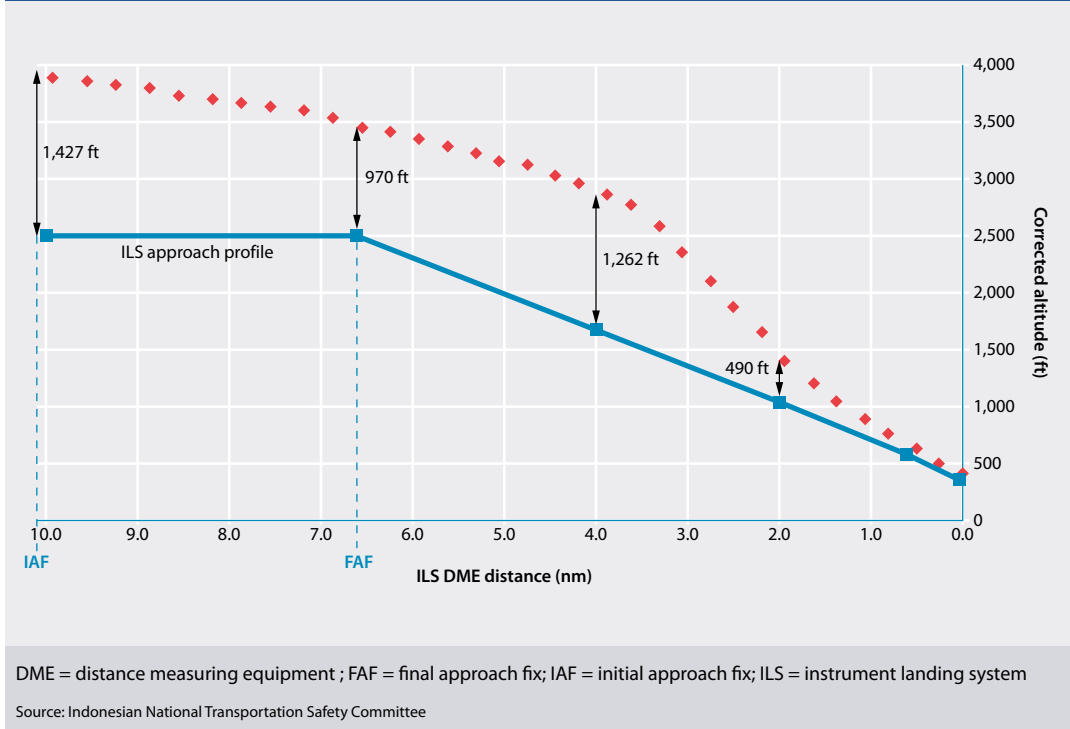
Figure 1

At 0655, the aircraft crossed the initial approach fix at 283 kt and at 3,927 ft — 1,427 ft higher than the published minimum crossing altitude of 2,500 ft (Figure 1, p. 44). The 737 tracked the localizer course from the initial approach fix inbound and crossed the final approach fix in clean configuration at 254 kt and at 3,470 ft — 970 ft above the published crossing altitude. Groundspeed was 286 kt; the tailwind component decreased as the aircraft descended.

The 737 was about 4 nm (7 km) from the runway and about 2,800 ft above ground level (AGL) — 1,262 ft above the glideslope — when the PIC began a steep descent. “The PIC descended the aircraft steeply in an attempt to reach the runway, but

### Aircraft Flight Path

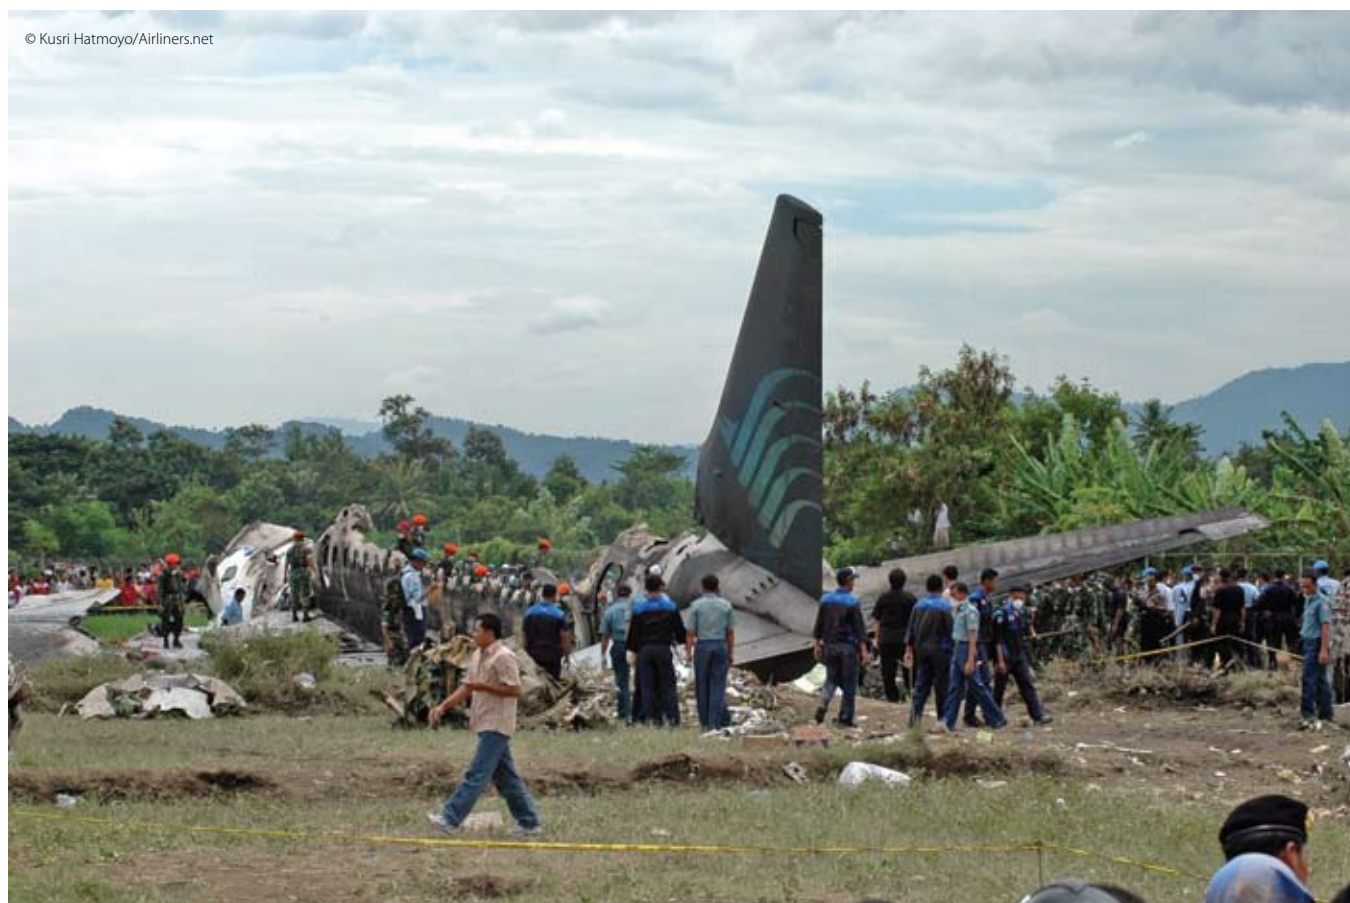
The 737 was 10 m (33 ft) right of the centerline when it overran the runway at 110 kt at 0658. It crossed three ditches and a road, and struck two fences and an embankment before stopping in a rice paddy 252 m (827 ft) from the end of the runway. The nosewheel assembly had separated from the aircraft on the runway. “The engines and landing gear separated from the aircraft and were destroyed,” the report said. “The right wing was severed from the fuselage, swung around the fuselage and came to rest on top of the left wing.”

There were 140 people aboard the aircraft. One flight attendant and 20 passengers were killed. One flight attendant and 11 passengers sustained serious injuries, and two flight attendants and 98 passengers sustained minor injuries. The two pilots, a flight attendant and four passengers were not injured. The aircraft was destroyed by the impact and a post-impact fire.
