The captain's decision to shut down the left engine while taxiing a McDonnell Douglas DC-9-50 with a known right hydraulic system problem was blamed for the airplane's collision with an Airbus A319-100 on the ramp at Minneapolis–St. Paul (Minnesota, U.S.) International Airport on May 10, 2005. Fluid in the DC-9's right hydraulic system had leaked from a fractured valve before the airplane landed in Minneapolis, and the subsequent shutdown of the left engine resulted in insufficient hydraulic pressure to effectively operate the brakes, steering and thrust reversers, said the report by the U.S. National Transportation Safety Board (NTSB).

A Northwest Airlines DC-9 struck an A319 after losing hydraulic pressure.

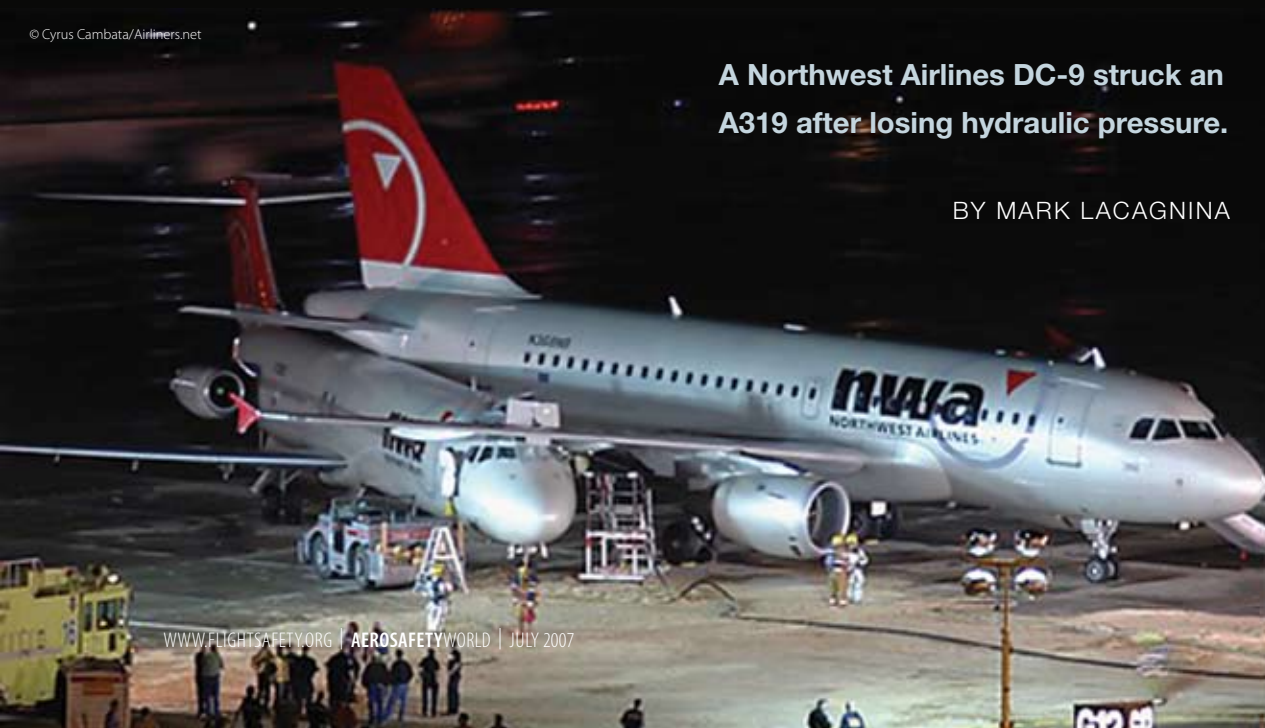
Fuel began pouring into the DC-9's flight deck from a ruptured wing tank in the Airbus.

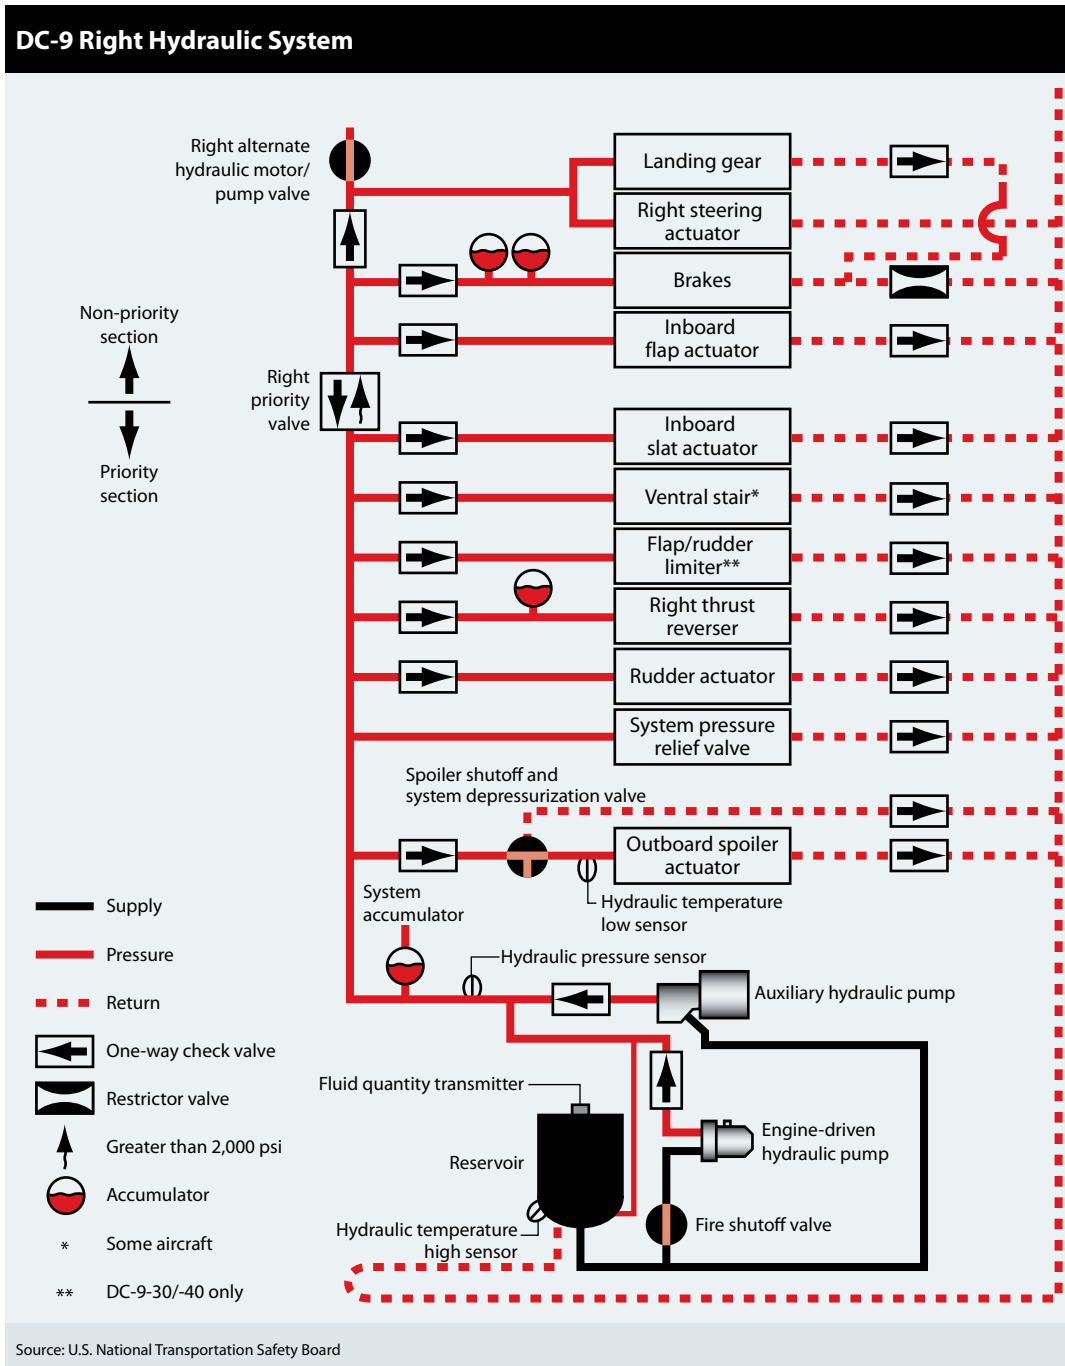
Figure 1

The DC-9's left hydraulic system and right hydraulic system have fluid reservoirs and engine-driven pumps. The right hydraulic system also has an electrically driven auxiliary pump (Figure 1, p. 34). An interconnected alternate pump can pressurize the left system or a portion of the right system if an engine-driven pump fails. However, hydraulic fluid cannot be routed from one system to the other.
