BY MARK LACAGNINA

**A relayed company message distracted the crew during an autoland approach.**

# Bad CALL

*This article is based on AAIB report no. 5/2008: “Report on the Accident to Boeing 737-300, Registration OO-TND, at Nottingham East Midlands Airport on 15 June 2006.”*

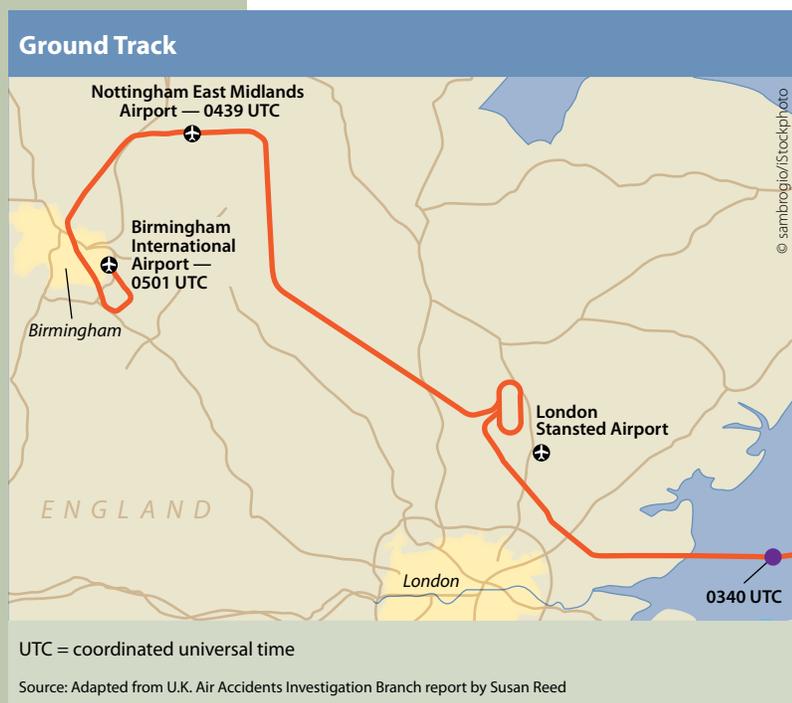
Figure 1

Believing that the visibility at Stansted would improve as the sun continued to rise, the crew requested and received clearance from ATC to hold (Figure 1). While flying a holding pattern northwest of the airport, however, the crew received several updates indicating that visibility was steadily decreasing. At 0401, they were advised that RVR was between 650 and 350 m (2,100 and 1,200 ft).

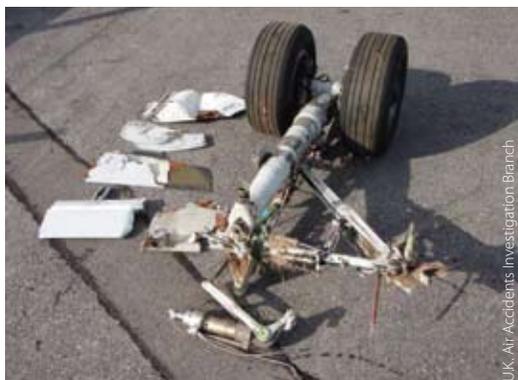
The fuse pins in the right main landing gear failed, as designed, on contact, preventing structural damage to the wing.

The impact occurred at 0439. After breaking off at its fuse pin attachment points, the right main gear struck the inboard flap assembly and the rear fuselage, and came close to striking the horizontal stabilizer. The bottom of the right engine nacelle and right wing tip also were damaged.

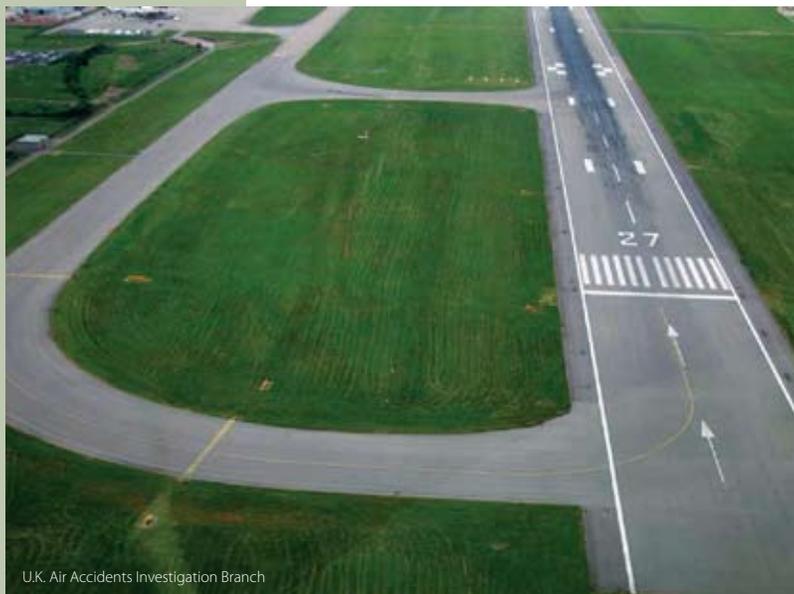
The scrapes in the center of the grassy area were made by the right main gear, engine nacelle and flap track.

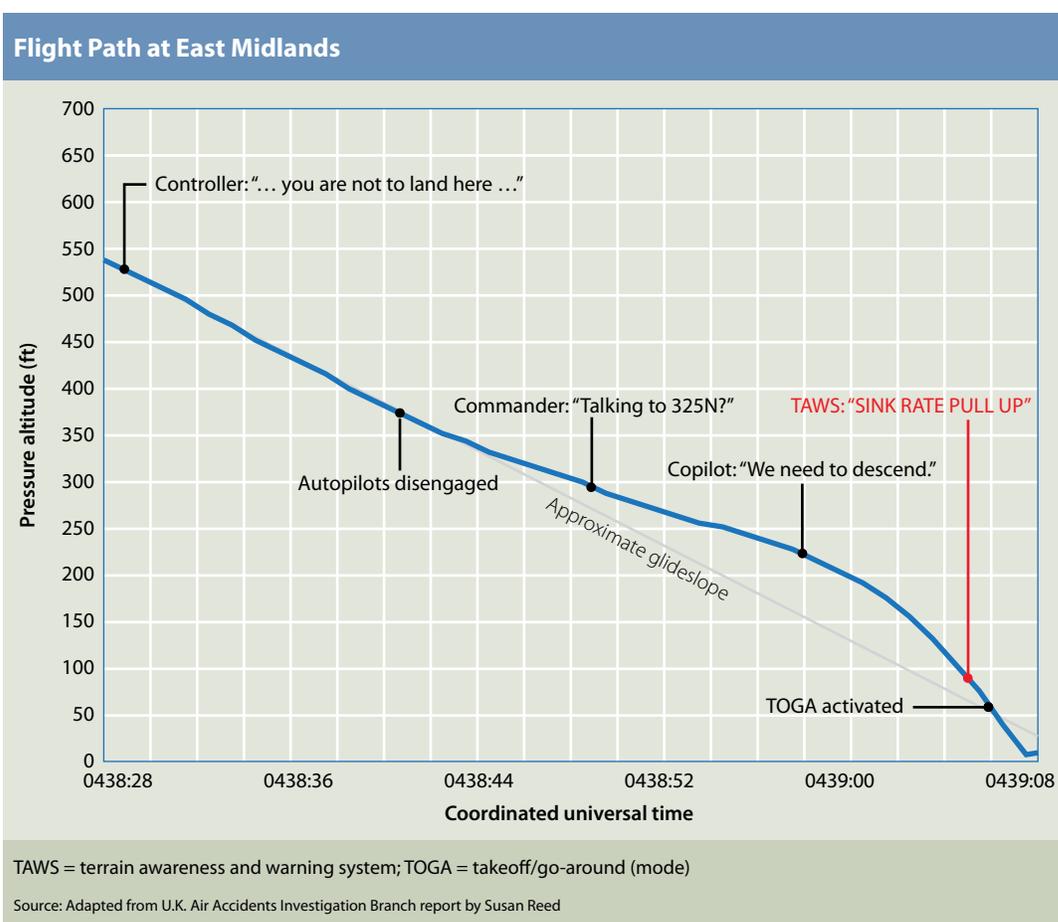
**Figure 2**

Figure 2 shows the aircraft’s flight path. It was within 2 nm (4 km) of the runway when the tower controller radioed, “Three two five November, I’ve been instructed that you are not to land here from your operation ... operational authority. At your discretion, you may go around.”

Both pilots heard the transmission, which had included only part of their call sign — “Quality” was omitted. The copilot, whose command of English was limited, did not realize that the transmission was meant for them and did not understand the message; thus, he did not reply to the controller. “With no response from the copilot, the commander was not sure whether the ATC message was for his aircraft and, if so, what it meant,” the report said. “He attempted to respond to ATC himself, but he inadvertently pressed the autopilot disconnect button as he started to speak, so that both autopilots disconnected.”
