A navigation problem distracted the AdamAir pilots from flying the aircraft.

OFF-COURSE *Confusion*

The flight crew's attention was focused on troubleshooting an inertial reference system (IRS) problem, and neither pilot was monitoring the flight instruments when the autopilot disengaged and the Boeing 737-400 began to roll and pitch nose-down, said the Indonesian National Transportation Safety Committee (NTSC). The pilots apparently became spatially disoriented and did not conduct the appropriate procedures to recover from the upset. The 737 descended into the Makassar Strait, near Sulawesi, Indonesia; all 102 people aboard were killed.

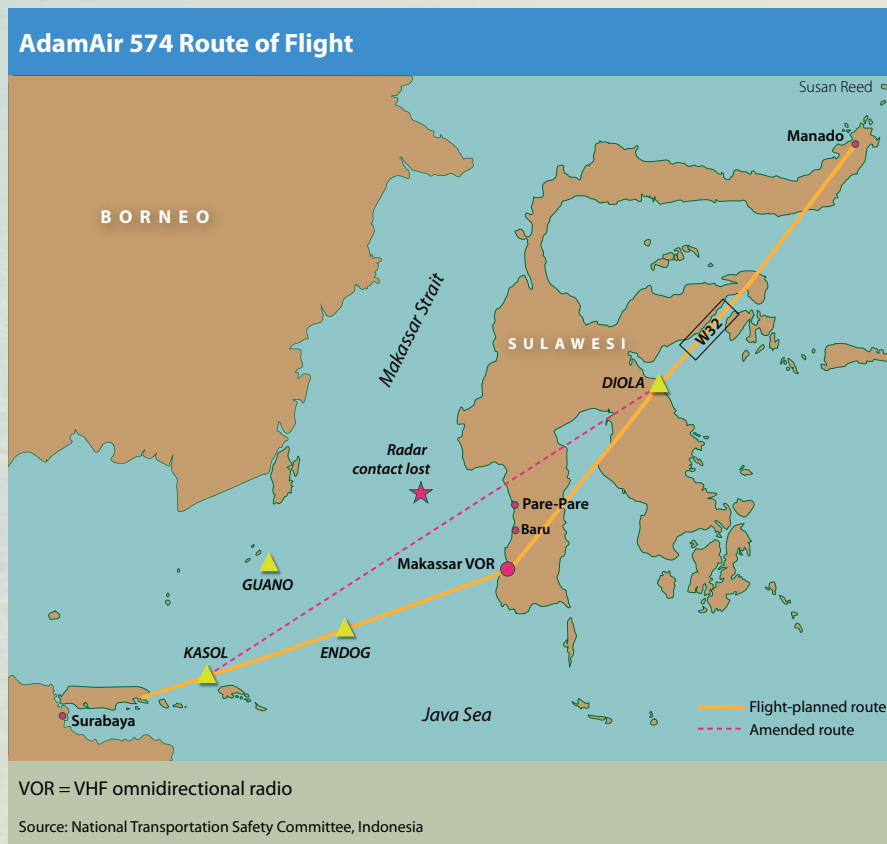
Figure 1

The aircraft departed from Surabaya's Djuanda Airport at 0559 coordinated universal time — 1359 local time. The crew established the 737 on Airway W32, which extends east-northeast from Surabaya over the Java Sea to the Makassar VOR (VHF omnidirectional radio) on the southwest coast of Sulawesi, then north-northeast to Manado, which is on the northern tip of the island (Figure 1).

The aircraft was north of the GUANO waypoint (see Figure 1) at 0637 when the new controller told the crew to fly directly to DIOLA. A few minutes later, the controller asked the crew for their heading, and the copilot replied that they were heading 046 degrees, direct to DIOLA. The controller told the crew to fly a heading of 070 degrees to track directly to the waypoint.

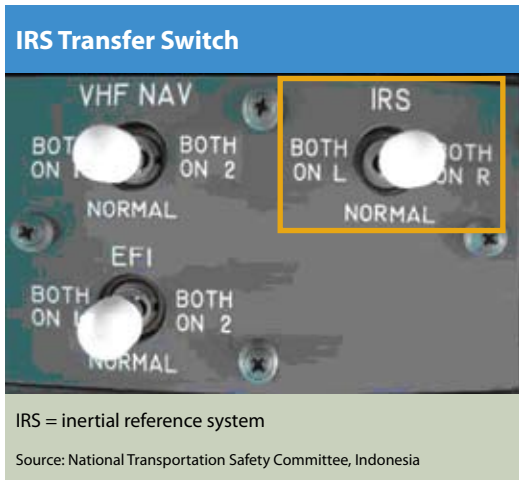
Figure 2

An IRS transfer switch and two IRU mode-selector switches are located on the 737’s overhead panel (Figure 2). The transfer switch has three positions: “BOTH ON L”; “NORMAL”; and “BOTH ON R.” When “NORMAL” is selected, the PIC’s electronic attitude director indicator (EADI) and electronic horizontal situation indicator (EHSI) receive data from the left IRU, and the copilot’s EADI and EHSI receive data from the right IRU. The other two switch positions are used to channel data either from the left IRU or the right IRU to both pilots’ instruments. The accident aircraft’s IRU transfer switch was selected to “NORMAL.”

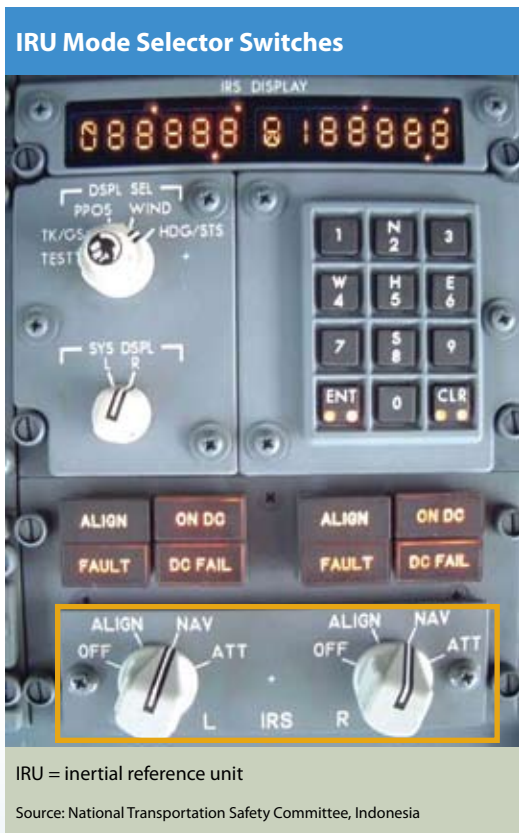
Figure 3

Each IRU has a mode-selector switch with three positions (Figure 3): “ALIGN,” which is used before departure for position initialization, using the latitude/longitude coordinates for the gate or an airport reference point, and to align the gyros vertically and with true north; “NAV,” for normal navigation; and “ATT,” the attitude

mode, which is used if alignment is lost in flight. When the attitude mode is selected, there is a brief transition period in which the autopilot disengages and several flight data parameters are replaced with failure warnings on the pilots’ flight instruments. The 737’s quick reference handbook (QRH) says that during this period, the aircraft should be hand-flown straight and level, with no power or configuration changes, until valid pitch and roll parameters are displayed. The QRH notes that the transition period is approximately 30 seconds.

The statement “but the left one is good” and other statements indicated that the crew suspected that the right IRU was malfunctioning but were confused by the absence of a failure warning. Nevertheless, the PIC eventually decided to use the IRS fault procedure in the QRH to realign the right IRU. He told the copilot to change the mode for the right IRU from navigation to attitude.

“However, after moving the IRU mode selector switch to ‘ATT,’ they did not comply with the QRH requirement to fly the aircraft straight and level at a constant airspeed for 30 seconds,” the report said. Consequently, when the autopilot disengaged, the aircraft began to roll right 1 to 2 degrees per second. The roll rate subsequently increased to 4 to 5 degrees per second. During

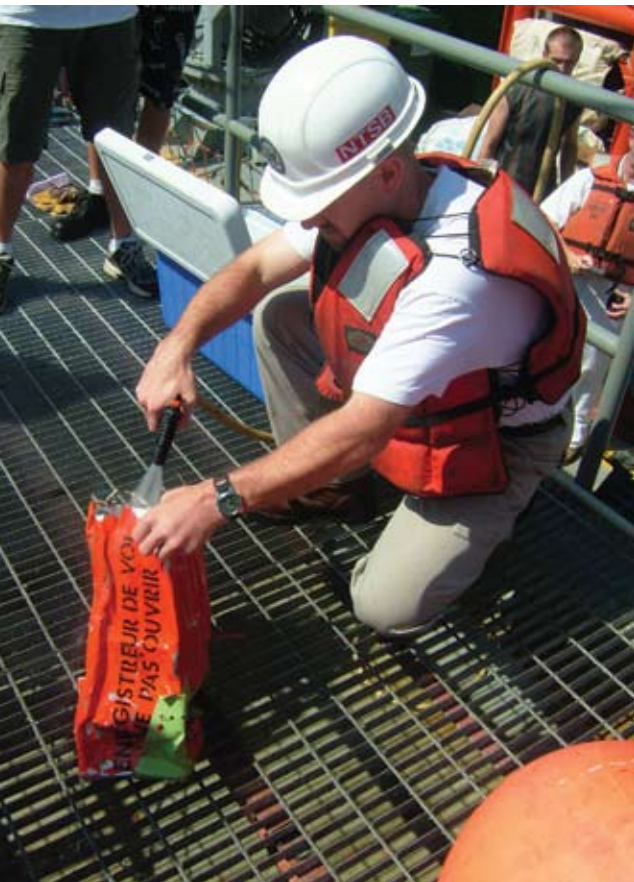
An NTSB representative flushes debris off a flight recorder recovered from the seabed by a remotely operated vehicle.
