Metro pilots lost the big picture during a difficult approach.

CFIT in Queensland

An experienced pilot with a history of noncompliance with standard operating procedures (SOPs), an inexperienced and nonassertive copilot, excessive airspeeds and descent rates during a nonprecision approach in bad weather, and the operator's disregard of its own rules and training standards were found to have played roles in the May 7, 2005, crash of a Fairchild Metro 23 in Queensland, Australia.

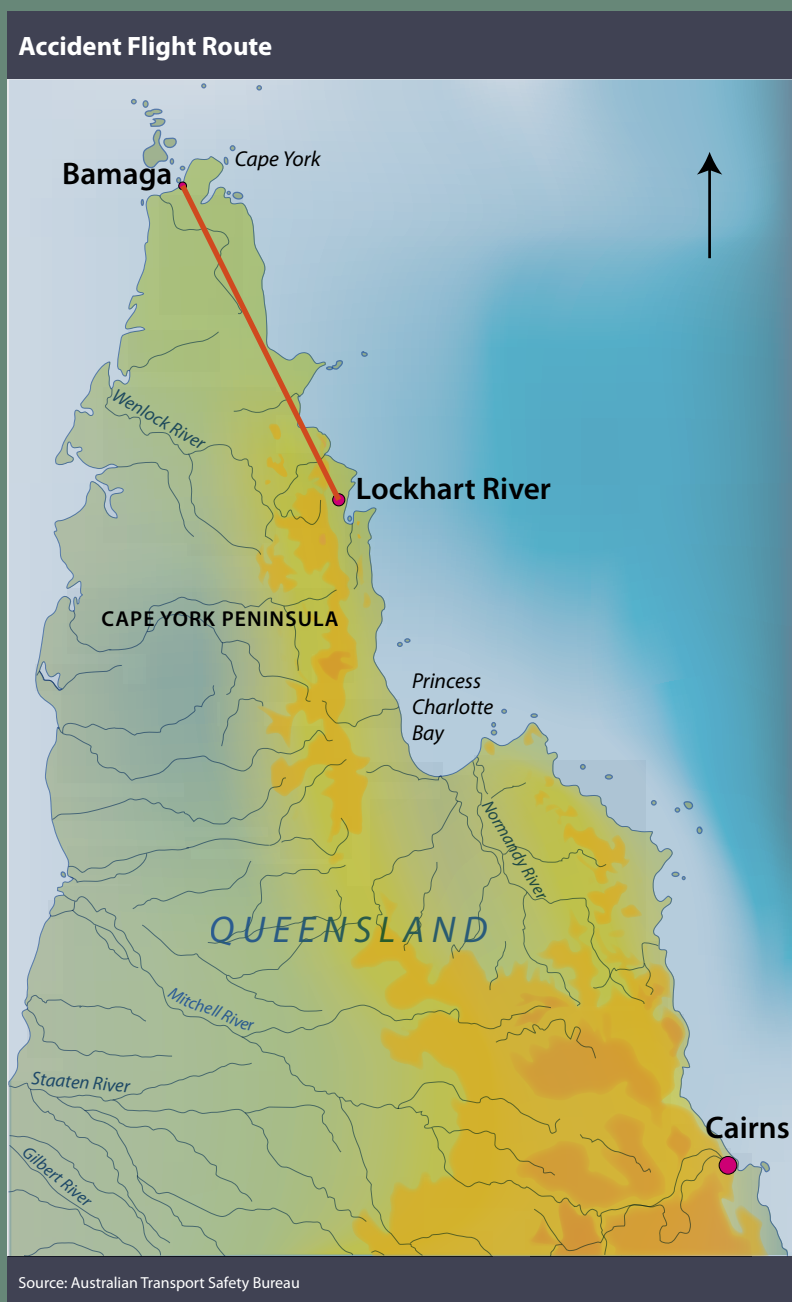
Figure 1

The morning of the accident, the flight crew had flown the Metro from Cairns to Lockhart River and Bamaga. The accident occurred on the return trip to Cairns, on the leg from Bamaga to Lockhart River (Figure 1).

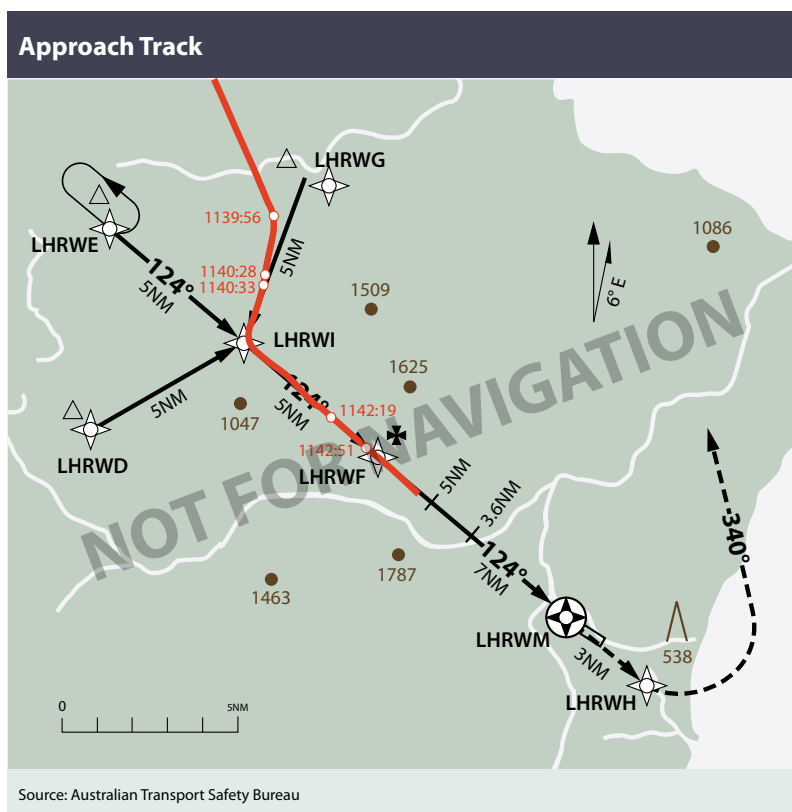
Figure 2

At 1139, the copilot announced on the airport’s common traffic advisory frequency (CTAF) that the Metro was over “Whiskey Golf” — the LHRWG waypoint, an initial approach fix — and was inbound to “Whiskey India” — LHRWI, the intermediate fix, which was 12.5 nm from the runway threshold (Figure 2).

Because of terrain northwest of the airport, the approach procedure is relatively complex. The final approach course is offset five degrees from the runway centerline because of a mountain northwest of the airport — the 1,787-ft obstacle spot elevation depicted on the plan view (Figure 2, p. 31). The constant descent angle is 3.49 degrees, rather than the optimal 3 degrees. The distance from the final approach fix to the MAP is 7 nm, rather

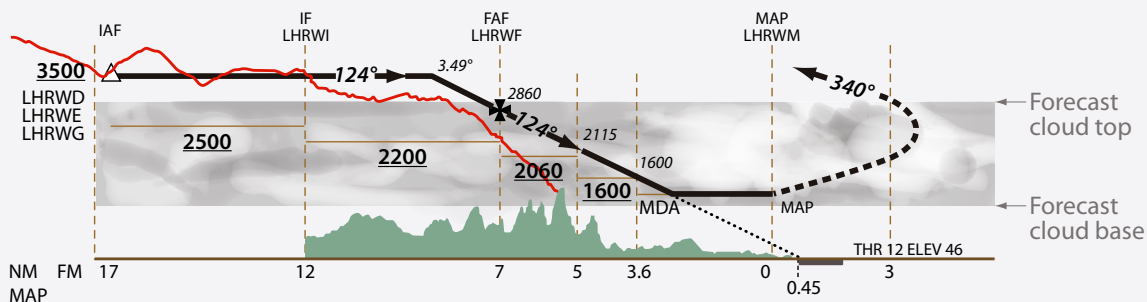
Figure 3

The aircraft then descended from 3,500 ft to 3,000 ft and remained at that altitude momentarily (Figure 3, p. 32). “During this level flight,

the aircraft's speed reduced to the maximum half-flap extension speed (180 kt) and the flaps were extended [to half of their travel],” the report said. “The aircraft did not descend below the segment minimum safe altitude (2,200 ft) during this initial descent and leveling.”

Soon after the landing gear was extended, about 1.4 nm from the final approach fix, the aircraft began to descend at 1,000 fpm. Airspeed was about 177 kt when the aircraft crossed the final approach fix. Power then was reduced, and the descent rate increased. Airspeed remained about 175 kt and the average descent rate was 1,700 fpm during the last 48 seconds of the flight. The aircraft descended below 2,060 ft, the published minimum altitude for the approach segment, soon after crossing the final approach fix.

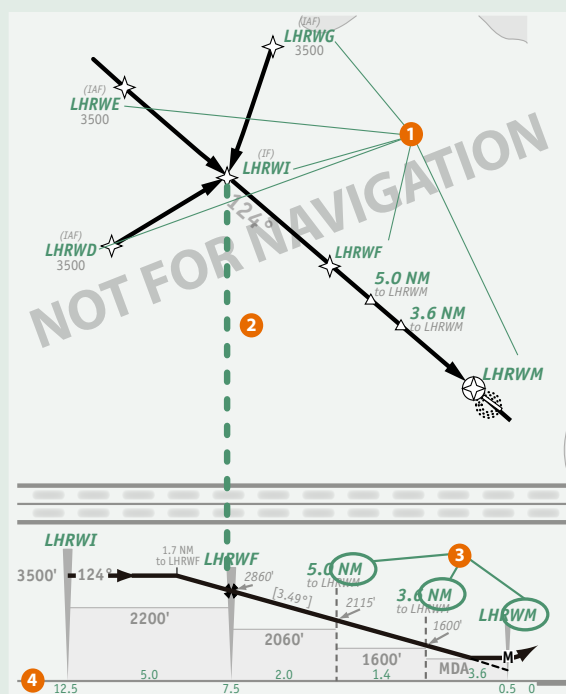
The information alignment factor on the Jeppesen chart resulted from the absence in the profile view of the initial approach fixes — LHRWD, LHRWE and LHRWG. The first waypoint in the profile view is the intermediate fix, LHRWI. This caused LHRWI in the plan view to be

aligned vertically with LHRWF in the profile view. The report said that this can cause a pilot to become confused when scanning the chart.

Another factor specific to the Jeppesen chart is the use of the same typeface and type size for waypoints and the stepdown fixes — 5.0 NM and 3.6 NM — on the final approach segment. The report said that this results in similar appearance of the letter "M" in the stepdown fixes and in LHRWM, and could lead to misidentification of the MAP in high-workload situations.

1. Similarity of waypoint names may make them more difficult to differentiate.
2. The vertical alignment of two different waypoints may cause confusion.
3. Labels end with the same letter and use the same typeface and size for different information.
4. The lower set of numbers shows the distances to the runway, but not to the missed approach point. The upper set of numbers shows the distance for each segment to the missed approach point, but not the distances from a waypoint to the missed approach point.

ATSB recommended that these safety factors be considered when

designing and approving RNAV/GNSS approaches. “There are limited options available to overcome these design problems,” the report said. “However, the overall influence that these variations can have needs to be considered by CASA when evaluating and deciding whether to accept the approach.”
